## SELECTED PROBLEMS OF CULTURAL HERITAGE PROTECTION IN A SMALL HISTORIC TOWN BASED ON THE EXAMPLE OF GŁOGÓW MAŁOPOLSKI

Joanna BARTKIEWICZ<sup>1,\*</sup>, Somayeh AFSHARIAZAD<sup>2</sup>

### Abstract

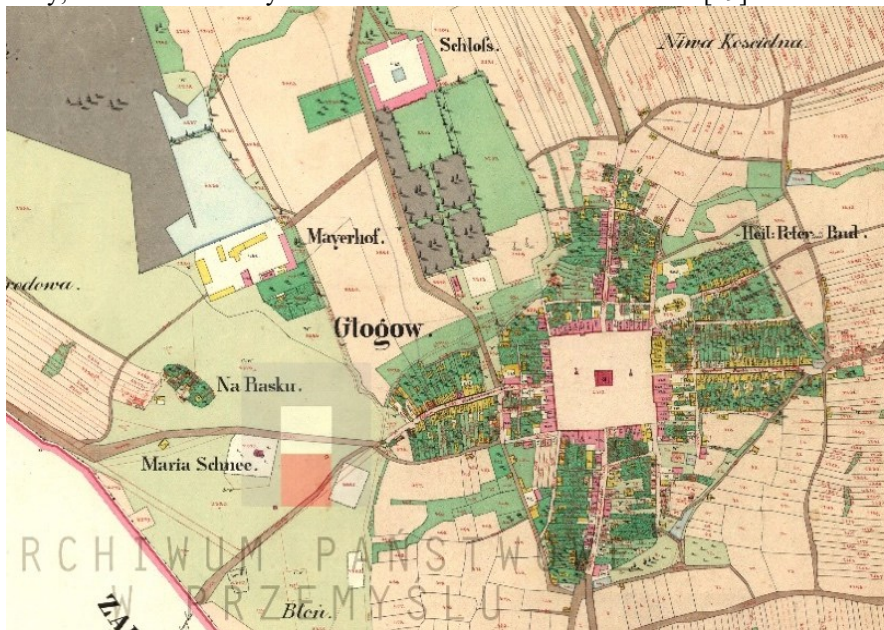
Blocks of buildings were laid out around the market square in 3×3 large cords, which, when the width of the streets was added, amounted to approximately 154×154 meters. These diagonals were intended for the location of public facilities such as a church, a bathhouse, a hospital, and a brewery. Another characteristic feature of this layout is the location of the Town Hall in the middle of the square, at the crossroads of the main streets [16]. It is worth mentioning that communication played an important role in economic centers, and Głogów Małopolski was such a center, as trade was one of the most important elements of the town [17]. In fact, the purpose of the foundation of the town of Głowów was to create a local economic center, a place for the exchange of goods that could compete with Rzeszów [18].

Fig. 3. Historical urban layout of Głogów Małopolski on a cadastral plan from 1849.

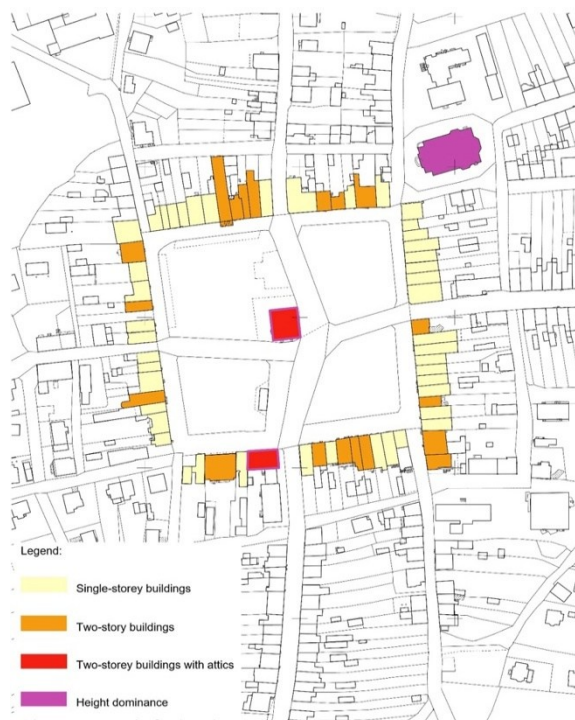
The vast majority of the analyzed buildings are single-story buildings located on plots whose fronts have still retained their original widths. The others, for the most part, were erected on plots created after the amalgamation of several smaller ones, also with original parameters.

The main high-rise dominants in the town are the aforementioned town hall, the Holy Trinity Parish Church located in the diagonal block of the market square, and the building located in the southern frontage, at the entrance to the market square from the direction of Rzeszów.

**Fig. 4.** Analysis of the height of buildings in the market square development in Głogów Małopolski

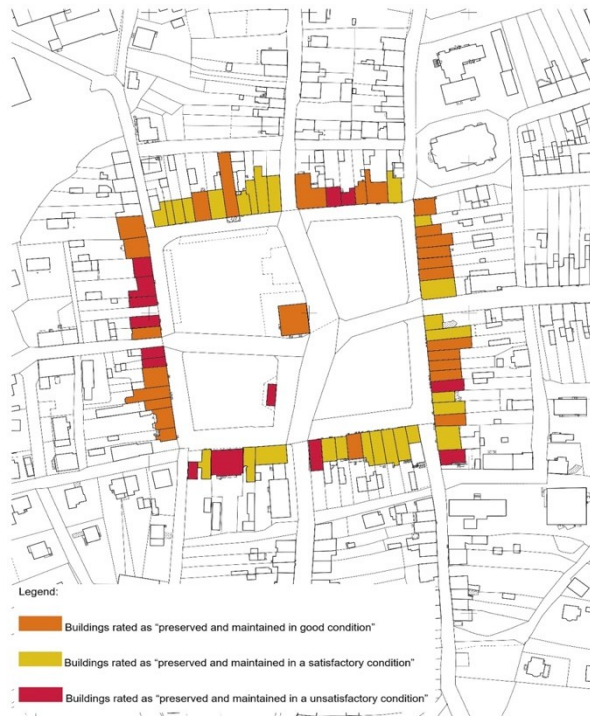
With regard to the discussion of the research on the degree of conservation of the substance, i.e., the buildings in the market facades, it should be noted that three criteria were adopted in order to carry out the relevant analyses. These were state of conservation (taking into account the possible process of deterioration), coloring (in terms of integration into the cultural landscape of the city center), and façade aesthetics (divisions, ornamentation, etc.). The buildings were assessed according to the three categories adopted: preserved and maintained in good condition, preserved and maintained in satisfactory condition, and preserved in unsatisfactory condition (see Fig. 5).

**Fig. 5.** Analysis of the state of preservation of market tenements in Głogów Małopolski

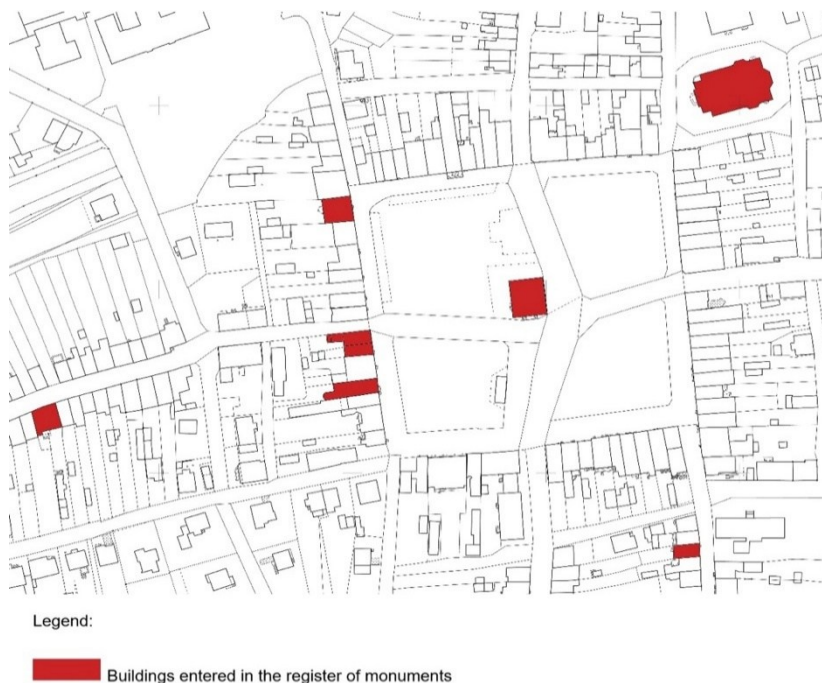
In Głogów there are eight buildings listed in the Register of Monuments of the Podkarpackie Province (Fig. 6). They are Holy Trinity Parish Church with the cemetery and the entrance gate (reg. no.: A-85 of 10.05.2004); "Na Piasku" Parish Cemetery with the Chapel of Our Lady of the Snows (reg. no.: 1278 of 15.07.1995); the Town Hall (reg. no.: 1250 of 18.03.1992); and historical residential houses: the house at 23 1 Maja Street (reg. No: 1179 of 18.03.1992), the house at 8 Rynek Street (reg. no.: A-648 of 20.06.1986), the house at 60 Rynek Street (reg. no.: 1163 of 06.1986), the house at 61 Rynek Street (reg. no.: 1164 of 06.1986), and the house at 6 Sienkiewicza Street (reg. no.: 1174 of 09.09.1987).

In addition to the above-mentioned buildings, the Renaissance urban layout of the town with its surrounding buildings (Reg. No. 392 of 31.06.1971) [21] is also protected on the basis of the area register. It includes the market square and several streets connected to it.

The entire area is entered in the register of monuments as a historical urban layout.

**Fig. 6.** Objects located in the area of Głogów Małopolski included in the register of immovable monuments of the Podkarpackie Voivodeship

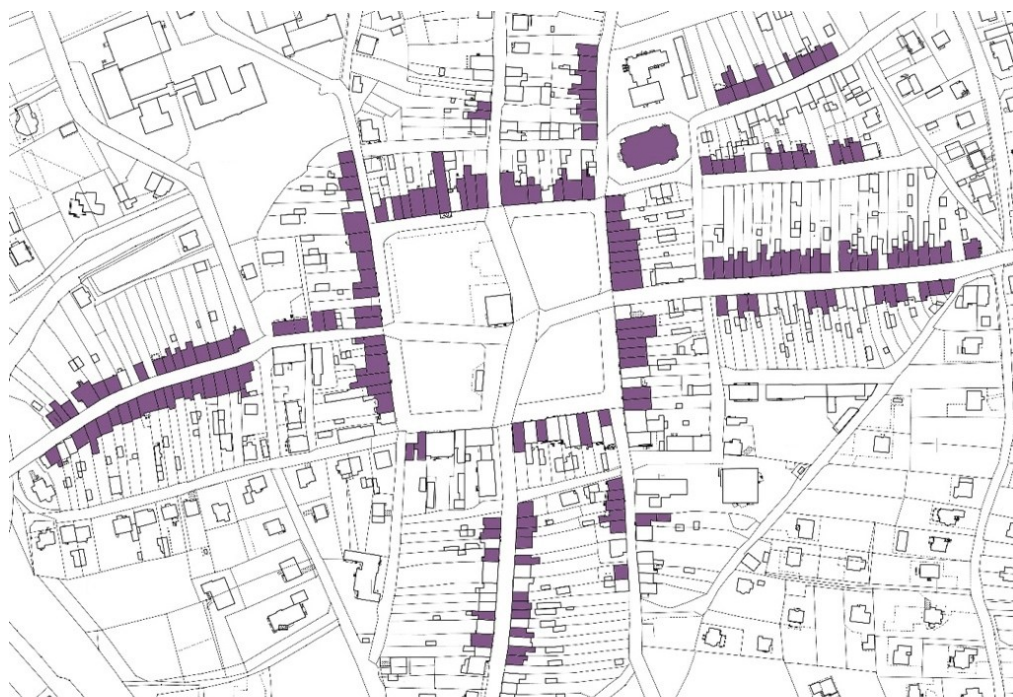
Other buildings of historical origin and value are listed in the Municipal Register of Historical Monuments (Fig. 7) This list includes most of the townhouses in the market squares.

Fig. 7. Objects located in the area of Głogów Małopolski included in the communal register of monuments

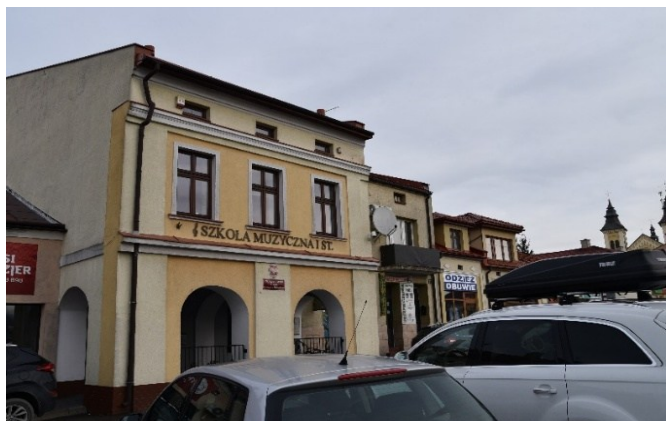
As a result of the field research (on-site inspections and inventory), it was found that the Music School building (Rynek 14) is the clear dominant feature of the northern frontage, as well as being the building in the best condition in this part of the market (Fig. 8). Another building worth mentioning is the house at Rynek 23, the facade of which is of great historical value due to its preserved divisions and ornaments (Fig. 9).

**Fig. 8.** View of the tenement in the northern frontage of the market square (Rynek 14) where the music school operates. Existing condition

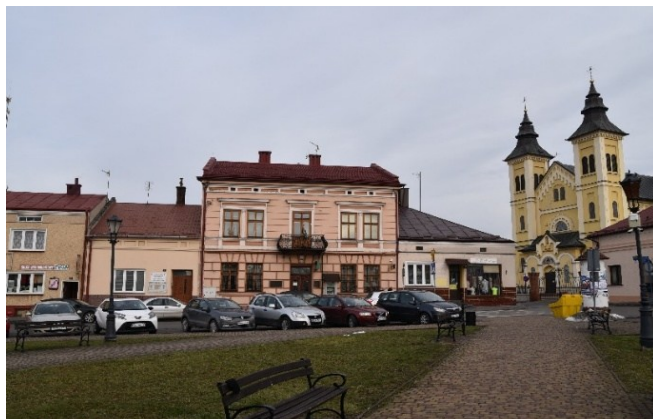
**Fig. 9.** View of a fragment of the northern frontage of the market and the facade of the Rynek 23 house, which is one of the few well-preserved. Existing condition

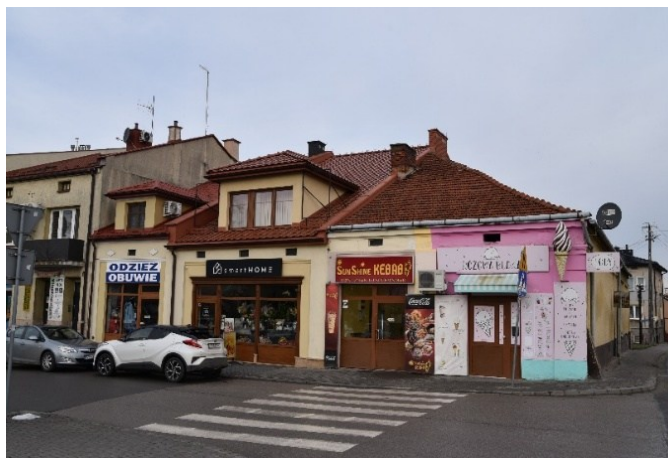
On the other hand, the buildings at the exit of Sikorskiego Street from the Market Square (Rynek 17, 18, 19) are among the most striking in terms of color, which is caused by advertising banners. In this frontage, buildings at Rynek 20 and Rynek 21 were rated the worst in terms of aesthetics, as their size does not correspond to the proportions and dimensions of the historic buildings (Fig. 10).

**Fig. 10.** View of a section of the northern frontage of the market and the houses at Rynek 17 and 18 with unsightly signs that negatively affect the perception of the historic cultural landscape of this space. Existing condition

The proposed action would remove excessive advertising from the city's public spaces. At present, it is common practice to place signs and advertising banners in colors inappropriate to their surroundings and of sizes disproportionate to the objects on which they are placed, which significantly reduces the aesthetic value of the historic center of Głogów (Figs. 10-12, 14). The proposed restriction and control in this respect could be based on Art. 17 para. 3 of the Act on the Protection and Care of Monuments and Sites, which stipulates that "on the territory of the Cultural Park or its part, prohibitions and restrictions may be imposed on the placement of boards, inscriptions, advertisements, and other signs not related to the protection of the Cultural Park, with the exception of traffic signs and signs related to the protection of public order and safety (...)" [22].

A good start to unifying the cultural landscape would be the introduction of uniform rules for the visual identification of public facilities - signs above the entrances to buildings of market tenements - the introduction of size restrictions, uniform colors, and the removal of the current banners and signs of unlimited color and size, which often almost 'hide' entire small buildings of single-story tenements.

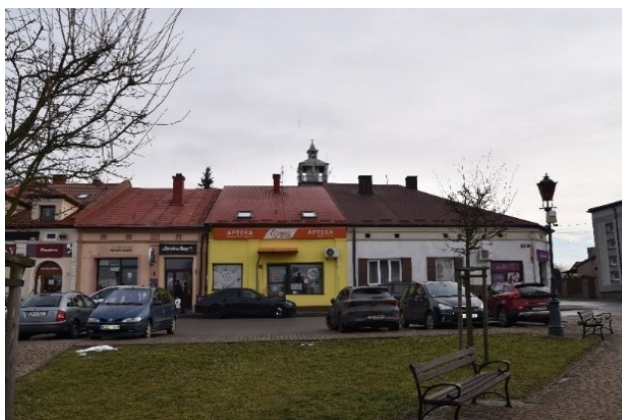
The eastern front of the market is the most uniform in height, but here there are two individual dominants, including one with a low aesthetic level (despite the renovation carried out)—Rynek 31 (Fig. 11).

**Fig. 11.** View of a section of the eastern frontage of the market square and the façade of the pharmacy building (Rynek 31) in a color negatively distinguished from the neighboring buildings. Existing condition

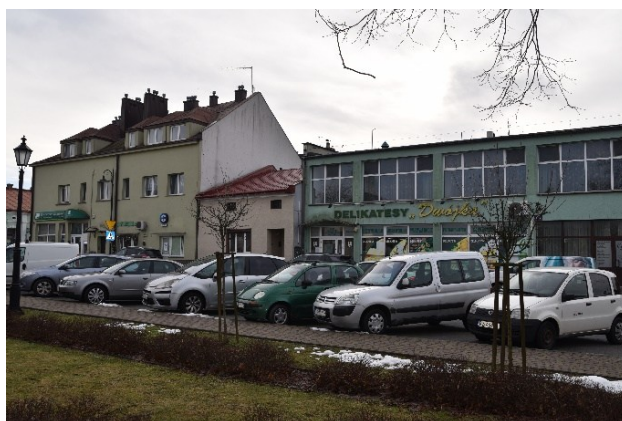
The southern frontage is the most degraded in terms of the degree of preservation of the historic divisions, and the elevations of selected buildings, such as the building at Rynek 53, which now houses a grocery store, do not fit harmoniously into the historic surroundings in terms of aesthetics or colors (Fig. 12).

**Fig. 12.** View of a section of the southern frontage of the market square and the facade of a grocery shop building (Rynek 53) with architecture, aesthetics, and colors alien to the historic cultural landscape of the historic town. Existing condition

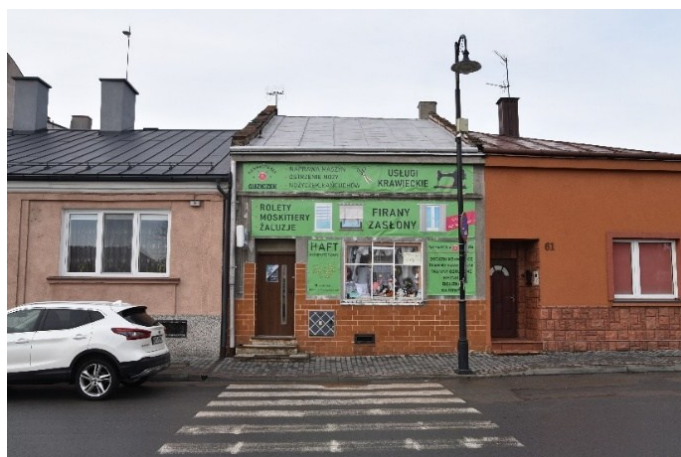
On the western side, there is a building with tailoring services – Rynek 60 (Fig. 13), which was almost completely covered with advertising banners, which had a negative impact on the visual perception not only of the building itself but also of the entire southern part of the western side of the development. In the building at Rynek 4 (Fig. 14), renovation works were started and interrupted. As a result, the building, or rather the front wall itself, has remained degraded and disturbs the visual perception of the western frontage, where the buildings are otherwise in a good state of preservation.

**Fig. 13.** View of a section of the western frontage of the market and the façade of the single-story house Rynek 60, which is almost entirely covered with advertising banners. Existing condition

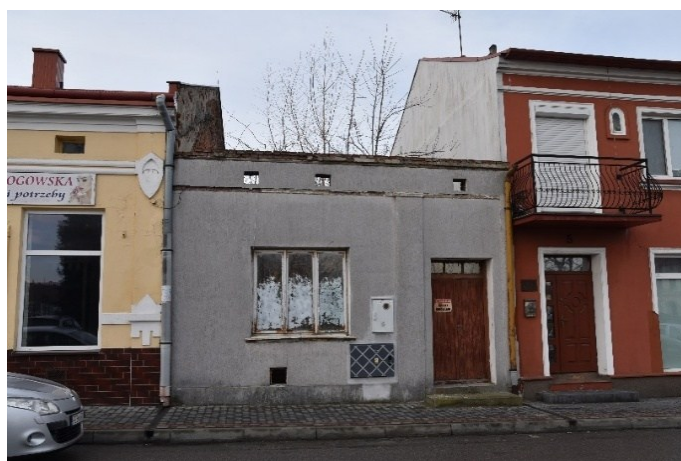
**Fig. 14.** View of a section of the western frontage of the market square and the façade of the neglected and degraded Rynek 4 building, where renovation works have been started and interrupted. Existing condition
