CONSERVATION ISSUES RELATED TO THE AVANT-CORPS OF KAROL POZNAŃSKI'S PALACE IN LODZ

Abstract

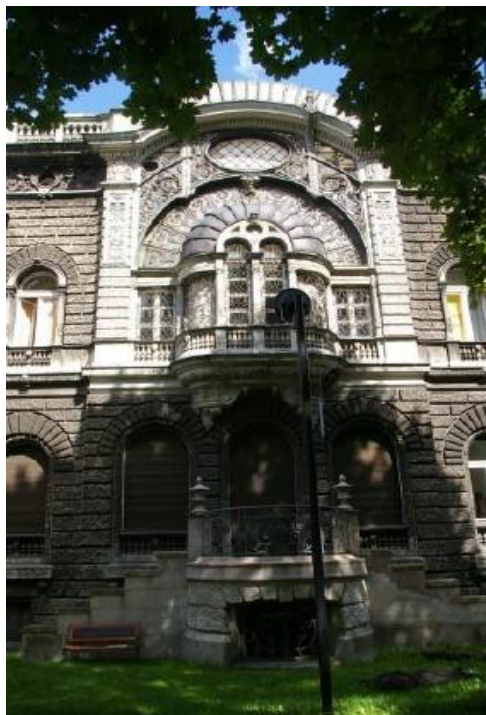
Fig. 1. Avant-corps before the conservation.
(Photo by “Marciniak & Witasiak Architekci”)

In 2012, when the described research [3] was conducted, it was noticed that the external surface of the bay window was covered with dark layers, which had a negative impact on the aesthetics of the entire structure (Fig. 4). On the garden side, there were windows and glazing, which were an important source of natural light, but their condition indicated the need for urgent maintenance. In particular, the largest of the cracks, with a shift, was located on the right side of the main bay window, in the area of the cornice, which suggested that the cornice crowning the avant-corps had also been destroyed. The preserved architectural detail was exceptionally well-chosen, although its appearance was weakened by the presence of microorganisms and minor defects attracted attention. The emerging network of shrinkage cracks, resulting from the mechanical and technological properties of the stucco, was further evidence of the changes to which the object had been subjected over the years. Thick layers of lichens were deposited in the nooks and crannies of the stucco detail, which negatively affected the visibility of the sculptural details. Two vertical strips were located in the upper part of the glazing of the avant-corps. Their original decoration with stucco was replaced with casts of artificial resin, attached to boards, which were covered with heavily flaked paint.

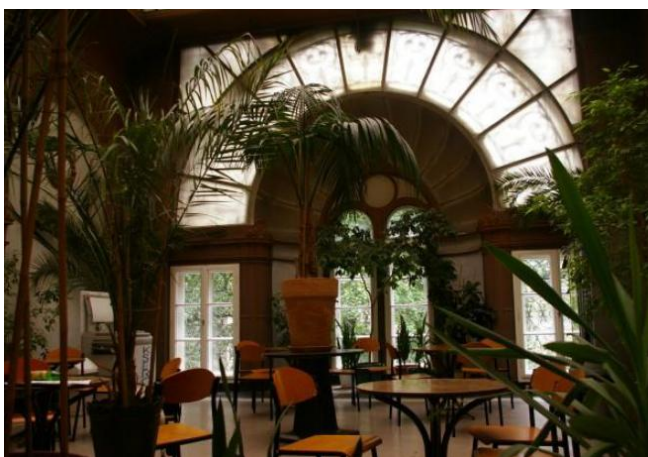
Fig. 2. Inside the avant-corps (Photo by “Marciniak & Witasiak Architekci”)

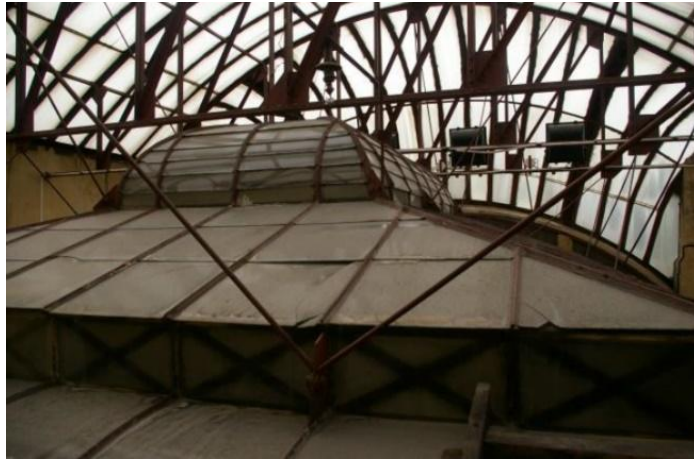
This dome is connected to the internal skeletal roof suspended on steel beams, which extends above the orangery on a quadrangular plan (Fig. 3). This impressive structure creates a wonderful solution for illuminating the interior of the winter garden. The top of the dome can be reached by an arched wooden ladder, which is an integral part of the building.

Fig. 3. Inside the dome (Photo by “Marciniak & Witasiak Architekci”)

The internal dome of the orangery, suspended from a steel structure with original glazing with slightly curved overlapping panes, was one of the most beautiful elements of this architecture. These panes, measuring 44×44 cm, were connected with the T-bars of the frame using putties. The glass, bent hot and matted on one side on the inside, was an excellent element illuminating the space of the orangery, adding lightness and a unique character. When the dome was fully functional after the installation of the technical condition, it allowed for pleasant lighting of the interior, which, combined with the oriental architectural decoration, enhanced the aesthetic impression. The research in 2012 undoubtedly indicated the need for urgent conservation work to preserve these unique architectural details from further degradation.

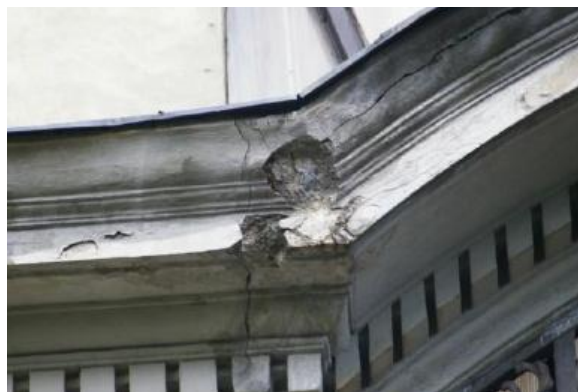
Fig. 4. Visible crack on the roof (Photo by “Marciniak & Witasiak Architekci”)

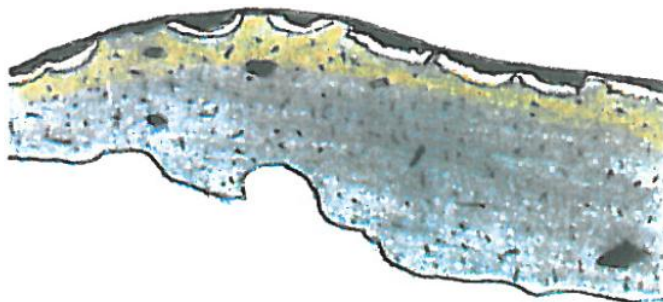
When preparing the project, the architectural studio “Marciniak & Witasiak Architekci” approached the issue of determining the color of the elements of the described avant-corps in an extremely professional manner. The tests of samples taken from Karol Poznański’s palace were carried out in the Scientific and Research Laboratory of the Monument Conservation Workshop in Toruń, founded in 1968 on the initiative of prof. Wiesław Domasłowski and prof. Tadeusz Polak. The laboratory, specializing in the study of painting materials and techniques and the conservation of stone monuments, has many years of experience and employs qualified specialists, which guarantees the high quality of the conducted analyses (Fig. 5) [8].

Fig. 5. Stratigraphic analysis (Photo by “Marciniak & Witasiak Architekci”)

The window joinery was subjected to stratigraphic analysis, thanks to which it was possible to determine its original color. The analysis of the sample taken in the building was carried out by mgr Elżbieta Orłowska [9]. Commissioned by the architects, she also carried out tests of mortars and polychromes from the bay window of the winter garden. Six samples taken from different elements of the avant-corps were analyzed: sculptural detail (right window and door trim), cornice, balusters, panels behind balusters and rustications. The tests included chemical analysis of the composition of mortars and identification of pigments and binders [9].

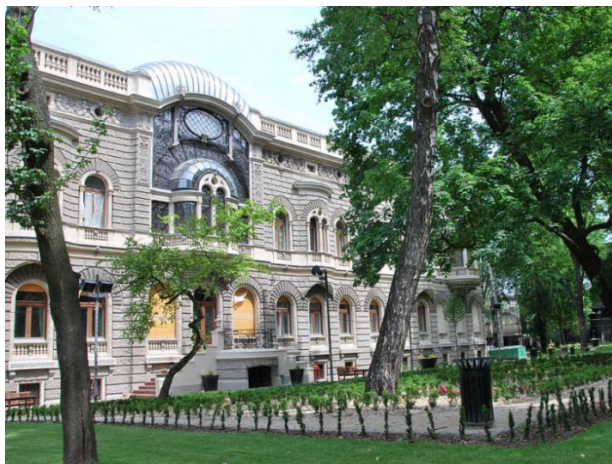
After the renovation works, the avant-corps took on a new, fresh character (Fig. 6). The effects of the actions were noticed in the improvement of the general state of preservation, as well as in the reconstruction of the historical appearance of details, which positively influenced the reception of the entire facility. Preserving the original forms and colors and carefully selecting the materials used and their individual modification contributed to the creation of a unique synergy between history and modernity.

Fig. 6. After revitalization (Photo by “Marciniak & Witasiak Architekci”)

New opening windows in the steel structure, designed in anthracite color with new safety glazing, introduced to the interior of the orangery not only a fresh quality but also ensured optimal light transmission. Modern materials do not distract from the historical character of the building but emphasize its architectural values. All stages of conservation work were closely monitored and documented, which allowed for maintaining full transparency and compliance with the regulations and standards regarding the protection of cultural heritage. Each action taken was consulted with conservators, which ensured that the results were in line with the requirements of quality and care for the historical substance.
