## PRESERVING UNDERGROUND PREMISES OF ARCHITECTURAL MONUMENTS: THE CASTLES OF ŠPILBERK IN BRNO AND OŚWIĘCIM

*The article is devoted to the study of underground spaces of architectural monuments. Using the example of architectural monuments located in Ukraine, the Czech Republic and Poland – the Kyiv-Pechersk Lavra in Kyiv, Špilberk Castle in Brno and the castle in Oświęcim – the most common problems of preservation, restoration and modern use of their underground spaces are analyzed. A comparative analysis of underground spaces of different times, different functions and in different regions showed the commonality of their preservation problems. A set of measures to eliminate the emergency state of underground spaces and options for their modern use is determined.*

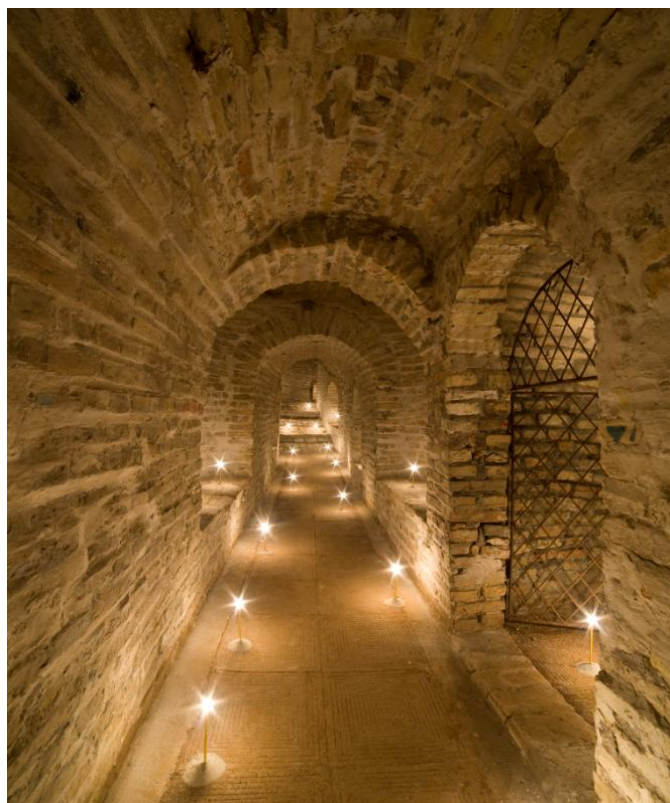
Today, the structure is a branched vaulted tunnel 50m long, with two entrances with brick stairs (Fig. 2). The volume of the structure can be conditionally divided into a staircase gallery, eastern, western and main premises and a system of corridors.

**Fig. 2.** Underground structure No. 2. Photo by Y. Holovatenko and V. Zaitseva, 2024

The depth of the tunnel is from 2.91 to 3.76m; in some places it reaches 8.15m. The width of the tunnel is 0.7-1.7m and the height is 1.9-2.0m. The main structures (walls and vaults) are built of yellow bricks of the 18<sup>th</sup> century measuring 28.0-29.5×15.0×5.0-5.5cm on a lime mortar on a loess base. 22 arched openings for niches of various sizes are arranged in the masonry of the walls. Some niches were bricked up. After their clearing, a masonry of red, poorly fired, fragile bricks of the 15<sup>th</sup>–16<sup>th</sup> centuries was discovered and parts of an earlier structure, the walls of which were not lined with bricks [6]. An interesting component of the structure is a passage, oval in plan, room with a spherical vault, on which the remains of clay plaster and whitewash have been preserved. The room has two steps along the eastern and western walls, measuring 1.93×0.6m and 1.8×0.6m. We have not found analogues of such rooms and their functional purpose remains a mystery.

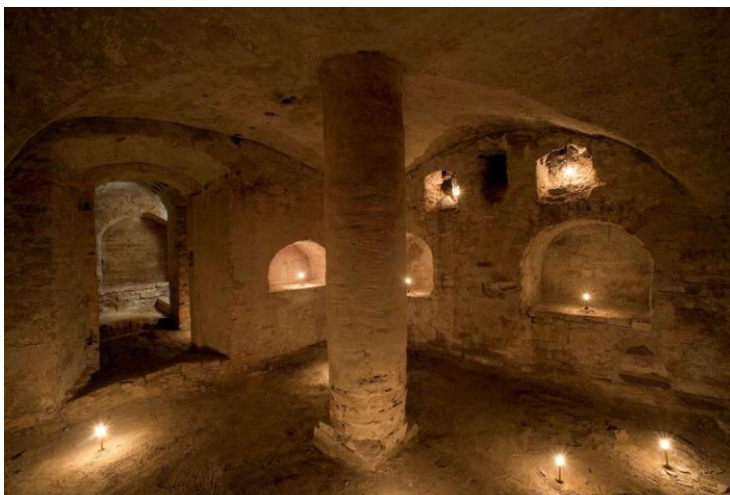
building) are decorated with niches with arched ends, a back wall faced with brick and an arched doorway in the southern part of the western wall. On the southern slope, metal curtains from the door with an eyelet have been preserved. In the northern wall, at a height of about 1.5m from the floor, there are two light windows (0.4×0.45m) with metal grilles and a vertical, rectangular opening like a chimney in the body of the wall (Fig. 3).

**Fig. 3.** Underground structure No. 3. Photo by Y. Holovatenko and V. Zaitseva, 2024

The structural features of underground structure No. 3 suggest that its original purpose was for long-term human habitation, as evidenced by the presence of skylights, a chimney and interior doors [10].

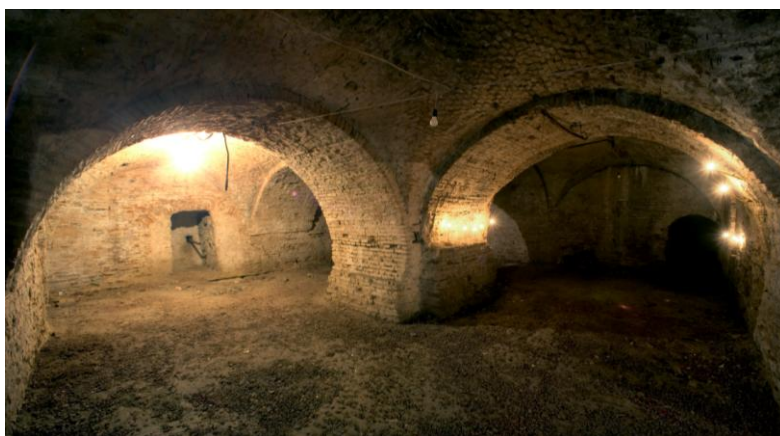
Located near the defensive walls, underground building No. 28 is currently connected to above-ground building No. 31, built in 1871–1874, but is not structurally attached. It was probably built at the turn of the 17th–18th centuries and was partially rebuilt at the end of the 19<sup>th</sup> – beginning of the 20<sup>th</sup> centuries. The modern volume consists of an entrance gallery and the main, western and northern rooms. The walls are lined with light ocher, pink and red bricks on lime mortar. The main room, measuring 11×11m, is brick, covered with a complex closed cylindrical vault 3.5m high, which rests on a pylon (2.4×2.8m), rectangular in plan, reinforced by wall arches (Fig. 4).

**Fig. 4.** The main room of underground structure No. 28. Photo by Y. Holovatenko and V. Zaitseva, 2024

The original entrance to the building was the western branch, which appeared like a brick gallery and was separated from the main building by a massive gate. The significant parameters of the gallery (6.9×2.5×2.8–3.9(h)m) and the presence of a wide and sloping entrance with a gate indicate the possibility of the entry of horse-drawn transport with heavy and oversized cargo. The structural features of the main volume – the thickness of the walls (up to 2.5m) and the presence of large niches—indicate the defensive function of the building – for storing gunpowder and ammunition. Apparently, in the first third of the 18<sup>th</sup> century, the building lost its defensive purpose and its massive brick foundation could have been used for civil construction during the construction of the ground-based building No. 31 [15].

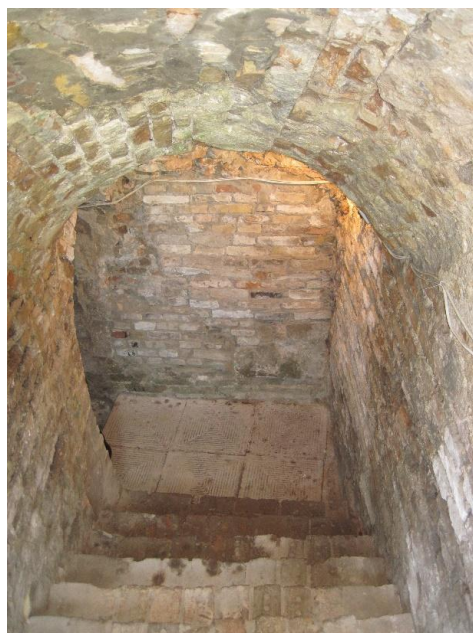
Underground structures are significantly affected by waterlogging of the soil massif due to the action of natural or man-made factors. Infiltration of atmospheric precipitation and changes in the properties of the state of the base soils lead to deformations, the formation of cracks, waterlogging and a decrease in the strength of the bearing properties of the structures of underground structures. Thus, due to the absence or damage of moisture-proof barriers and orderly drainage in the underground structures of the Lavra, surface water seepage occurs annually during precipitation (Fig. 5).

**Fig. 5.** Infiltration of atmospheric precipitation due to violation of waterproofing (underground structure No. 2).

The migration of moisture saturated with salts causes their crystallization on the surface of the walls and vaults of the structure. A prime example is underground structures No. 28 and No. 11, where, as a result of long-term exposure to moisture, mineral formations of various shapes in the form of stalactites, stalagmites and flow layers were formed.

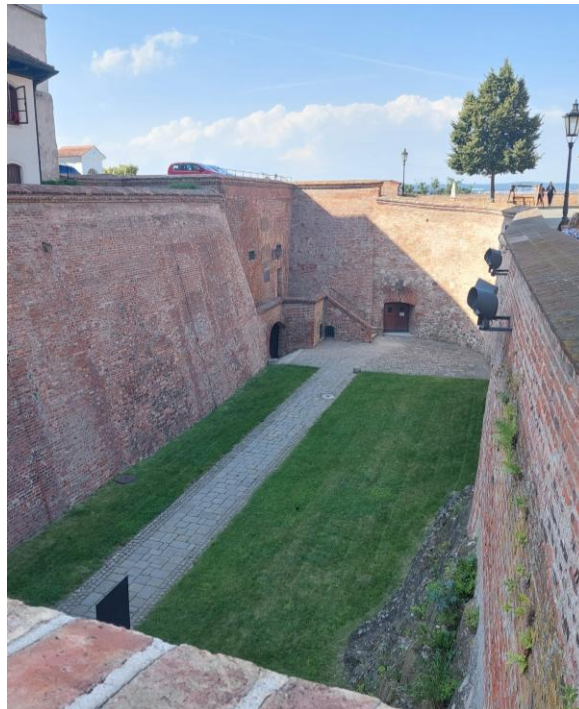
**Fig. 6.** The entrance to casemates at Špilberk.

The casemates of Špilberk Castle are an architectural curiosity and are among the most visited tourist attractions in Brno (Fig. 6). In military terminology, casemates are spaces protected from shelling, often vaulted, located underground or above ground within fortress elements. At Špilberk Castle, they originally served as warehouses and shelters for the military garrison in case of danger. The Špilberk casemates are not underground but located at and above ground level [19].

The casemates at Špilberk were built in 1742 during the rebuilding of the castle into a baroque fortress under the leadership of Colonel Rochepin. Špilberk Castle is one of the main landmarks of Brno, located at the confluence of the Svitava and Svatka rivers in South Moravia. The Gothic castle was originally built in the middle of the 13<sup>th</sup> century as the residence of the Moravian lords and in the 14<sup>th</sup> century, it served as a residential castle of the Moravian branch of the Luxembourg family. However, the importance of the castle gradually declined from the end of the 15<sup>th</sup> century until the middle of the 17<sup>th</sup> century, when it finally emerged as an important defensive stronghold during the Swedish occupation of Moravia (1643–1645). After this event, the castle was significantly fortified and modified.

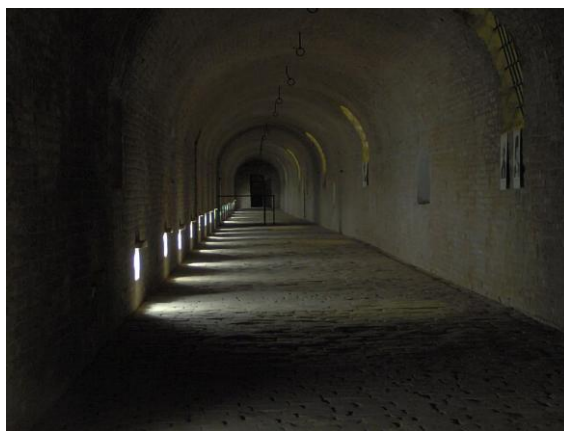
Fig. 7. Casemate in Špilberk Castle.

In addition to the older prison building in the rear ditch, the upper floor of the northern barracks, known as the Josephine tract, was also rebuilt for prison purposes. The first prisoners were placed there in June 1784. In December 1784, the emperor ordered those criminals sentenced to life imprisonment to be transferred to the lowest and worst casemates. Casemates, two-story vaulted brick corridors, were built into the northern and southern castle moats of Špilberk and were originally used to house military units (Fig. 7). On the south floor was a kitchen with ovens capable of baking bread for up to five thousand people. The casemates had skylights for light and air, hearths with chimney and a tiled stove [21]. On the lowest floor, wooden cells were built where the convicts were permanently chained to the wall with heavy chains. The cells, each measuring 2×1.5 meters and up to 2.5 meters high, were made of thick boards and beams [22] (Fig. 8).

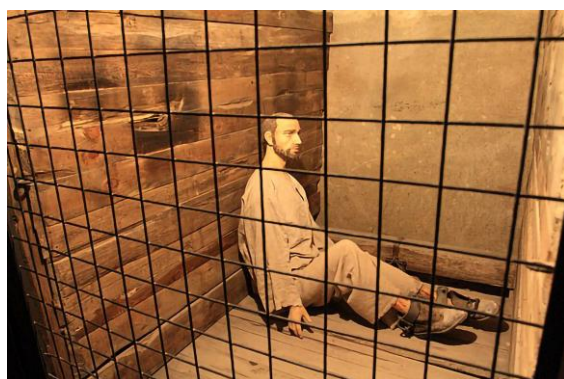
Fig. 8. Wooden cell for prisoner. Historical reconstruction with a mannequin.

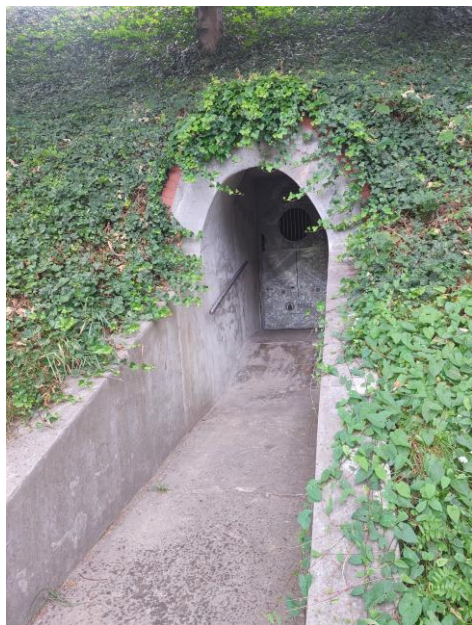
**Fig. 9.** Entrance from the Sola River side.

An important landmark in Oświęcim is the Piast Castle [29]. Castle Hill has two tunnels, located between Zamkowa Street and Bulwarna Street. The tunnels are completely underground structures with an area of approximately 300m<sup>2</sup>. Five entrances are from different sides of Castle Hill and one is through the rampart to the castle courtyard (Fig. 9). The object is included in the register of historical buildings and is subject to conservation protection.

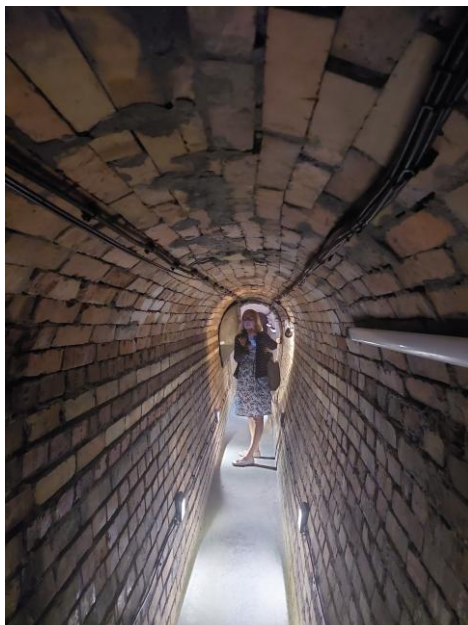
The older, so-called “long” or “Austrian” tunnel runs east-west, connecting the opposite slopes of the hill. It was probably built of brick at the end of the 18<sup>th</sup> century, during the partition of the Polish-Lithuanian Commonwealth, when Oświęcim passed to the Austrian Empire. The tunnel has a pear-shaped cross-section (Fig. 10).

**Fig. 10.** The oldest tunnel of the Austrian period.

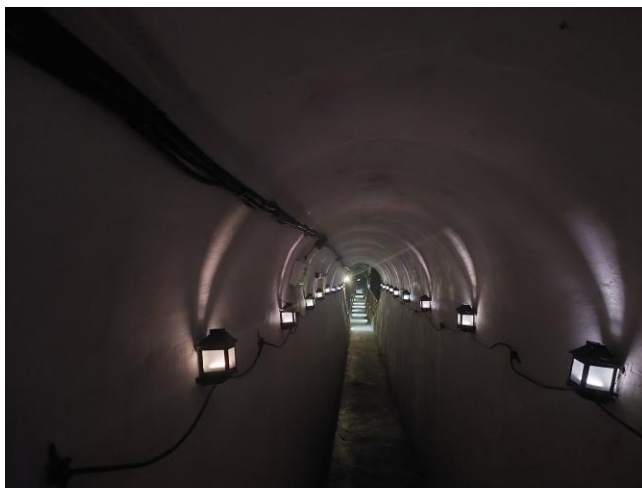
During the occupation of 1940–1944, the Germans cleared the existing Austrian tunnel and widened it. They also dug a second tunnel in a north-south direction, perpendicular to the previous Austrian tunnel [30]. Known as the “transverse tunnel,” it is built of reinforced concrete rings and has a partial ellipse in cross-section (Figs. 11 and 12).

**Fig. 11.** Tunnel of the German period.
