## WALL PAINTING AS CHARACTERISTIC DECOR OF UKRAINIAN CHURCHES: EXPERIENCE OF THE UKRAINIAN RESTORATION SCHOOL

### Abstract

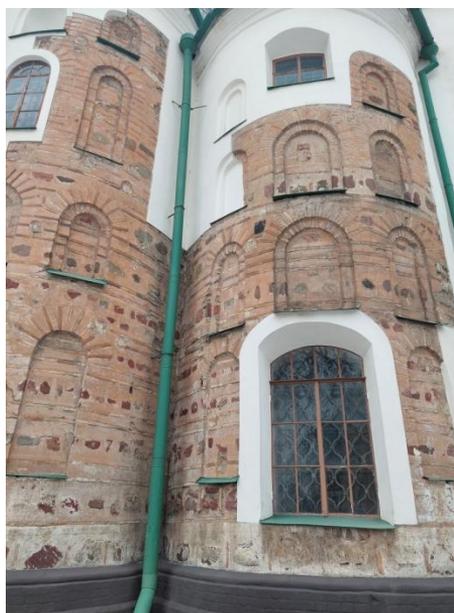
**Fig. 3.** Apses of St. Sophia Cathedral in Kyiv Photo by Y. Ivashko, 2024

It is significant that just as the St. Sophia Cathedral today has elements of Kyivan Rus architecture and Baroque elements, the St. Michael’s Cathedral combines features of Kyivan Rus architecture in the tier of walls and smaller domes and features of Baroque in the outlines and proportions of the central dome. In contrast, the Church of All Saints in Uman is a direct allusion to Kyivan Rus architecture (Fig. 3), except for the onion-shaped domes.

Specialists of the Ukrrestavratsiia Corporation have accumulated extensive experience in the study, restoration, and reproduction of Kyivan Rus frescoes (Fig. 3). The restoration procedure consisted of the following stages:

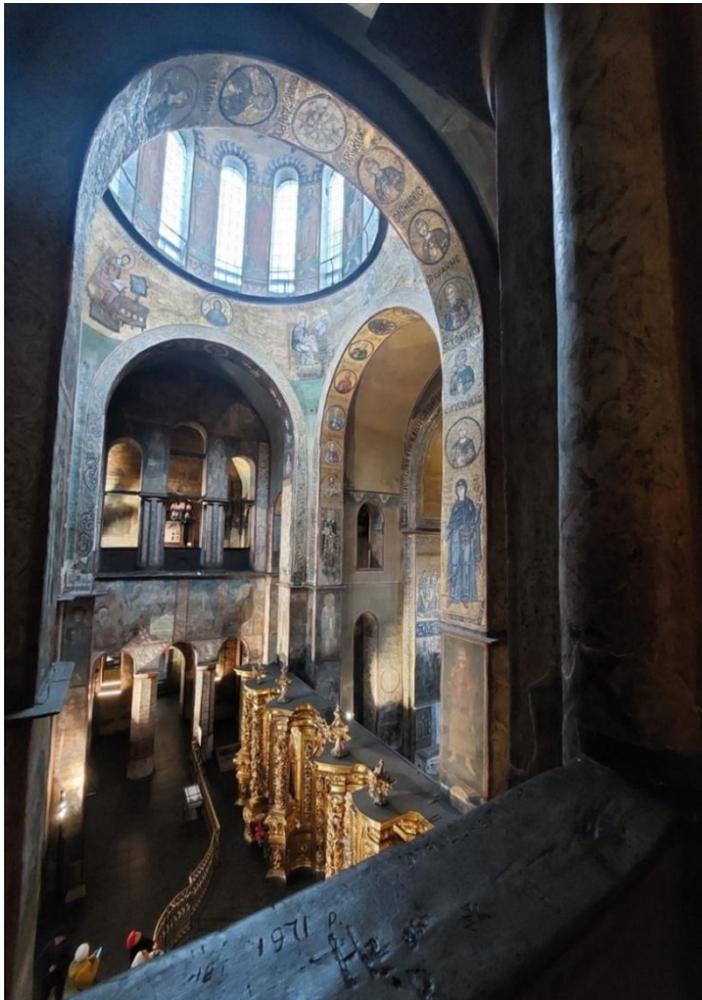
Fig. 4. Fragment of the interior of St. Sophia Cathedral. View from the choir,  
Photo by Y. Ivashko, 2024

- the method of historical analysis and the method of art historical analysis – for analyzing the features of murals from the times of Kyivan Rus and the Baroque (Fig. 4);
- the method of comparative analysis – for comparing the techniques of performing murals and frescoes;
- the method of restoration analysis – for analyzing the applied restoration technologies;
- the method of systemic analysis – for presenting the decoration of the interiors of temples as a holistic system, where all parts of a single whole are interconnected canonically, visually, constructively, substantively and stylistically;
- the method of photo fixation and the graph-analytical method – for a visual evidence base for conclusions.

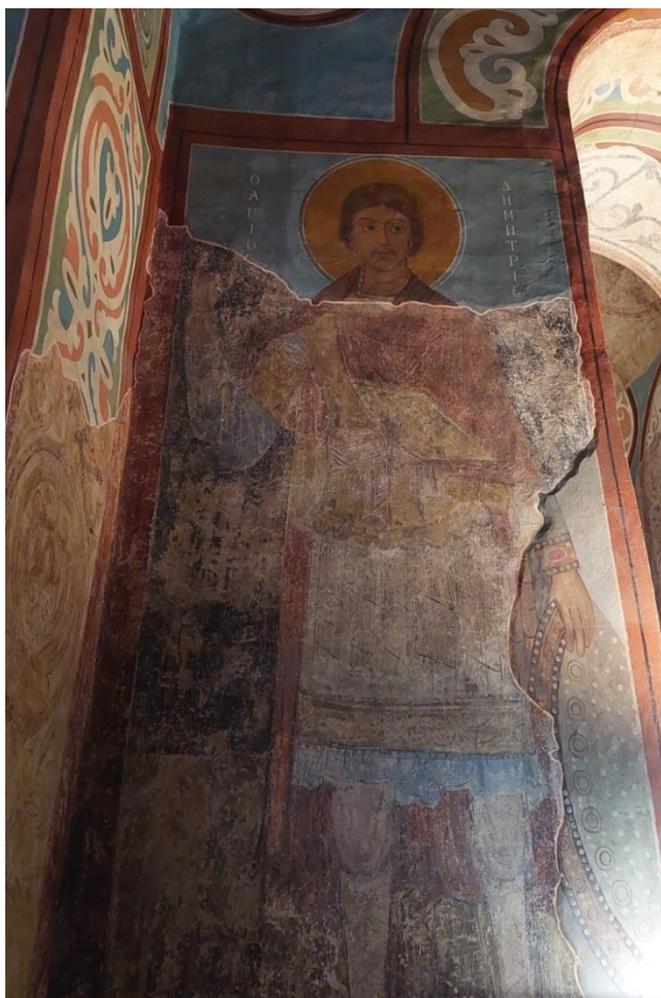
**Fig. 5.** Revealing the 11<sup>th</sup>-century fresco from the 19<sup>th</sup>-century oil paintings. Fragments from different periods are separated by a thin line. Photo by Y. Ivashko, 2024

Traditionally, valuable murals from different periods are separated by a thin light line, as is done in the wall paintings of St. Sophia Cathedral (Fig. 5).

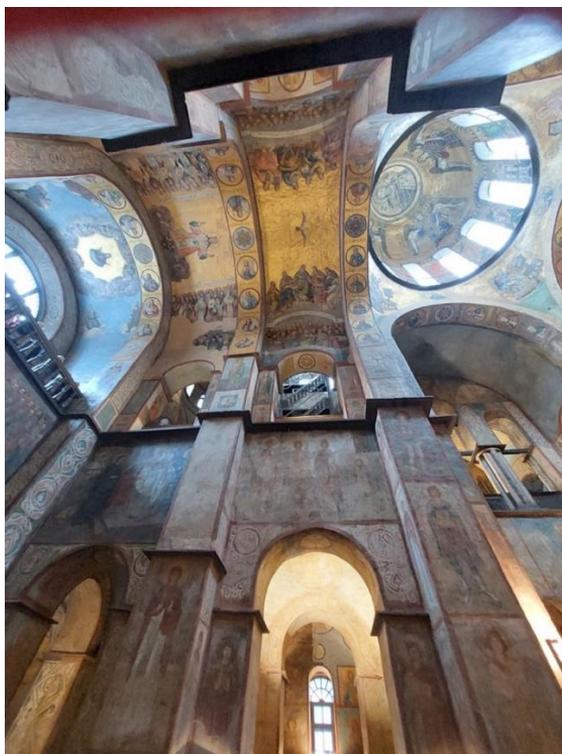
**Fig. 6.** View of the main under-domed space of St. Sophia Cathedral, Photo by Y. Ivashko, 2024

In Saint Sophia Cathedral, one observes a distinctive synthesis of the arts—fresco painting, mosaic decoration, and a carved iconostasis—integrated harmoniously with the architectural forms and structural composition of the monument (Fig. 6).
