INNOVATION METHOD FOR RESTORATION AND COMPLETION OF SCAGLIOLA IN HISTORICAL ROYAL PALACES IN CAIRO, EGYPT, CASE STUDY

Keywords: Micro-balloons; Decorative elements; SEM-EDX; Deterioration; Zafaran Palace; Conservation; Polymer

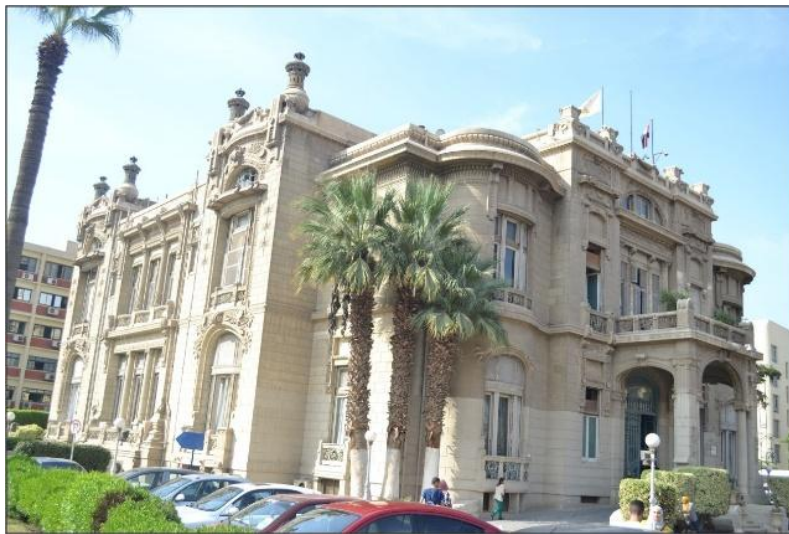
Fig. 1. Zafaran palace (1870 AD)

In Egypt, during the 18th and 19th centuries, especially under the rule of Muhammad Ali and his dynasty, European architectural styles heavily influenced the country. Engineers were brought from Europe to design and construct palaces for the rulers and nobility during this period. *Zafaran Palace*, which is the subject of the study, is an excellent example of this influence (see Fig. 1).

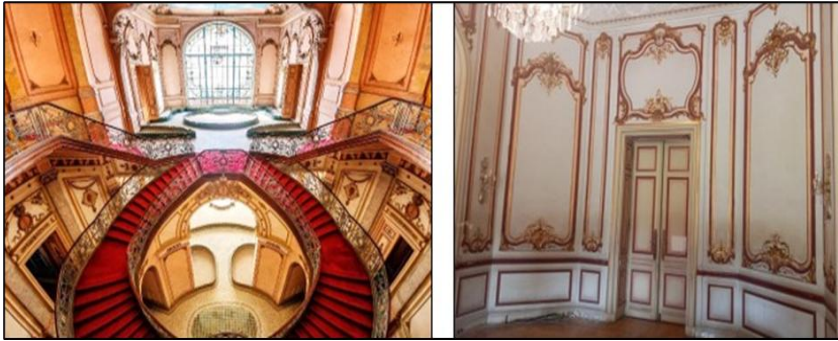
Fig. 2. Examples of decorative and architectural elements in *Zafaran* Palace

Zafaran Palace was built with limestone, and its facades were coated with artificial limestone blocks. It consists of four floors, a basement, two main floors, and a roof. The area of the basement is 1504 m², while the areas of each of the ground and first floors are 1377 m². The palace has two main entrances: one in the northern façade and the other in the southern façade. Otherwise, there are two subsidiary ones leading to the basement floor. The palace was built, influenced by Baroque art and distinguished by decorative elements of various shapes, which included bouquets of roses and flower branches scattered across the four facades of the palace, which were characterized by the accumulation of plant units as well as the prominent blocks of the facades (see Fig. 2) [20-25].

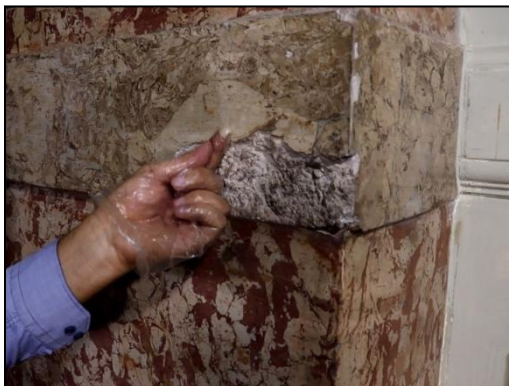
Fig. 4. deterioration phenomena forms in Scagliola at Zafaran palace

The collected studied samples, detached due to the occurrence of secession, belonged to a column base located in the main hall of the palace (Figs.3,4). The samples were taken from a fragment of a column and had fallen as a result of being exposed to many fine cracks (crackle).

However, micro cracks, cracks, and exfoliation are considered the most visible damage configurations in scagliola units used in the construction of columns and other cladding elements in *Zafaran* Palace (see Fig. 4). The visual survey of scagliola elements in the palace revealed a diversity of characteristic decay forms. The cycle of cooling and heating during day and night has caused exfoliation, deformation, and microcracks due to dimensional changes in the scagliola [24-27]. Otherwise, the main observed deterioration phenomenon is the separation or exfoliation of scagliola parts as a result of their exposure to microcracks. This phenomenon is very similar to the phenomenon of glass cracks (see Fig. 4).

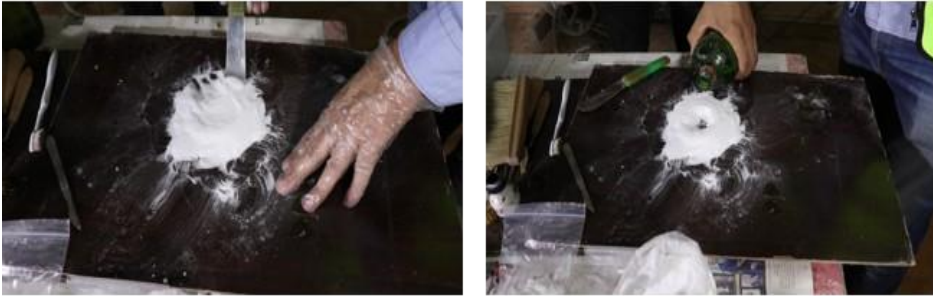
Fig. 9. The mixture of the proposed method application

- ***Mixing the microballoons Compound:*** the glass microballoons (microballoons are white, very fine, and light hollow glass balls used with epoxy and polyester resin). Its bulk density (140-150 g/l), specific density (0.20 g/cm³), and particle size distribution (50 μm and particle sizing 200 μm) were combined with the prepared binder in a suitable container. The mixture must blend thoroughly until the mixture is smooth and homogeneous (Fig. 9)
