WROCLAW SCHOOL OF RESEARCH AND CONSERVATION OF ARCHITECTURE – SELECTED RESEARCH AND CONSERVATION PROJECTS CARRIED OUT IN THE TEMPLE OF HATSHEPSUT AT DEIR EL-BAHARI BETWEEN 2000-2020

The activities of the Wrocław School of Research and Conservation of Architecture in the Temple of Hatshepsut in Deir el-Bahari in Egypt between the years 2000 and 2020 are presented herein. These activities are based on a selection of research and conservation projects carried out by specialists from the Wrocław University of Science and Technology in cooperation with the Centre of Mediterranean Archaeology of the University of Warsaw. During the period under review, the author of the article served as the architect of the mission, with the presented projects being executed as original initiatives or under her supervision. The emphasis placed on the interdisciplinary nature of the work, incorporating archaeological, architectural, conservation, and engineering research, is noteworthy. The significance of these research endeavors for the preservation of cultural heritage and the education of future architects and conservators is also highlighted.

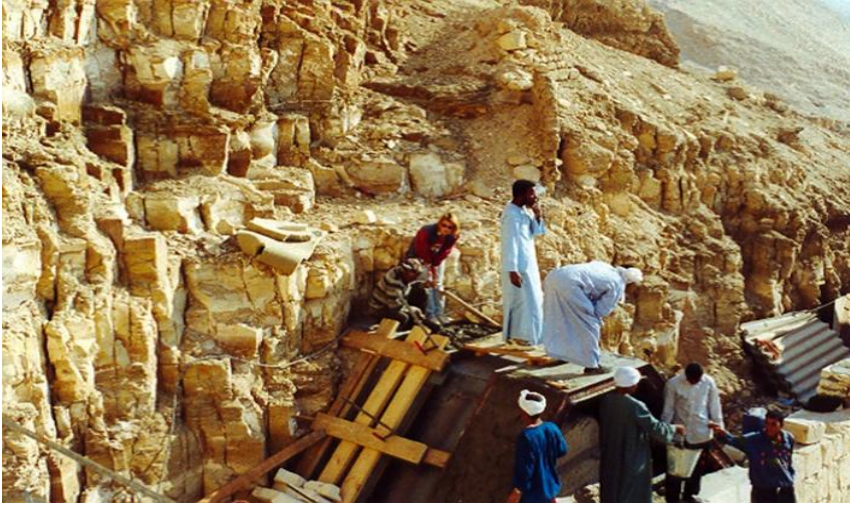
Fig. 2. The Sun Cult Complex. Shrine of Anubis and the northern wall of the courtyard during the project. State during conservation work in 2005.

The next major project, which was completed and made available to tourists, was the project of conservation and exhibition of the Solar Cult Complex. Archaeological and Egyptological research carried out since the 1980s and 1990s provided the basis for architectural research. The work was carried out by a team of specialists from PP Pracownia Konserwacji Zabytków (State Enterprise of Monument Conservation Workshops) until the end of 1989, and in 1993 the work was continued by the Centre of Mediterranean Archaeology of the University of Warsaw. In 2001, the author of the article joined the group of researchers, focusing her work on the Solar Cult Complex. As the chief architect of the mission, I was responsible for architectural research, preparation, and supervision of the conservation and exhibition project for this part of the temple. The implementation of this comprehensive task began with familiarization with the previous archaeological, Egyptological, and architectural research. Analyses, summaries, and conclusions were published in the article: *Historia badań i konserwacji architektury w świątyni Hatszepsut w Deir el-Bahari* [History of research and conservation of architecture in the Temple of Hatshepsut at Deir el-Bahari] [6]. The Egyptological studies developed and published by Professor Janusz Karkowski, which were the basis for the implementation of the project of reconstructing part of the Solar Cult Complex, were significant for the entire project. The conservation conclusions and postulates included a general concept of the exhibition as well as functional and spatial clarity of the entire undertaking. Detailed guidelines were developed for individual fragments of the complex, starting with the reconstruction of the courtyard walls and securing the Anubis Chapel with the exhibition of the passage from the Re-Horachte vestibule to the open courtyard. This exhibition was prepared by the author based on the Egyptological research of J. Karkowski and the initial concept of the architect Andrzej Kwaśnica from PP Pracownia Konserwacji Zabytków. The most significant undertaking was the preparation of a project for the protection and conservation of the Anubis Chapel. The project assumed the execution of the protection of the chapel with a reinforced concrete structure hidden behind the northern wall of the complex, preparation of design documentation for glass and steel doors securing the interior of the chapel, and a project for the conservation of polychromes. The project of the exhibition of the entire complex was prepared by the author of the article, and in the case of the protection of the Anubis Chapel, the design assumptions and the structural design were prepared by Eng. Mieczysław Michiewicz. The project included the implementation of a steel-reinforced concrete structure located above the upper surface of the chapel vault. The basis of the supporting structure was trapezoidal frames made of I-beam sections, supported on foundations made of steel beams. The foundations were based on sockets carved in the rock wall on the north side and on the south side in the reconstructed stone wall of the courtyard. The steel structure was covered with an anti-corrosion paint coating. Concreting of the slabs was carried out using the so-called traditional formwork made of galvanized steel sheets, which also served as protection for the upper surface of the vault from contamination with wet concrete mass. The upper surface of the roof structure was covered with two layers of bituminous mass, which

provided additional waterproof and moisture protection. The entire structure was covered with rock rubble, which also served as a cushioning layer (Fig. 2).

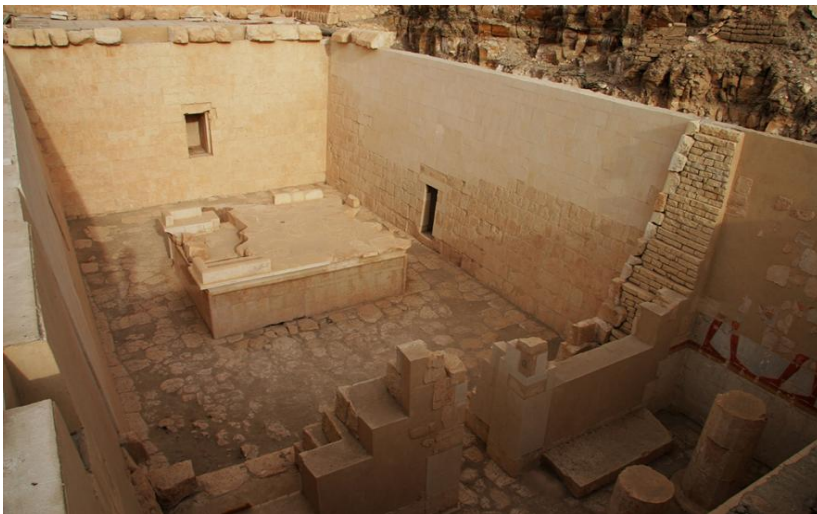
Fig. 3. Solar Cult Complex. General view toward the west and north. State during conservation work in 2005 (Photo M. Jawornicki)

The conservation program and conservation of the chapel interior polychrome were carried out by Maria Lulkiewicz-Podkowińska, a conservator of works of art in the field of painting. The last important element of the exhibition project of the Solar Cult Complex was the conservation of the free-standing solar altar. The conservation program was developed by Izabela Uchman, a conservator of works of art. The description of the entire project implementation was published in the article [7]. The last stage of the Solar Cult Complex restoration project was the implementation of the exhibition of the courtyard wall finials and securing the polychrome in the entrance to the complex with glass screens. The projects were implemented in the years 2008–2010 (Fig. 3).

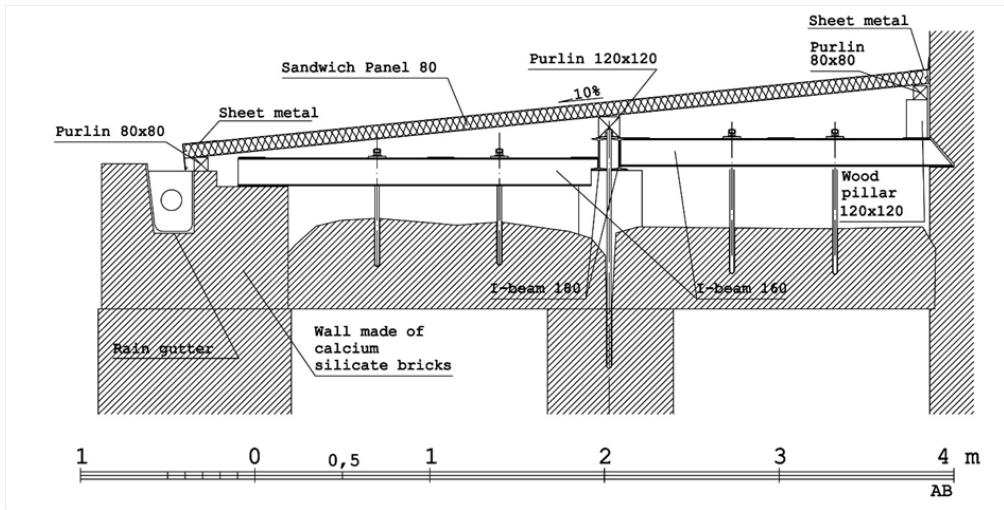
Fig. 4. Project of the strengthening and roofing of the Vestibule of the Hathor Chapel ceiling section.
(Drawing by A. Brzozowska-Jawornicka)

Subsequent architectural and conservation projects were carried out in the southern part of the Upper Terrace of the Temple of Queen Hatshepsut. The project was related to the reinforcement and securing of the ceiling of the Hathor Chapel. The concept of the protection and supervision of the implementation was to be carried out by Eng. M. Michiewicz, and Dr. Eng. Arch. Aleksandra Brzozowska-Jawornicka, from the Wrocław University of Science and Technology. The state of preservation of the ceiling above the vestibule of the Hathor Chapel raised doubts and the resulting threats for many years. The external surface of the ceiling slabs had flaked off, and their surface was covered with a network of cracks, some of which went through the entire thickness of the slabs. The cracks and markings of the ceiling slabs caused the destruction of the paint coatings from the inside of the chapel. The flaking and cracks of the ceiling slabs were caused by atmospheric factors and the significant exposure of the surfaces to the sun. For many years, the interior of the vestibule of the Hathor Chapel and the adjacent niches were secured with temporary wooden and steel structures. Over time, however, it became justified to properly secure the vestibule ceiling. In 2009, a decision was made to implement a project to secure the vestibule ceiling of the Hathor Chapel. After completing the architectural and conservation documentation, actions were taken to strengthen the ceiling (Fig. 4). The most difficult stage of the project was the construction of a steel structure to take the load from the damaged stone slabs and transfer it to the solid and stable surfaces of the external walls and columns. The stone slabs were anchored to the steel structure with injection resin using stainless steel rods. A decision was made to preserve the paintwork on the underside of the slabs. In this way, eight slabs were reinforced above the vestibule of the Hathor Chapel, and then a roof was made of light sandwich panels placed on a wooden structure to protect the whole from overheating and precipitation (Fig. 5). The angle of the roof was selected so that visitors to the temple could not see the roof from the level of the Hathor Chapel. Similarly, to the roof over the North Chapel of Amun, a drainage channel was also made hidden in the wall with a slope towards the south, leading the water out of the temple [10].

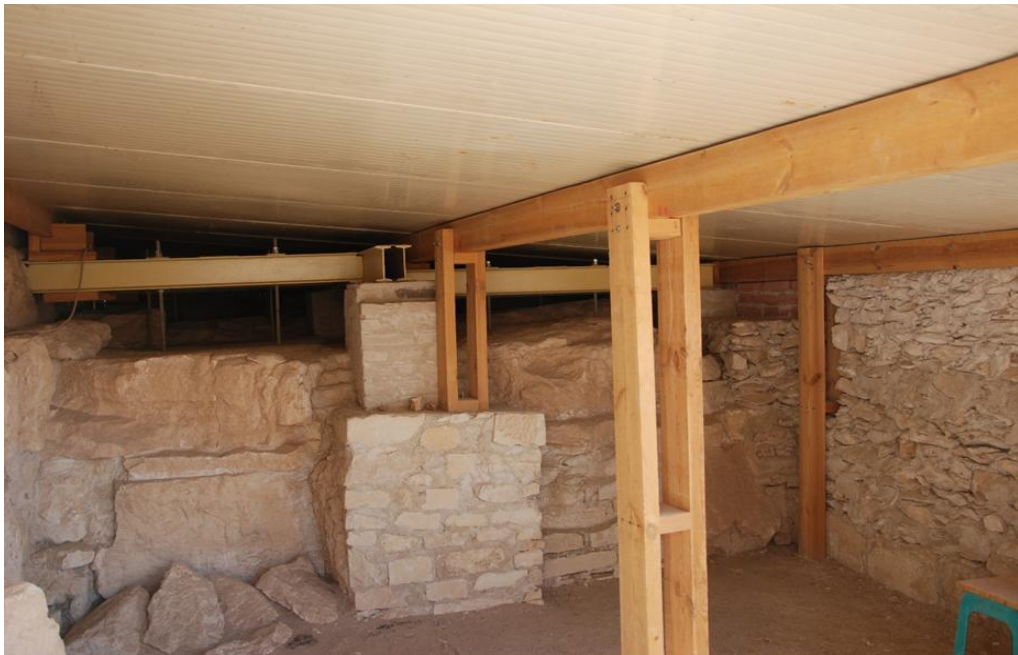
Fig. 5. Strengthening and roofing the vestibule of the Hathor Chapel.

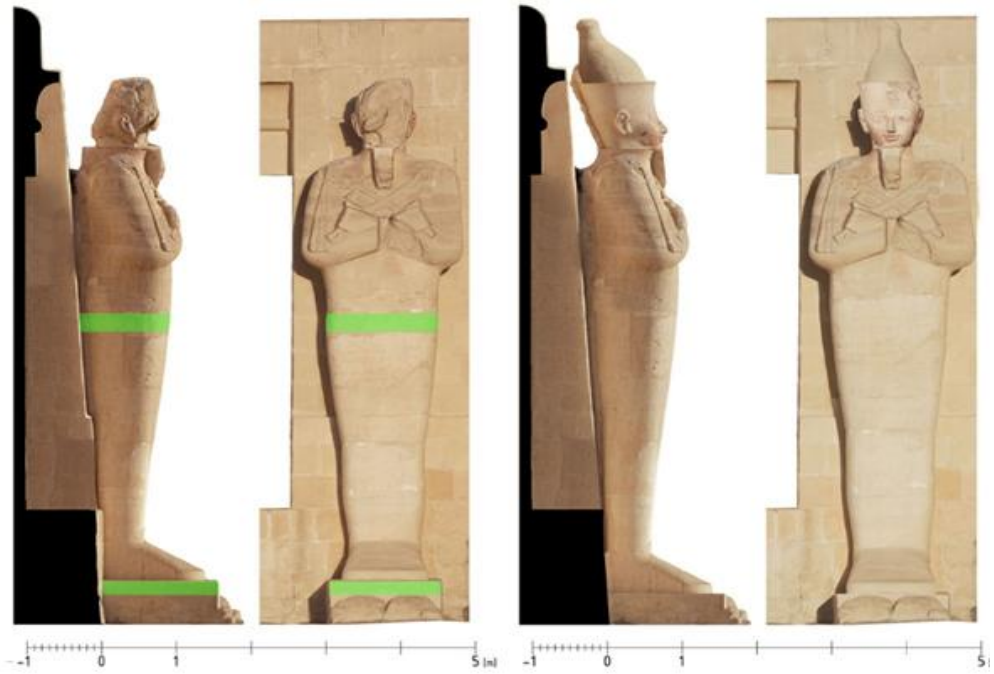
Fig. 8. 3D documentation of the reconstruction of Queen Hatshepsut's Osiride statue from the northern colossus. (Drawing by M. Caban)

The scope of architectural research, which was the basis for the project and the repeated reconstruction, included the study carried out with Mariusz Caban from the Wrocław University of Science and Technology concerning the colossus of the Osirian figure located on the northern side of the Lower Terrace of the temple. This study was undertaken due to noticeable errors in the reconstruction made at the beginning of the 20th century. In 1911, an American mission led by Herbert E. Winlock from the Metropolitan Museum of Art in New York began its work in the Hatshepsut temple. Over the following years, the mission under his direction made many discoveries, starting from foundation deposit pits, sarcophagi, and mummies to a large number of temple sculptures. In the 1927-1928 season, the American mission discovered, among others, a large group of fragments of figures of the god Osiris with the face of the queen. An important group turned out to be blocks of colossal statues of the queen as Osiris. It was determined that the statues were about 7.25 m high. Winlock's significant discovery was the recognition that on the north side of the Hunting Portico, within the smoother, sloping wall at the top, there is a limestone pedestal on a sandstone floor. During research, scratches were identified and documented on the south wall at the top of the Obelisk Portico. The Obelisk Portico was reconstructed at the end of the 19th century, when a mission led by Edouard Naville was working in the Hatshepsut Temple, and Somers Clarke was responsible for the restoration. By interpreting the scratches and discovering fragments of the queen's statues, Winlock's team determined the function of the chipped stone block protruding from the wall. It was assumed that it was a block connecting the figure of the colossus to the wall [17]. From Winlock's notes we could learn that a decision was made to reconstruct the northern colossus of the queen's figure. In April 1928, Emile Baraize was to perform the reconstruction on the preserved pedestal in the northern portico [18]. In the years 2005-2016, documentation was carried out, and research was undertaken on the porticoes of the lower terrace in order to verify the achievements of H. Winlock's mission regarding the figures of the queen as Osiris. Students from the Wrocław University of Science and Technology, Sara Arbter and Paweł Srokowski, participated in the development of the inventory. Based on this documentation and research on proportions and modules, a second reconstruction of the Osirian figure was developed (Fig. 8). The main executor of this reconstruction was the sculptor and artist Wojciech Myjak. The research was published in the article [19].
