PRESERVATION AND ADAPTIVE REUSE OF THE FORMER AUSCHWITZ I SLAUGHTERHOUSE AS A VISITORS' CENTER STRATEGY

Abstract: *The aim of the article is to share the author's own experiences of the "Kozień Architekci" architectural office in modernizing a slaughterhouse belonging to the Camp Auschwitz I service area and incorporating it into the overall complex, taking into account the historical value of the former Auschwitz camp grounds. The approach to its preservation does not apply the strict rules that are followed at the protected-by-law memorial. The degraded building was adapted to the functional needs of visitors while restoring its wartime character, securing and highlighting historical fragments of its structure. Thanks to this approach, the museum gained a new place to serve visitors, taking it outside the protected area and at the same time incorporating it into the museum complex by recognizing the former slaughterhouse building as the most important point of the whole visitors' center.*

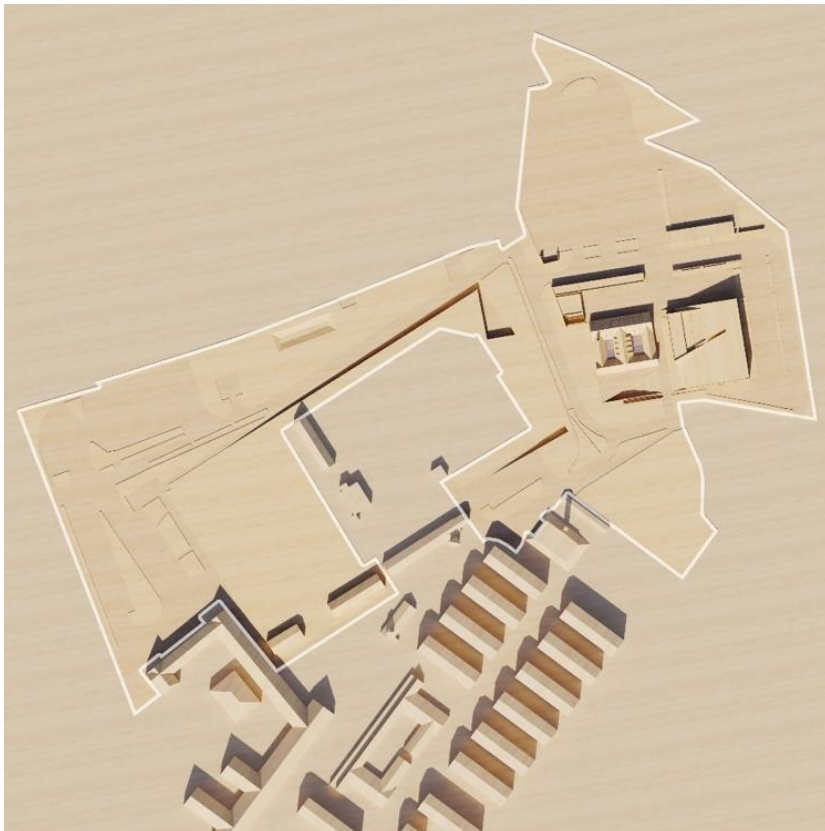
Fig. 2. Development plan for the project area of the Visitors' Center at the Auschwitz-Birkenau State Museum in Oświęcim (project: "Kozień Architekci")

An analysis of the building's history verifies the layout of the rooms (Fig 2). The most valuable parts are considered to be the interior of the main hall, supported by reinforced concrete columns, the adjoining room intended for service functions, and the perpendicular hall—the oldest part of the building, where the waiting rooms are located. The pre-war bunker is treated as

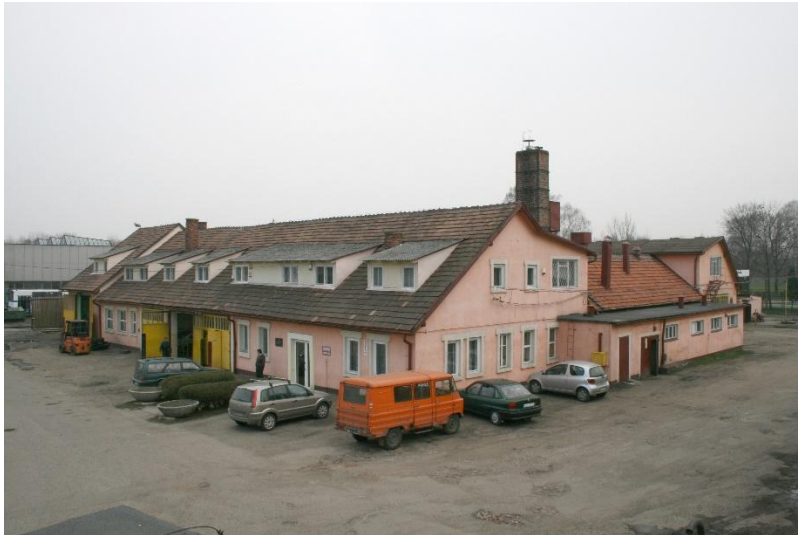
Fig. 3. The building of the former camp slaughterhouse used by the bus depot – before the investment (photo: "Kozień Architekci" Archive)

a relic; its exterior can be seen from the courtyard, while its interior can be viewed from the stairs leading down to the basement (Figs. 3-6).

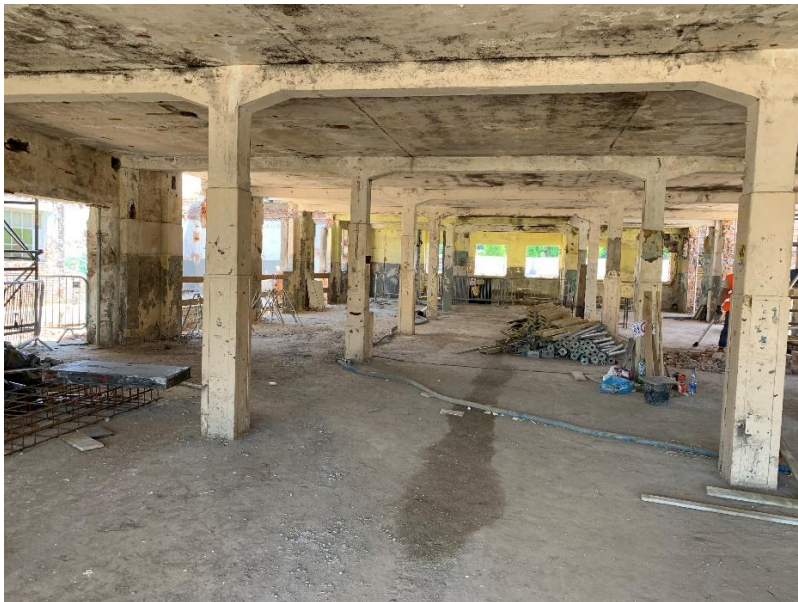
Fig. 4. The hall of the former camp slaughterhouse used by the bus depot – before the investment (photo: "Kozień Architekci" Archive)

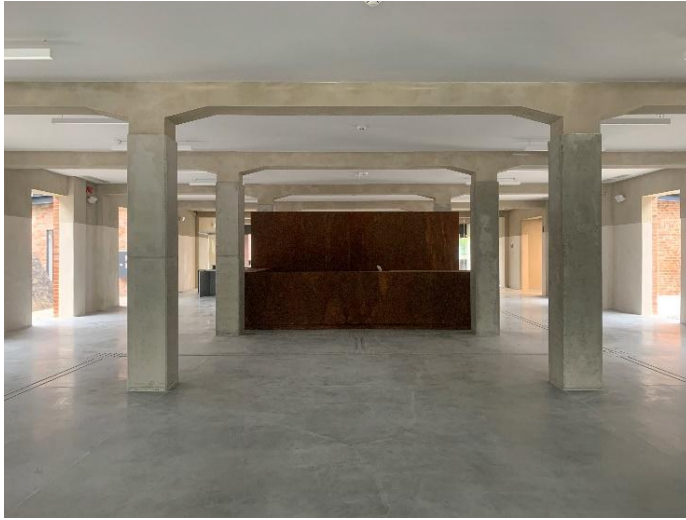
Fig. 5. Adaptation by “Kozień Architekci” of the hall of the former camp slaughterhouse for the hall of the Visitors’ Center of the Auschwitz-Birkenau State Museum in Oświęcim, (photo: “Kozień Architekci” Archive)

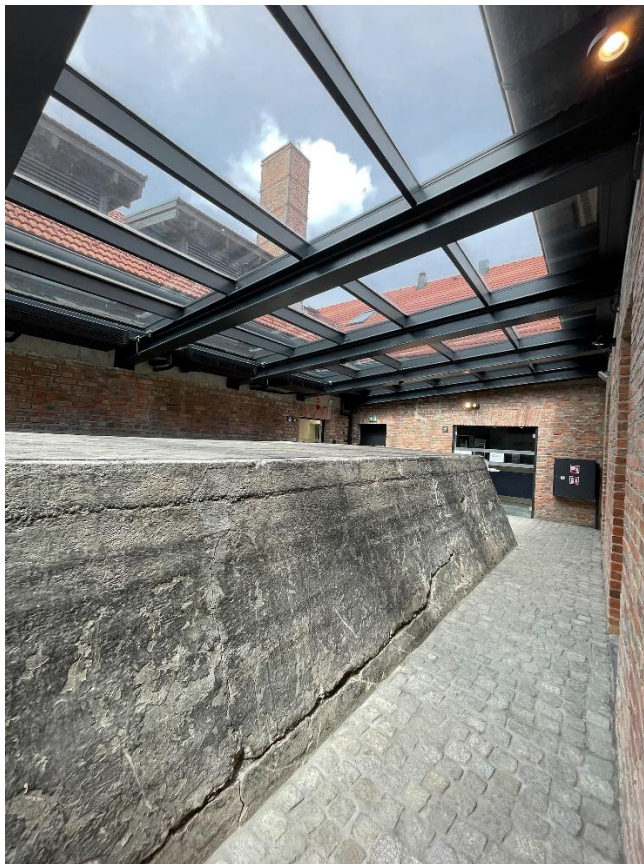
Fig. 6. Adaptation by “Kozień Architekci” of the courtyard of the former camp slaughterhouse and historic bunker – now the Visitors’ Center of the Auschwitz-Birkenau State Museum in Oświęcim (photo: “Kozień Architekci” Archive)

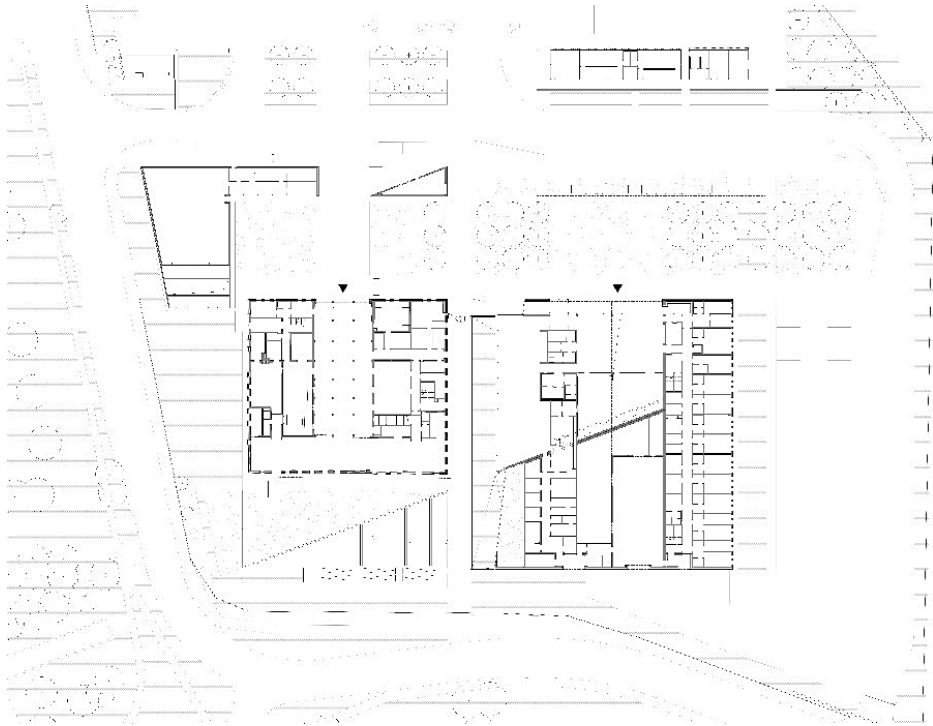
Fig. 7. Ground floor plan of the Visitors' Center project for the Auschwitz-Birkenau State Museum in Oświęcim (project by "Kozień Architekci")

The historic slaughterhouse building is being converted into a facility that not only serves basic visitor services but also constitutes the main, primary entrance for visitors to the museum grounds. The building is being restored to its highly probable original wartime character, with the aim of avoiding significant interventions in its external form. The existing two-story building, with a basement added as a result of reconstruction, expansion, and change of use, will be used to serve and accommodate visitors to the Auschwitz-Birkenau State Museum in Oświęcim (Figs 7 and 8).

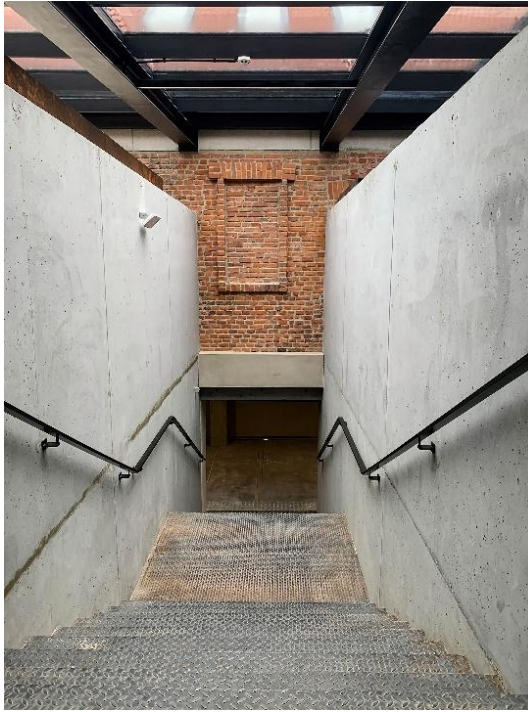
Fig. 9. Adaptation by “Kozień Architekci” of the descent into the basement of the former camp slaughterhouse – now the Visitors’ Center of the Auschwitz-Birkenau State Museum in Oświęcim (photo: “Kozień Architekci” Archive)

The main entrance to the building is located on the side of the driveway with stops for passengers (northeast side). The creation of a forecourt is intended to raise the status and importance of the existing building. Visitors proceed through the lobby to the waiting room, from which they descend via side passages to the former cold storage hall in the basement. Visitor traffic is divided between two staircases to improve traffic flow. In the former cold store hall, visitors pick up headphones and begin their tour of the museum, heading towards the underground passage. On their way back, visitors stop at the headphone collection point and, passing through the bookshop, head towards the exit (Figs. 9 and 10).

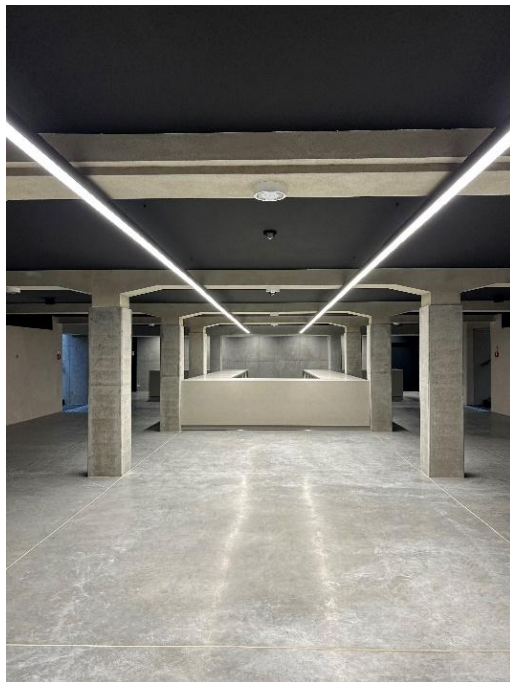
Fig. 10. Adaptation by “Kozień Architekci” of the cold storage hall in the basement of the former camp slaughterhouse – now the Visitors’ Center of the Auschwitz-Birkenau State Museum in Oświęcim (photo: “Kozień Architekci” Archive)

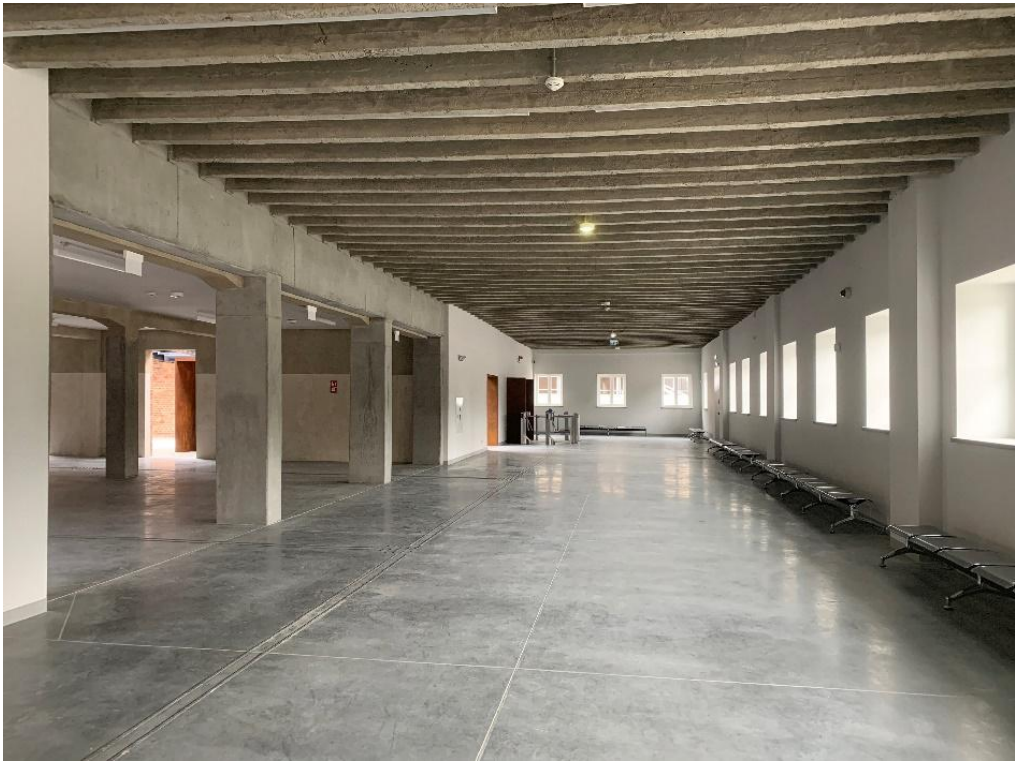
Fig. 11. Adaptation by “Kozień Architekci” of the hall with original ribbed concrete ceiling in the former camp slaughterhouse – now the Visitors’ Center of the Auschwitz-Birkenau State Museum in Oświęcim (photo: “Kozień Architekci” Archive)

Secondary alterations to the gable walls and roof slopes were removed, restoring the symmetry of the gable walls (e.g., by lowering the roof slopes in the northeast corner). The dimensions of the building and the layout of the roof slopes were retained after adjustments were made to restore them to their original condition. Only the necessary external elements were introduced, resulting from the technical infrastructure of the redesigned building, such as air intakes and exhausts and sewage vents. They were located in the part of the roof visible from the courtyards. The annex from phase VIII on the west side of the building was demolished. The two-courtyard layout of the building was retained. The ammunition bunker, as the oldest part of the building, was retained. Secondary structures in the inner courtyards, including the bunker superstructure, were demolished. The original form of the facility as a stand-alone building was retained. The newly designed buildings forming part of the complex were located at such distances that they did not interfere with the perception of its original form. The planned extension of the COO building will be carried out at basement level, without interfering with the original structure. The walls obstructing the perception of the internal courtyards as a whole were removed. Glass walls and partial-height walls were used to separate the interior space. In order to make functional use of the courtyards (one courtyard serves as a cash hall and dispatch room, while the other exposes the bunker and also serves as a communication area in front of the commercial services complex), they were covered with a glass roof. Roof windows were used to illuminate the rooms located in the attic (Fig 11).

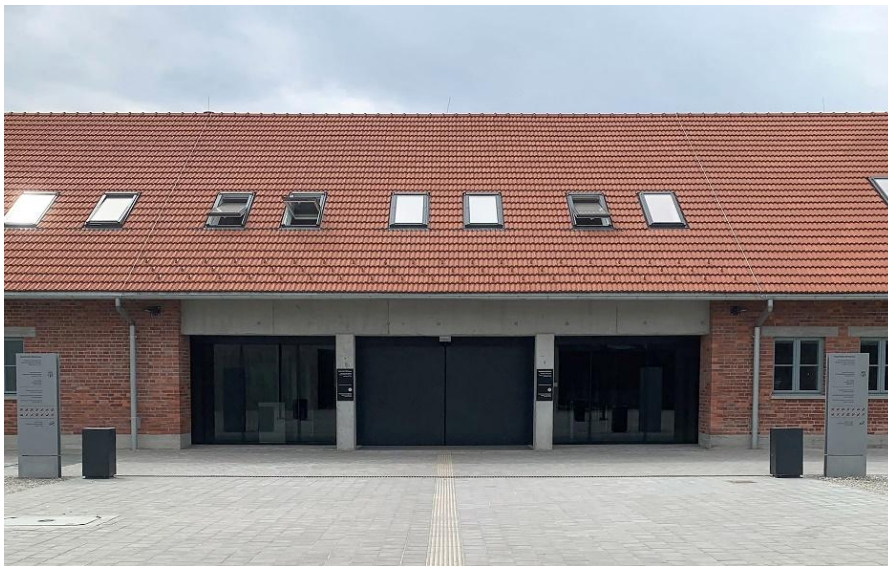
Fig. 12. Adaptation by “Kozień Architekci” of the main entrance to the former camp slaughterhouse – now the Visitors’ Center of the Auschwitz-Birkenau State Museum in Oświęcim (photo: “Kozień Architekci” Archive)

The garage doors in the northern, eastern, and western facades were removed as foreign elements distorting the original character of the building. Due to the small amount of original material preserved in the external walls, especially above the line of the modern window sills, it is impossible to remove the plaster from the walls in order to expose the raw brick in which the building was constructed. It was decided to use recycled historical brick, fired using traditional methods, with a color and properties similar to those of the other buildings in the camp, on the external facades and internal walls of the courtyards. The frames of all openings were removed. The roof surfaces were covered with ceramic tiles like those used in the camp. The room located on the bunker was removed. The room next to the bunker was removed. The existing window and door frames were replaced. The new design is adapted to the character of the woodwork in other buildings in the camp. The woodwork is dove-gray on the outside and white on the inside. An arcade was introduced in the central part of the northern façade in place of the existing garage doors, as a form of roofing for the entrance while at the same time using solutions that allow the space of the column hall to be read. In the background, a glass facade and structural profiles made of blackened steel were used (Fig 12).
