INTERPRETATIVE RECONSTRUCTION OF A MODERNIST VILLA BASED ON RESEARCH INTO ITS HISTORICAL CONTEXT

The article describes the process of aesthetic modernization together with the renovation of a modernist villa from 1932 located on the border of Poznan's 'Abyssinia' district, which was built in the 1930s. The building has not been fully completed, and its planned original external appearance remains unknown to this day. Thus, the research process is a combination of reconstruction and research hypotheses as to the intended form of the building. In the absence of source material, the decision was made to develop an original research method. This method, hereafter referred to as the "feature catalogue," was implemented in the villa reconstruction project. The catalogue and developed research method showed a 67% agreement between the design proposal (A) and 19% for (B). In view of the results obtained, concept (B) was rejected, while concept (A) was refined to a level of 86%. The conclusion of the article indicates the superiority of statistical research methods over traditional methods in historic architecture research.

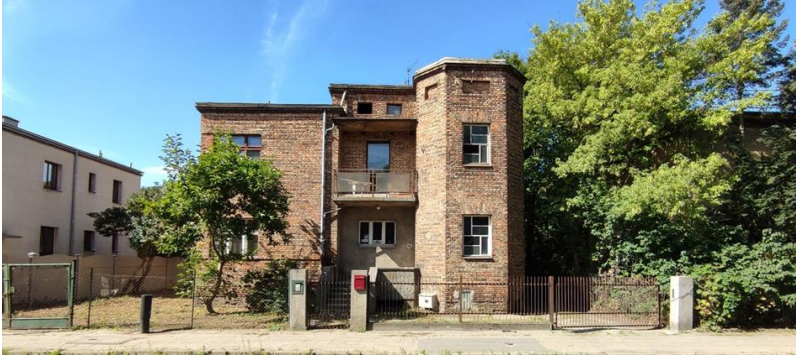
Fig. 2. The villa, current view from Grochowska Street, current state.

located in a compact development of a fragment of a housing estate in the district of Grunwald, surrounded by buildings with a single-family residential function; some of the neighboring buildings also have additional functions in the form of offices or commercial premises on the ground floors or basements of the buildings (Fig. 2.)

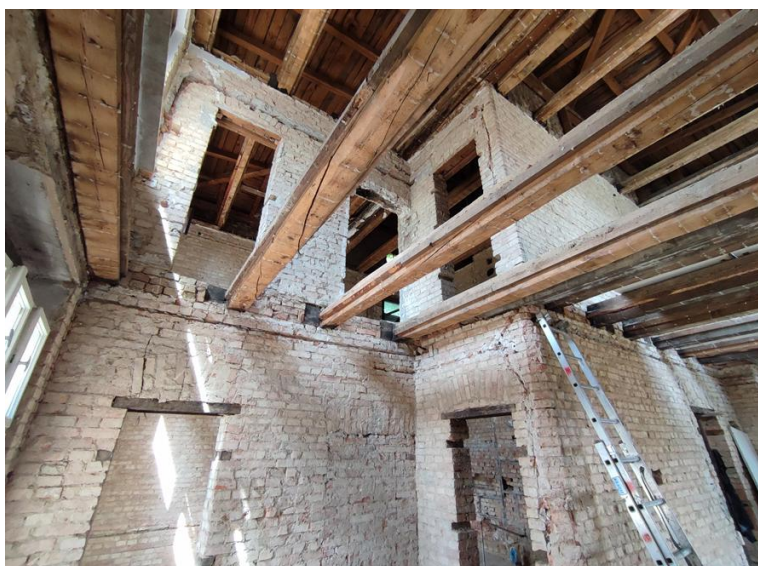
Fig. 7. View of the existing condition of the floor beams and load-bearing walls.

This evaluation focused on key load-bearing and envelope components, the results of which are presented in figures 5 and 6. The structural expertise aimed not only to identify critical

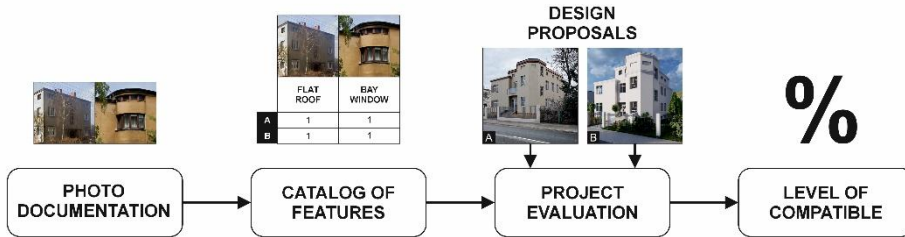
Fig. 8. A schematic diagram illustrating the research procedure was developed to visualize the sequence, interrelations, and methodological framework of the study. This diagram outlines each stage of the research process—from the initial identification and documentation of the case study through the formulation of research assumptions to the comparative analysis of conceptual design variants and final conclusions. It serves as a concise representation of the workflow, clarifying the logic and structure behind the adopted approach.

The study was divided into four stages (Fig. 8), where the first one consisted of collecting photographic documentation and inventorying characteristic features of buildings located in the ‘Abyssinia’ district of Poznan. The buildings had to be subjected to a selection process - those that had not been modernized in accordance with the principles of historic preservation were an example of negative interference with the historic fabric and were excluded from the study.

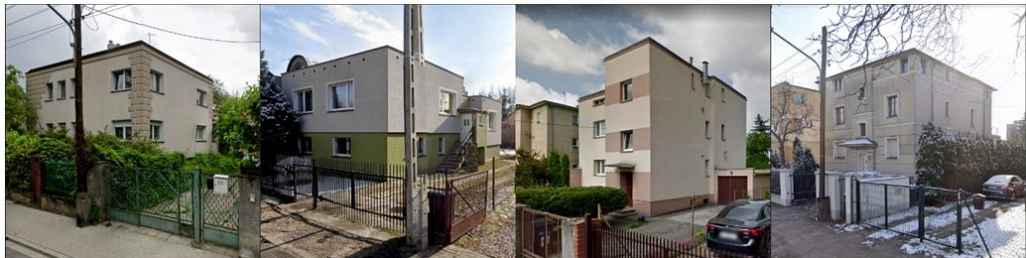
Fig. 9. The study includes a selection of negative examples of modernization interventions carried out on modernist buildings located in the ‘Abyssinia’ district. These cases were analyzed to highlight the consequences of inappropriate renovation practices, including the loss of original architectural features, the use of incongruous materials, and the introduction of stylistically inconsistent elements. By documenting these unsuccessful transformations, the research aims to identify common errors and oversights that compromise the historical and aesthetic value of early 20th-century modernist architecture. These examples serve as a critical reference point in shaping responsible design strategies for future conservation and adaptation projects.

The selection was based on guidelines taken from historical sources, where the most relevant ones were described in the Polish Building Law [13] of 1928. Based on the building documents, it was possible to define the boundary conditions that the residential architecture of the interwar period should meet. The described assumptions specify the geometrical features, choice of materials, colors, and dimensions of the distinct parts of the buildings erected in this location in the 1930s (Fig. 9).

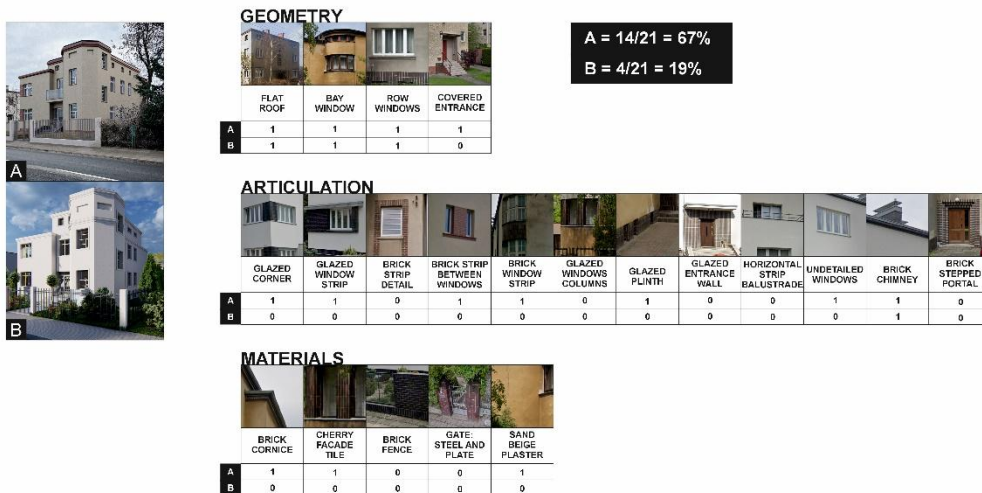
Fig. 10. Evaluation of two different project proposals in the adopted evaluation system.

The ‘GEOMETRY’ group included features such as a covered entrance, row windows, and a window bay. The most numerous group, ‘ARTICULATION,’ included, among others, a glazed corner, window beltline, inter-window beltline, and horizontal band balustrades, while the group ‘MATERIALS’ included considerations related to the materials used for the cornice, fence, and plinth, as well as the color of the plaster. Following the research concept presented in the publication ‘Methods of supporting the design of residential architecture—from system methods to grammar of forms’ [14], the set of features, together with illustrations, was collected in a table (Fig. 10).

The third stage of the study consists of evaluating two distinctive design concepts according to an established scheme. If a given design concept meets a certain feature criterion, a value of 1 is recorded in the table. Otherwise, the given design proposal receives a value of 0. The obtained results are collected in a table and passed on for further calculations. In the fourth step, using standard statistical methods (average), the percentage of compliance with the feature catalog is determined for each design proposal separately.

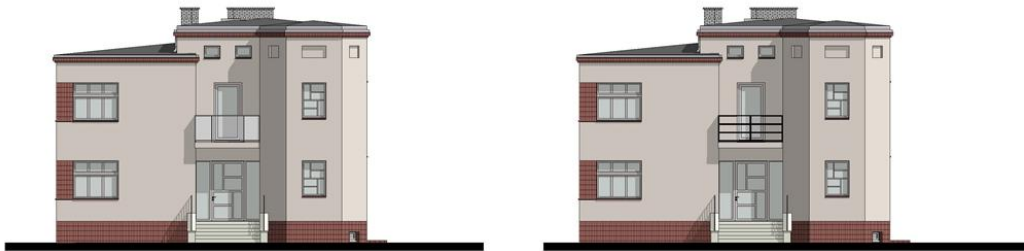
Fig. 12. South-west elevation, after changes regarding the sub-criteria of the method, selection of variables.

The study found an extreme incompatibility between concept (B) (Fig. 12) and the catalog of features. The proposal was considered to have no chance of improvement and was consequently rejected altogether. Corrective action was taken against concept (A) (Fig. 13), although it showed an acceptable level of compatibility.

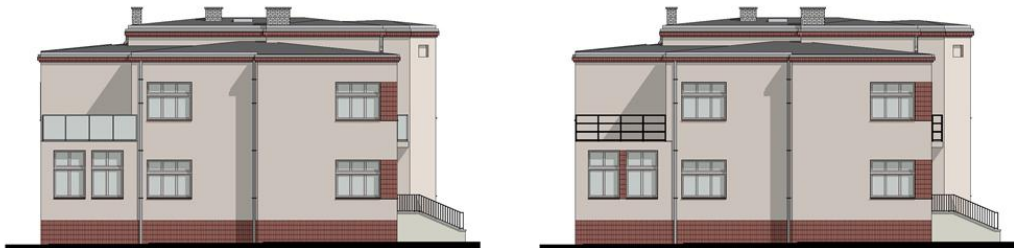
Fig. 13. The south-west façade of the building, documented in its original state prior to any modifications, was analyzed in relation to the sub-criteria defined within the adopted research method. This analysis focused on the selection and evaluation of specific architectural and technical variables relevant to the façade's historical, aesthetic, and structural characteristics. Particular attention was given to aspects such as material integrity, composition and proportion, window typology, and decorative elements, all of which were assessed for their compliance with the stylistic framework of 1930s modernism. This evaluation provided a foundational reference for determining the scope and direction of proposed interventions.

The study revealed some features of the design proposal's incompatibility with the accepted catalog of features. Concept (A) failed to meet, amongst other features, the presence of a horizontal strip balustrade, an inter-window post with glazed ceramic tile cladding, a brick fence, a fixed wicket, and tiles.

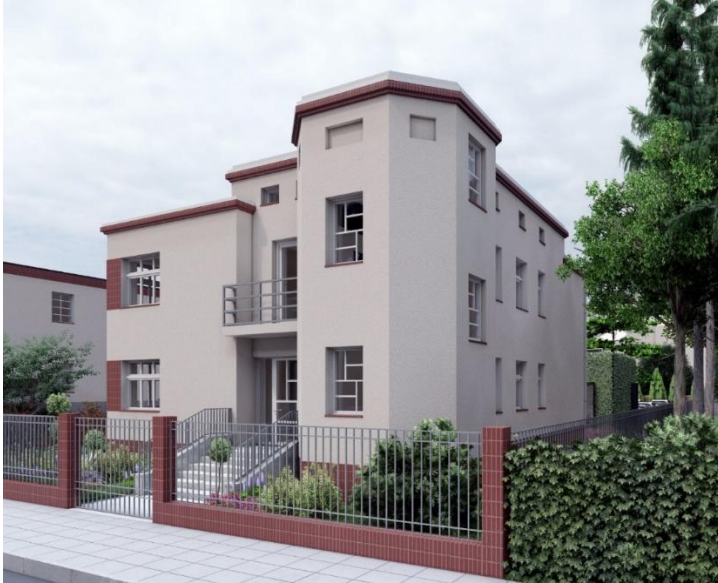
Fig. 14. Perspective view of the villa from Grunwaldzka Street in the final version to be implemented.

comprehensive and balanced approach to heritage conservation. The project reconciles the protection of historical architectural values with the requirements of contemporary functionality, user comfort, and current building standards (Fig. 14). The complexity of the undertaking required interdisciplinary cooperation between specialists in architecture, structural engineering, conservation, building physics, and installation systems.
