## ANALYSIS OF THE DESTRUCTION AND STRATEGY FOR THE BRICKWORK AND STONE DECOR CONSOLIDATION IN THE BUKOVINA AND DALMATIA METROPOLITANS' RESIDENCE

Iryna KOROTUN<sup>1,\*</sup>, Ruslan YURIICHUK<sup>1</sup>, Oksana HALUNKA<sup>1</sup>, Grzegorz TWARDOWSKI<sup>2</sup>

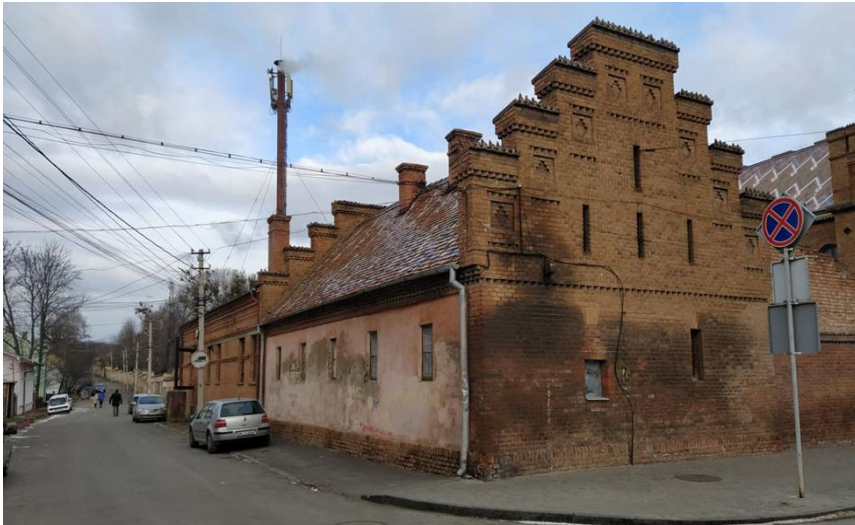
**Fig. 1.** Wetting and contamination of the facade surfaces of the outbuildings of the Seminary Building due to capillary wetting

Destruction of bricks due to wetting and subsequent salt crystallization. A significant part of the buildings in the Residences of the Metropolitans of Bukovina and Dalmatia complex exhibit lesions characteristic of poor-quality foundation waterproofing. This not only worsens the visual object's value but also creates conditions for the further development of biodegraders, which additionally accelerates the degradation of materials (Fig. 1).

The absence or degradation of foundations' horizontal and vertical waterproofing is one of the main reasons for capillary wetting of the walls of historical and modern buildings. In such conditions, moisture from the soil rises along the capillary system of the masonry, which leads to chronic wetting of the lower zones of the walls. Capillary suction ensures a constant flow of not only water, but also dissolved salts, which migrate into the thickness of the masonry and crystallize in the pores and on the surface of the materials. This creates conditions for intensive salt weathering, destruction of mortar joints, and progressive degradation of bricks and natural stone. Increased humidity of materials significantly changes their physical and mechanical properties, reducing compressive and shear strength, as well as increasing sensitivity to freeze-thaw cycles. Moisture-saturated joints and stone elements become more vulnerable to frost damage, which accelerates the formation of microcracks, loss of cohesion, and local collapses of surface layers. In the long term, this can lead to a decrease in the bearing capacity of walls, the development of deformations, and an increase in the risk of structural damage. In addition to physical degradation, capillary moistening has a significant negative impact on the aesthetic perception of buildings. Constantly moistened areas contribute to the formation of efflorescence, dark spots, biofilms, and microbiological colonies, which distort the historical appearance of facades and interiors.

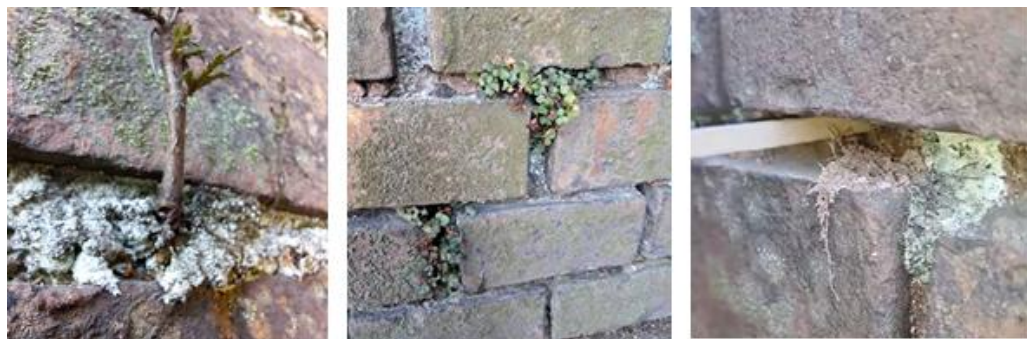
**Fig. 2.** Destruction of seams and brickwork surfaces by plants and the process of their removal  
(photo by K. Varvanych, 2025)

Biodegraders are a critical factor in the degradation of brickwork and natural stone facades, as they activate chemical corrosion of minerals; increase porosity and capillary wetting; indirectly enhance the formation of efflorescence and salt crystallization; and accelerate the physical destruction of surface layers (Fig. 2).

Biodegradation of brickwork by fungi. Fungal colonization of historic brick leads to mechanical damage through hyphal growth in pores and chemical degradation through organic acids (oxalic, citric, etc.). GC-MS, a highly sensitive analytical method combining the separation of mixtures (GC) with their identification (MS), is used to analyze volatile and semi-volatile organic compounds by separating them by retention time and then identifying them by ion mass, and SEM-EDX, a materials analysis method combining high-resolution surface imaging (SEM) with qualitative and quantitative elemental composition (EDX/EDS), which determines the morphology, particle size, impurities, and phases on solid samples (metals, polymers, and minerals), confirmed the demineralization and loss of cohesion of the ceramic matrix due to the action of biodegraders [11].

The group of biological destroyers includes bacteria, fungi, lichens, grasses, shrubs, trees, and mosses. Plants cling to the microcracks of the stone with their root system (Figs. 2, 4b). Over the years, plant growth and thickening of the roots expand the cracks and destroy the stone [16], [24].

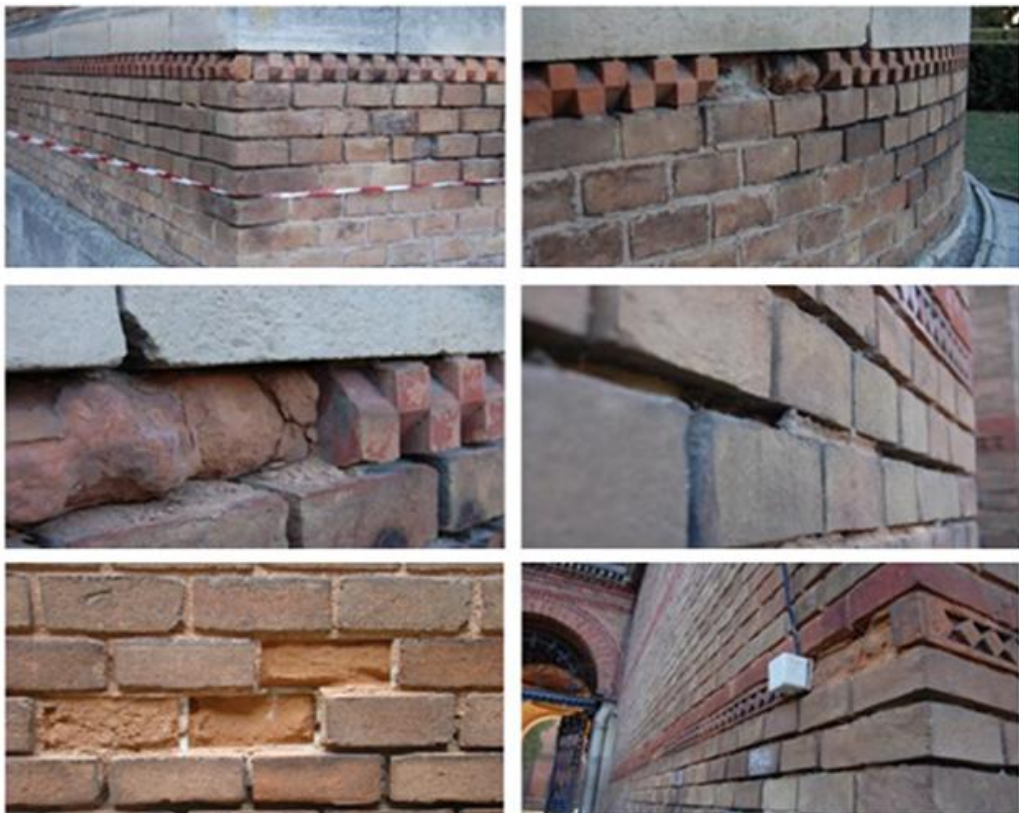
**Fig. 3.** Seams' weathering and decorative and masonry elements' destruction under the atmospheric factors' influence. Seminary building of the Bukovina and Dalmatia Metropolitans' Residence. Research of the Yuriy Fedkovych Chernivtsi National University Master students (Yerokhin B., Ilichuk M., Mazur O., supervisor I.V. Korotun, 2015)

Intensive weathering and destruction of brickwork joints with local deepening up to 10 cm. The causes and consequences of deep degradation of brickwork joints lie in deep weathering and destruction of mortar joints in brickwork, which in places reaches a depth of up to 10 cm (Fig. 3). This phenomenon is a consequence of the complex action of physical, chemical, and physicochemical processes, associated primarily with moistening, cyclic freezing-thawing, and crystallization of soluble salts. As shown in fundamental studies of the degradation of historical solutions, the presence of moisture in the pores and capillaries of the mortar leads to the formation of ice lenses and internal stresses in the process of the phase transition of water into ice, which causes micro-crack formation, loss of cohesion, and gradual dispersion of the solution material. Internal damage caused by ice crystallization in pores is one of the most important factors limiting the service life of historical structures [12].

Crystallization of soluble salts (sulfates, chlorides, and nitrates) in the pores of the solution creates crystallization pressure that exceeds the strength of lime solutions and leads to deep destruction of the joints (subflorescence) [12], [13].

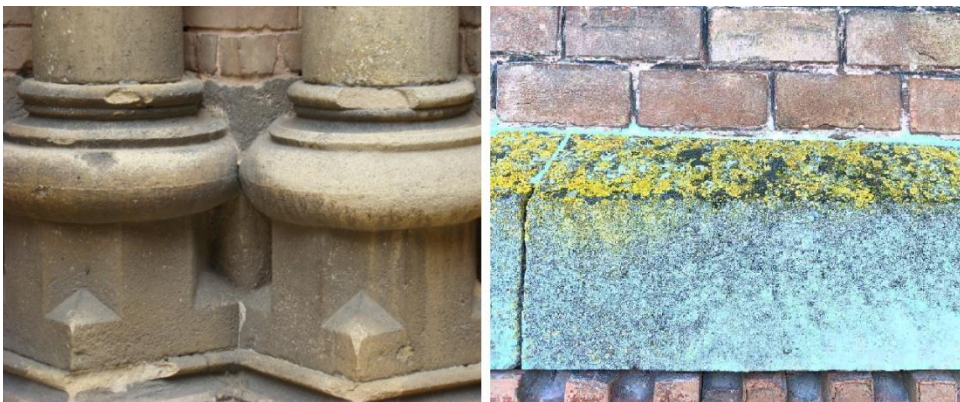
**Fig. 4.** Chemical and biological damage to the limestone surface on the Seminary Complex's facades (photo by I. Korotun, 2026)

The intensification of damage to stone facade parts is associated with such man-made causes as atmospheric pollution of the urban environment – increased air content of sulfur dioxide ( $\text{SO}_2$ ), nitrogen oxides ( $\text{NO}_x$ ), soot, heavy metals, and light organic compounds contribute to the formation of acid rain. This leads to sulfation, nitration, and carbonization of the stone surface layer, the black crusts' formation, and the mineral structure bonds' destruction (Fig. 4a).

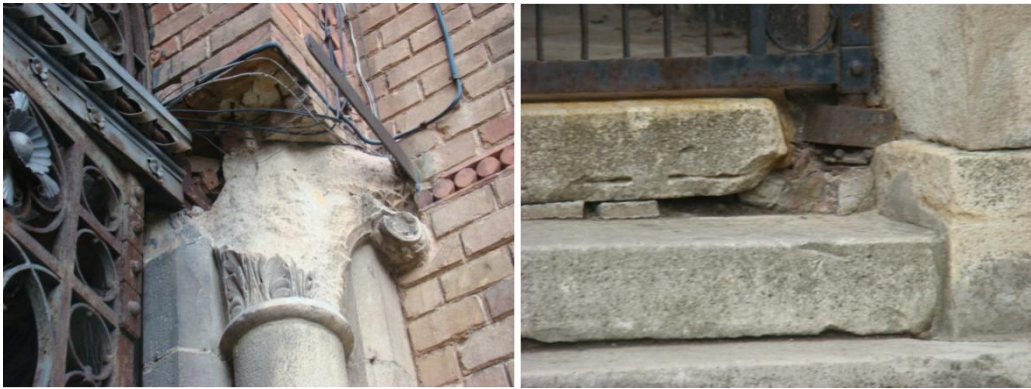
**Fig. 5.** Destruction (stone body's rupture) of limestone from contact with the gate iron fasteners. Gallery of the Seminary Building of the Residence of the Metropolitans of Bukovina and Dalmatia (photo by I. Korotun, 2015)

The change in microclimate due to man-made heating, or the so-called "urban heat island effect," increases the amplitude of daily and seasonal temperature fluctuations, which increases thermal stress in stone elements and causes their microcracking. The metal elements used to fasten facade elements work to "rupture" the body of the stone elements, which leads to their destruction (Fig. 5).

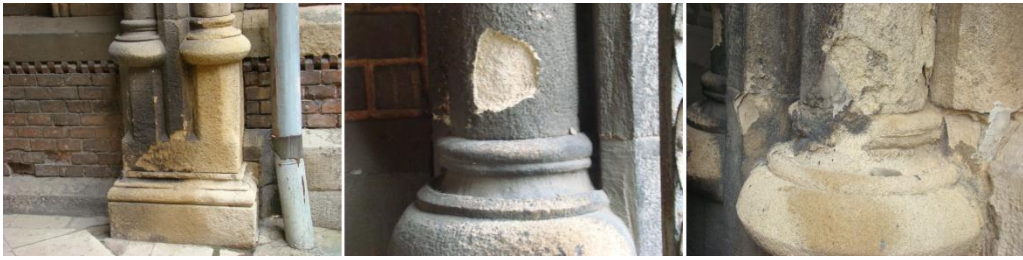
**Fig. 6.** Structural changes and destruction of limestone surfaces: "wild patina." Gallery of the Seminary Building of the Residence of the Metropolitans of Bukovina and Dalmatia (photo by I. Korotun, 2025)

Also, a special manifestation of the degradation of the limestone surface is the so-called "wild patina," which is formed as a result of uneven weathering, local accumulation of contaminants, biological colonization, and salt deposits. Such a patina is not a stable protective film, but, on the contrary, an indicator of active destruction processes, since it is accompanied by increased hygroscopicity, moisture accumulation, and increased chemical corrosion of the calcite phase. As a result, the "wild patina" masks the real state of the material, complicates the diagnosis of the degree of degradation, and contributes to further loss of material, which emphasizes the need for its scientifically based analysis and a controlled approach to cleaning and consolidating the surface of limestone elements (Fig. 6).
