## CONSTRUCTION AND STRUCTURAL SPECIFICITIES OF WARTIME RESTORATION OF EARLY 20<sup>TH</sup>-CENTURY HERITAGE BUILDINGS IN LVIV

*The article presents the results of an examination of residential buildings at 44 Konovaltsia Street and 62 Stryiska Street in Lviv, which were damaged as a result of Russian airstrikes on the city. These buildings are architectural monuments of local historical significance and require a comprehensive approach to their reconstruction. In accordance with the technical condition inspection reports, emergency and priority conservation work was carried out. Currently, scientific and design documents for the rehabilitation of the buildings have been developed. During the design work, the key point in the pre-project research was the calculation and scientifically based confirmation of the principles of operation of historical structural elements and the justification for the use of new structural schemes, as well as intervention in the authentic structure of the monument. For a detailed study of the objects, archival materials, acts of assessment of the character of destruction, and acts of technical condition of buildings, as well as digital documentation,

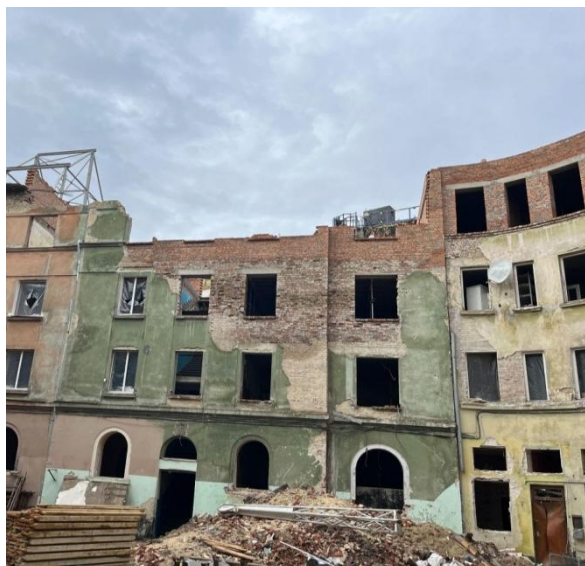
**Fig. 1.** 64 Stryiska Street: view of the facade from the inner courtyard documented on 20 October 2023 (photo: Ihor Bokalo)

Since 2022, Lviv has periodically experienced missile strikes. Although targeted less frequently than many other Ukrainian cities, the city is characterized by an exceptionally dense concentration of historically and architecturally valuable buildings, which makes its unique architectural heritage especially vulnerable to such attacks. On 6 July 2023, a Russian missile struck the residential complex at 50-76B Stryiska Street (Fig. 1). Later, on 4 September 2024,

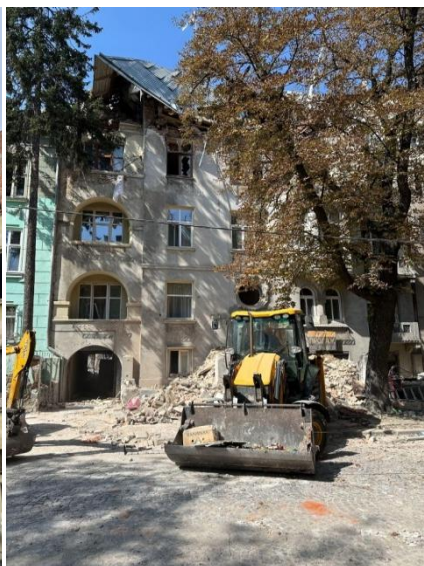
**Fig. 2.** Main façade of 44 Konovaltsia Street shortly after the missile attack, documented on 4 September 2024 (photo: Mariana Kaplinska)

Lviv was attacked by Kinzhal missiles, resulting in damage to multiple protected heritage buildings in two districts of the city. The epicenter of one of the strikes was located at 44 Konovaltsia Street (Fig. 2). The following analysis focuses on the two affected sites

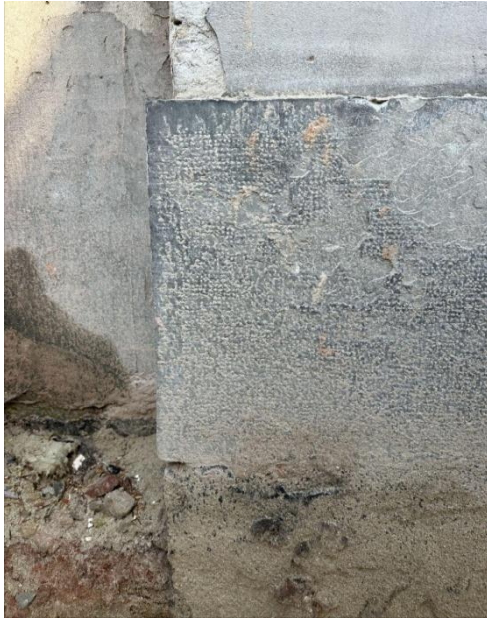
**Fig. 4.** Sandstone block on the main façade of 44 Konovaltsia Street (photo: Mariana Kaplinska)

basement level was faced with dressed sandstone blocks with an average thickness of about 100 mm (Fig. 4).

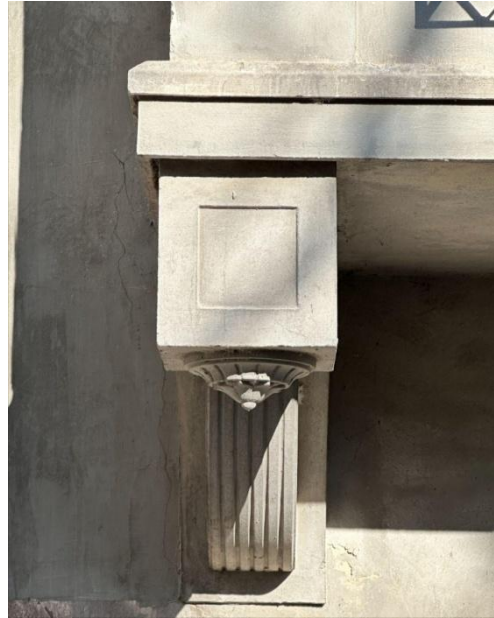
**Fig. 5.** Plaster decoration of the main façade of 44 Konovaltsia Street (photo: Mariana Kaplinska)

Of particular note is the original façade finishing, which employed a through-colored lime-sand plaster pigmented with finely dispersed soot collected from chimneys—an expected solution in a city entirely dependent on stove-based heating. This method ensured a uniform grey tone resembling exposed cement without the application of a surface paint layer (Fig. 5).

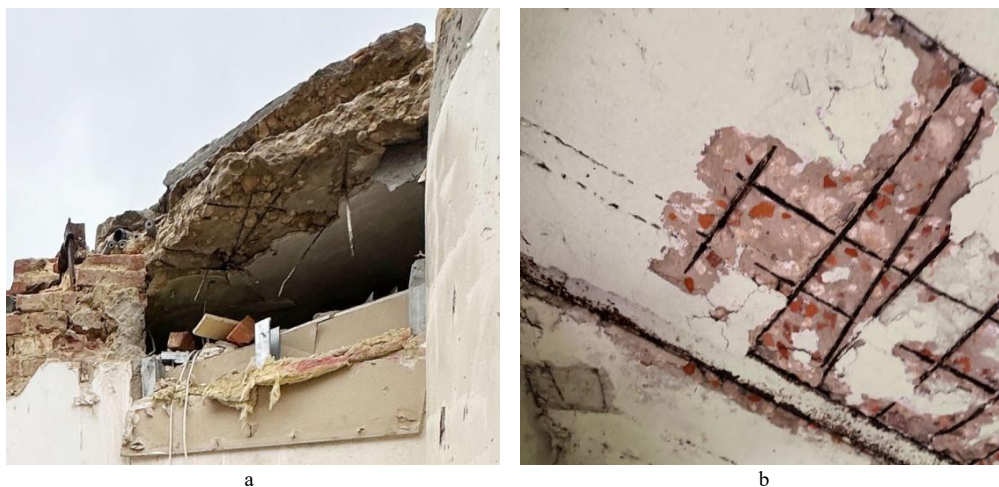
**Fig. 6.** Early reinforced concrete at 44 Konovaltsia Street: view of the third floor (a) an fragment of the ceiling (b), documented on 28 January, 2025 (photo: Ihor Bokalo)

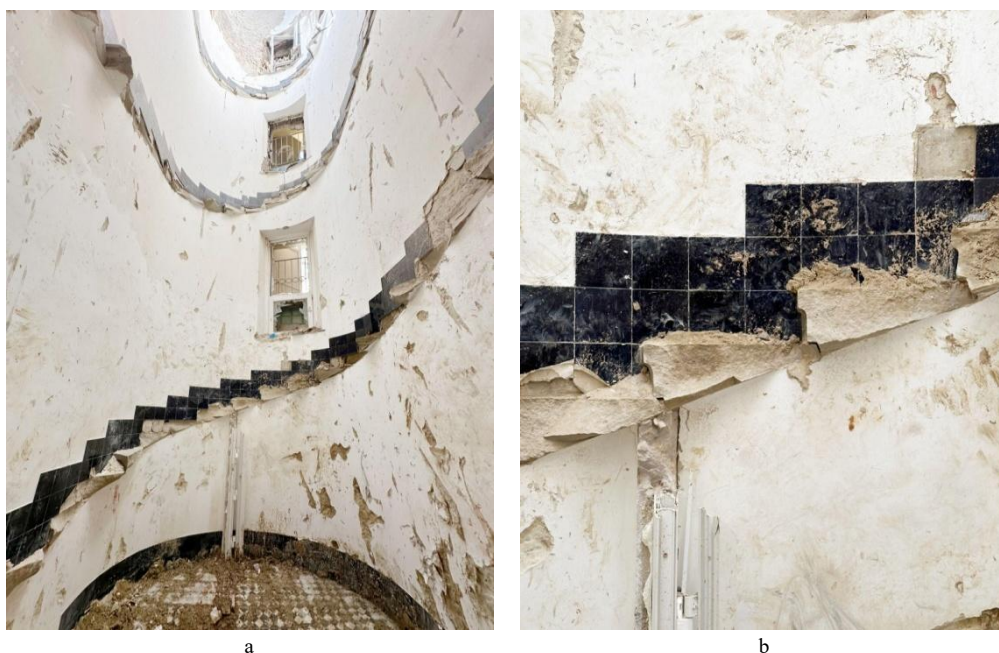
**Fig. 7.** The main stone staircase at 44 Konovaltsia Street, ruined by the attack: general view (a) and close-up (b). Documented on 04 September, 2024 (photo: Mariana Kaplinska)

A direct missile impact caused a progressive collapse of the main staircase, followed by the total loss of the roof structure, the attic story, the third floor, and partial damage to the second floor.

New stairs for the main stairwell were constructed in monolithic reinforced concrete and subsequently clad with 40 mm thick natural sandstone slabs, as reconstructing the original cantilevered stone steps anchored into the masonry walls was not technically feasible under post-impact conditions.

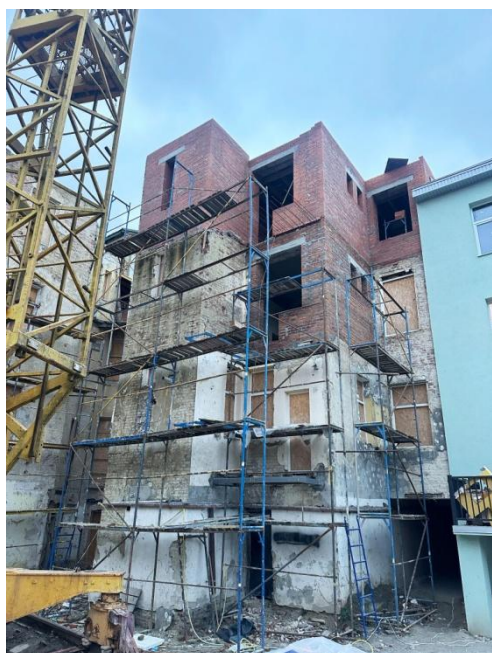
**Fig. 11.** Rear façade of 44 Konovaltsia Street during the restoration works, documented on 5 December 2025 (photo: Ihor Bokalo)

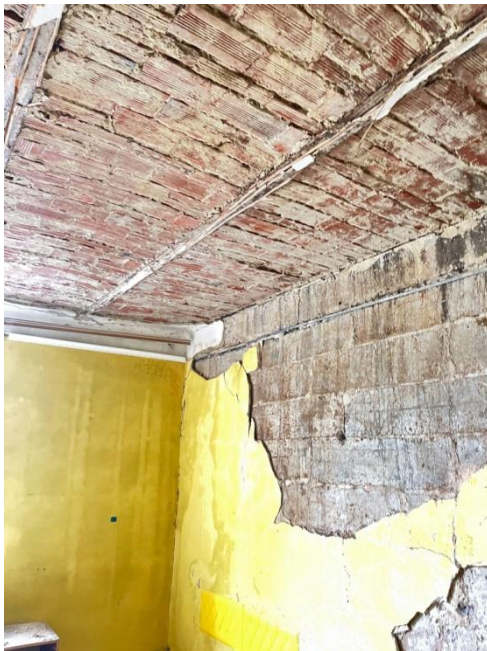
**Fig. 15.** Hollow brick jack arch floor structure on metal I-beams and a gypsum block partition in Building No. 64 on Stryiska Street after the missile strike, documented on 20 October 2023. (photo: Ihor Bokalo)

The inter-story floor structures were originally executed as a jack arch system (Fig. 15). Between the basement and the ground floor, the arches are infilled with solid brick, while the upper floors employ hollow ceramic block infill, forming shallow ceramic jack arches

approximately 70 mm thick. Above the arches, a leveling lime-sand screed with the addition of cement was applied, serving as a base for the subfloor and parquet flooring. This solution provided effective thermal and acoustic insulation.

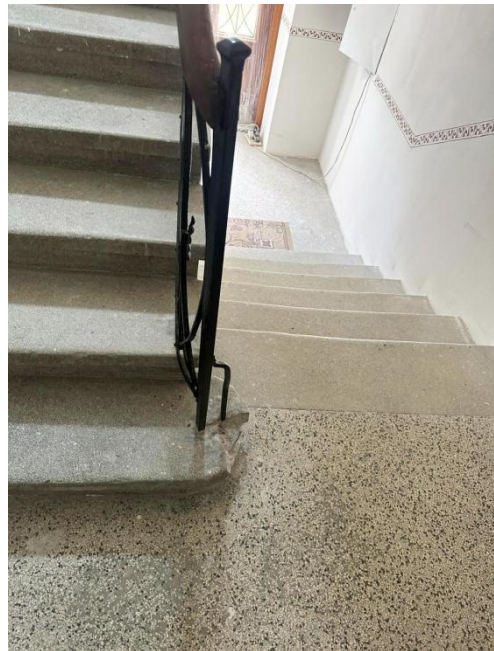
**Fig. 16.** Historic stairs finished in terrazzo in Building No. 68 on Stryiska Street during the restoration works, documented on 11 June 2025 (photo: Ihor Bokalo)

The staircases are two-flight structures supported on steel I-beam stringers. The steel framework was covered with metal lath and plastered, with the finish shaped into decorative recessed panels. Prefabricated reinforced-concrete treads were mounted onto the steel structure, with factory-applied bush-hammered surfaces intended to provide a mechanical key for the finishing layer (Fig. 20). The final finish was executed in the terrazzo technique: an on-site applied marble-chip mortar layer approximately 10 mm thick was polished, resulting in high wear resistance and a durable finished surface (Figs. 116 and 17).

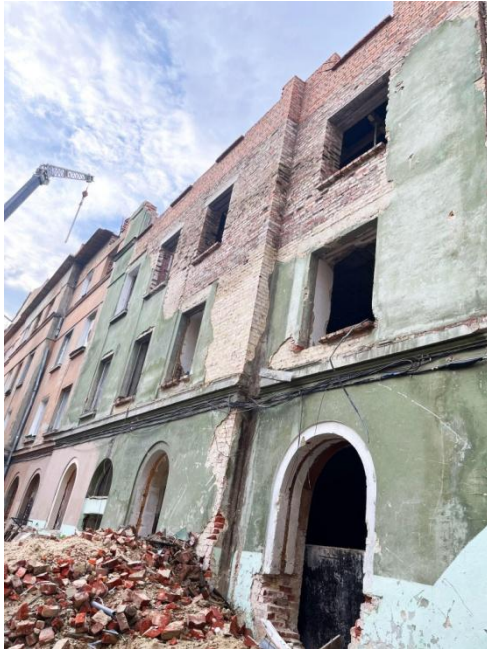
**Fig. 18.** Rear façade of Building No. 64 on Stryiska Street during the restoration process, documented on 20 October 2023 (photo: Ihor Bokalo)

The reconstruction of the walls initially relied on historic bricks salvaged from the collapse debris generated by the missile strike (Fig. 18). Following the dismantling of unstable wall

sections, the rubble was sorted on site within the inner courtyard of the complex, allowing reusable masonry units to be recovered. The reconstruction process included mechanical cleaning of the salvaged historic bricks, which made it possible to reuse them in the rebuilding of Building No. 64 up to the level of the third story, as well as in the reconstruction of historic ventilation and chimney shafts.

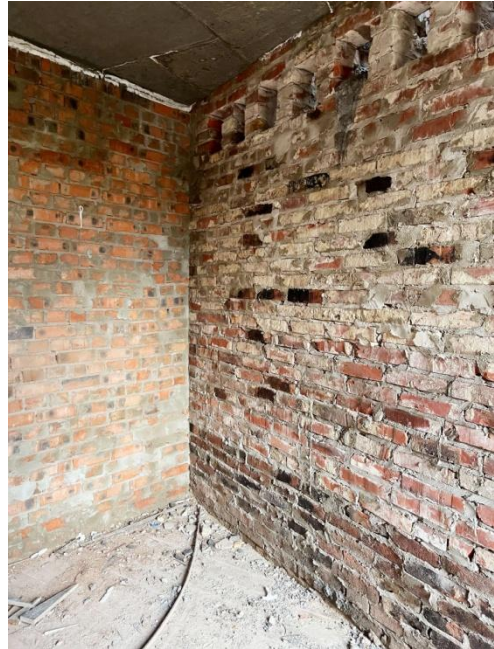
**Fig. 19.** Wall masonry composed of contemporary and historic bricks at 64 Stryiska Street, documented on 20 October 2023 (photo: Ihor Bokalo)

The use of reclaimed historic brick was not limited to conservation considerations but was also informed by material compatibility requirements. Its application allowed the masonry to be rebuilt in continuity with the original bonding logic, maintaining joint thicknesses and wall connections consistent with the historic fabric. However, the quantity of salvaged material proved insufficient. As a result, the subsequent use of contemporary bricks with differing dimensions (250x120x65) led to local reductions in wall thickness and to misalignment of masonry courses (Fig. 19). The bonding of new masonry to the existing historic walls was resolved through anchoring with steel rods.

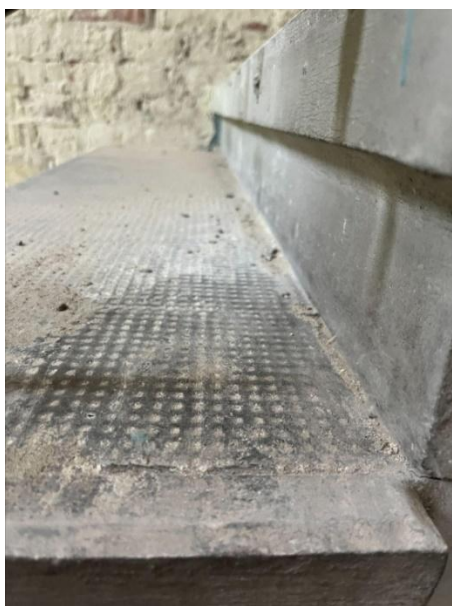
**Fig. 20.** Historic prefabricated reinforced concrete stair treads with factory-applied bush-hammered surfaces, intended as a base for the terrazzo finish, in Building No. 68 on Stryiska Street, documented on 19 March 2025 (photo: Ihor Bokalo)

In Building No. 64, where the stairwell had been completely lost, the reconstruction aimed to reproduce the historic appearance of the staircases, although the construction technology necessarily differed (Fig. 21). The stair treads were produced as prefabricated elements using specially prepared molds. A marble-chip mixture was first applied to the mold surfaces, after which the reinforced-concrete treads were cast. Once cured, the elements were polished and installed onto steel I-beam stringers. The surrounding stairwell finishes were subsequently reinstated using plaster to reproduce the original architectural articulation. In the remaining buildings of the complex, the staircases sustained only fragmentary damage. Here, losses were addressed through local recasting of reinforced-concrete elements, while the terrazzo finish was carefully patched and integrated to maintain continuity with the historic fabric.

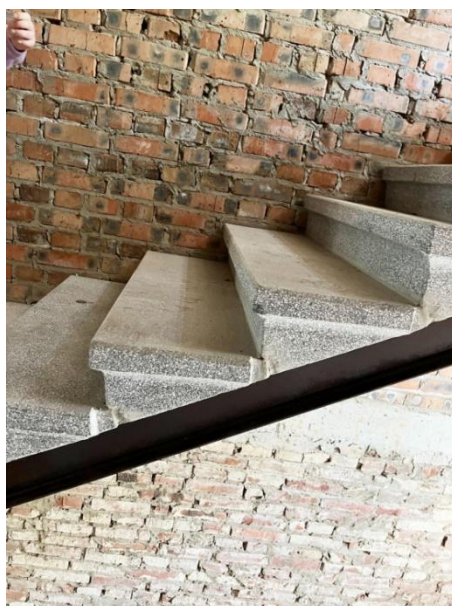
**Fig. 21.** Reconstructed contemporary prefabricated reinforced concrete stair treads installed on steel stringers in Building No. 64 on Stryiska Street during the reconstruction process, documented on 29 April 2024(photo: Ihor Bokalo)

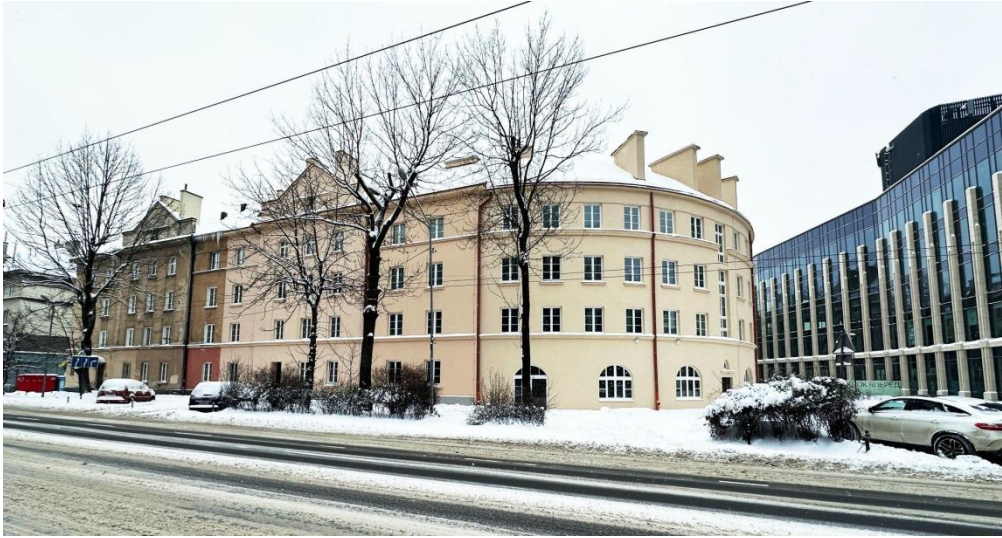
**Fig. 22.** View of the restored residential complex on Stryiska Street from the north, documented on 9 January 2025 (photo: Mariana Kaplinska)

Beyond the scale of individual buildings, the interventions discussed in this study have clear urban significance. The completion of the Stryiska Street complex restored the integrity of an entire historic urban block (Fig. 22), while the reinstatement of 44 Konovaltsia Street re-establishes the continuity of the historic street frontage. Notably, the neighboring building at 44a Konovaltsia Street had already been damaged during the Second World War and subsequently restored in its original architectural form, marking a rare continuity of wartime damage and restoration at the same location.
