# CONSERVATION AND ADAPTATION OF HISTORIC TENEMENT HOUSES AS A TOOL FOR SHAPING URBAN IDENTITY: THE CASE OF CZĘSTOCHOWA

*This article discusses the issues of conservation and adaptation of historic buildings as essential elements shaping the historical urban structure of the city of Czestochowa. Czestochowa is a medium-sized town. It was chosen because of its significance, both historical and cultural. It is an important pilgrimage and academic and tourist center. The architectural and urban solutions should reflect the uniqueness of the place and its cultural identity. The article presents numerous activities that aim at organizing the historical layout of downtown buildings related to the protection and preservation of historic substance. The historic tenement houses located within Daszyński Square – the oldest fragment of the historical part of the city – were chosen as a case study. The analysis emphasizes the possibilities of preserving and adapting historic tenement houses as key factors in improving the city's image, referring to contemporary functional needs with the historical heritage of the place. The research includes an archival and library query and "in situ" observa

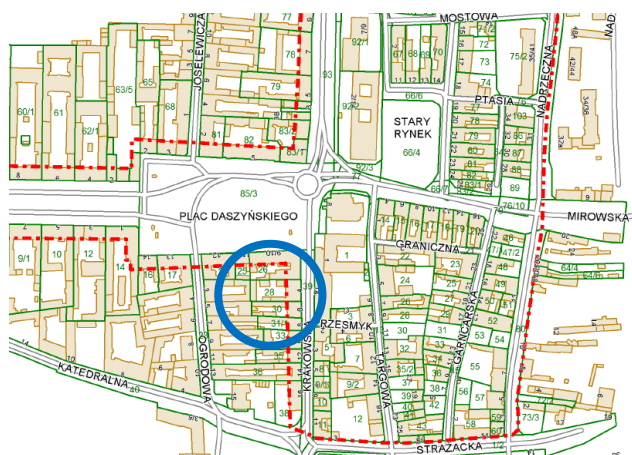
**Fig. 1.** The historic urban layout of the city of Częstochowa with the boundaries of the area under conservation protection; the subject of research is marked in a circle [4]

The legal basis for the activities conducted was the Act on the Protection of Monuments and the Care of Monuments of 2003 (as amended) and the provisions of the Construction Law. The methodology used, based on the functional and spatial analysis of the city as well as the architectural analysis of the building, enabled a comprehensive assessment of the process of modernization and renovation of the historic tenement house (Fig. 1).

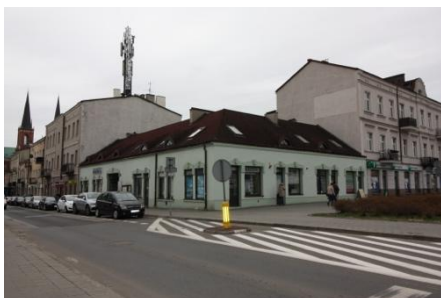
**Fig. 4.** Tenement at 9 Daszyński Square  
(Northern façade)  
(author's photos: A. Broda, 1983)

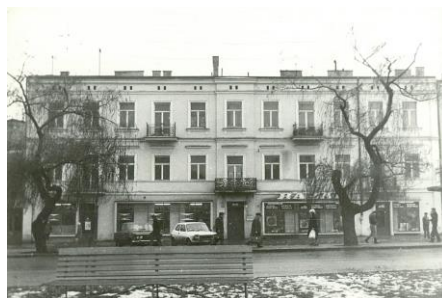
**Fig. 5.** Tenement at 9 Daszyński Square  
(Northern façade) (author's photos:  
N. Solkiewicz-Kos, M. Tubielewicz-Michalczuk, 2026)

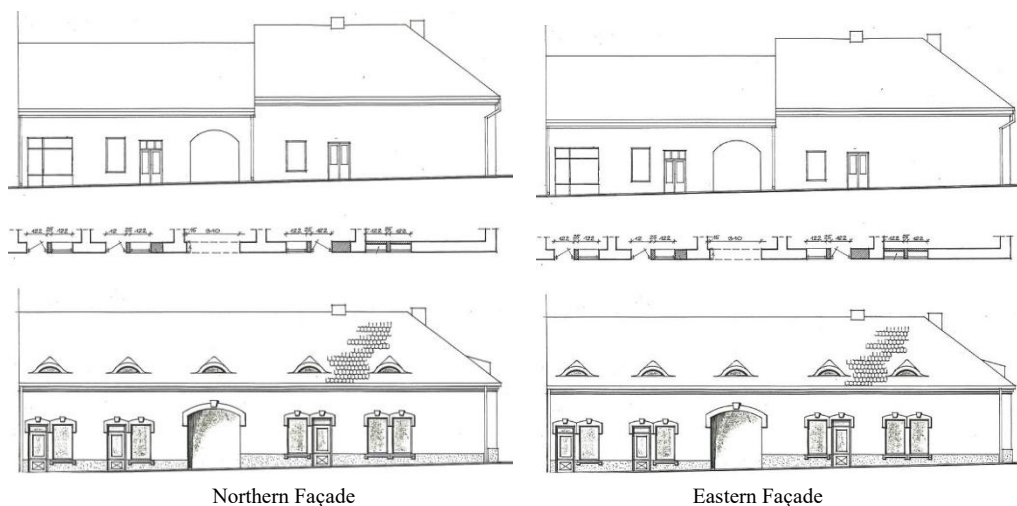
**Fig. 12.** The condition of the tenement house before the modernization (see above) and the condition of the tenement house after modernization. The visibly designed stairs to the basement have not been implemented.

Author of the study: Arch. Lech Nowotarski

The most visible transformations included the façade, which—despite its modest shape—was developed in a way referring to the neighboring buildings. Wide shop windows were introduced, and their lintels and door frames were accentuated with segmental arches with

decorative keystones, which was a subtle nod to the historicizing detail present in the tenement houses on the square. However, the final implementation did not fully correspond to the original design assumptions—the window and door joinery was simplified; these changes slightly weakened the intended stylistic effect (Figs. 12 and 13).
