## IR THERMOGRAPHY IN MOISTURE AND EARTHQUAKE DAMAGE DETECTION PERFORMED IN THE ŽIČA MONASTERY, SERBIA

Slavica RISTIĆ<sup>1\*</sup>, Suzana POLIĆ-RADOVANOVIĆ<sup>2</sup>

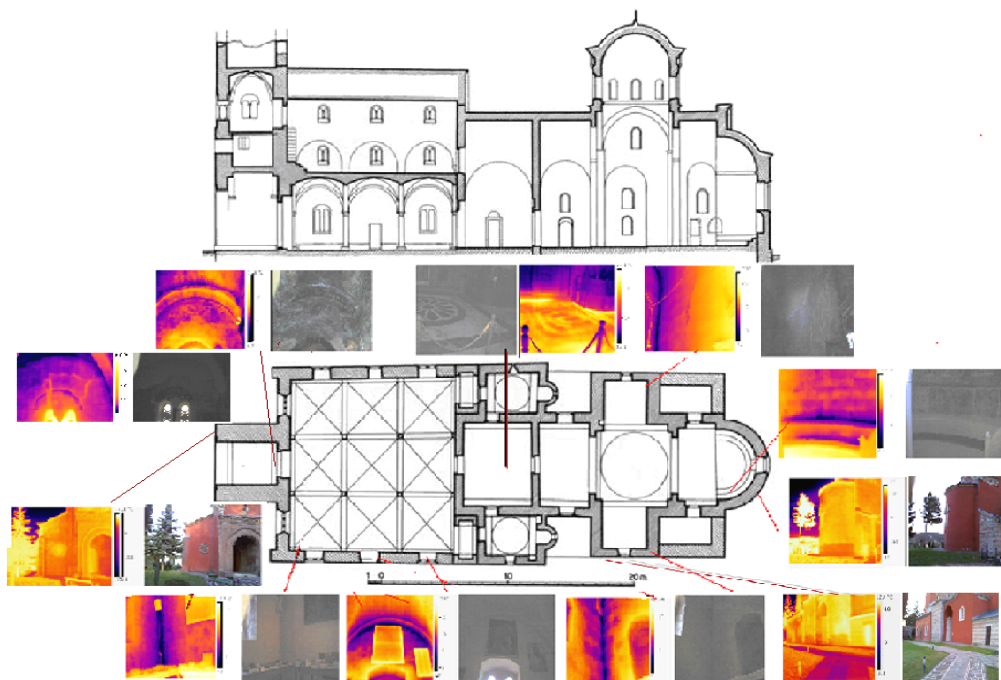
Fig. 1. Architectural drawing of the Žiča Monastery, the Church of St. Savior, illustrated by photos and thermograms

The thermograms and digital photos of some parts of the monastic buildings are presented together. Figure 1 shows an architectural drawing of the Žiča Monastery, Church of the Saint Savior, illustrated by photos and thermograms.
