OIL PAINTING COLLECTION: RISK ASSESSMENT, EVALUATION AND MITIGATION STRATEGIES

Mafalda FERNANDES, Sara BABO¹, Maria Filomena MACEDO^{1,2*}

Keywords: Preventive Conservation; Risk Assessment; Oil Painting; Historic House.

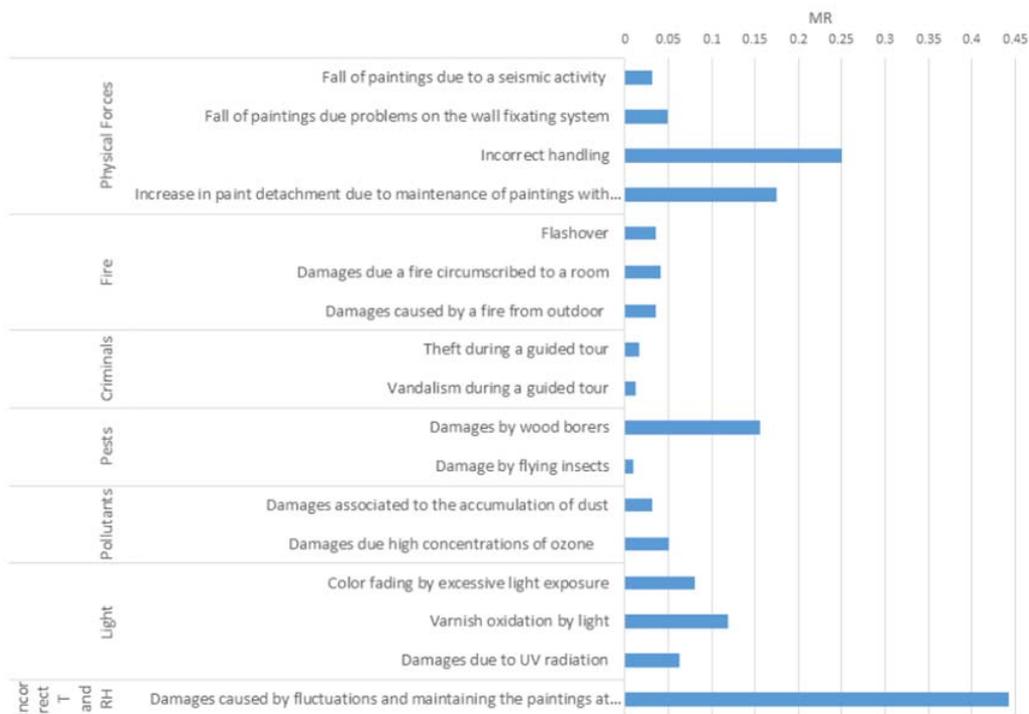
Figure 3 shows the MR results obtained for the specific risks affecting this oil painting collection.

Fig. 3. Magnitude of the main specific risks (MR) calculated for the oil painting collection on display in “Casa dos Patudos”

Since the opening of the Museum, the staff working in “Casa dos Patudos” never had training on preventive conservation or collections care; as a result some works of art were already damaged by incorrect handling. As it was reported by the staff, at least one painting has fallen due to incorrect handling. Every painting is handled on a regular basis for loans, cleaning or to apply insecticides in the frame. The loss of value is moderated because the damages will be localized and mainly on the frame. Nevertheless, this risk magnitude presents one of the highest values (Fig. 3).
