## THE STUDY OF CONSERVATION STATE OF A WOODEN CHURCH FROM BOZ VILLAGE, HUNEDOARA COUNTY, ROMANIA

### *Abstract*

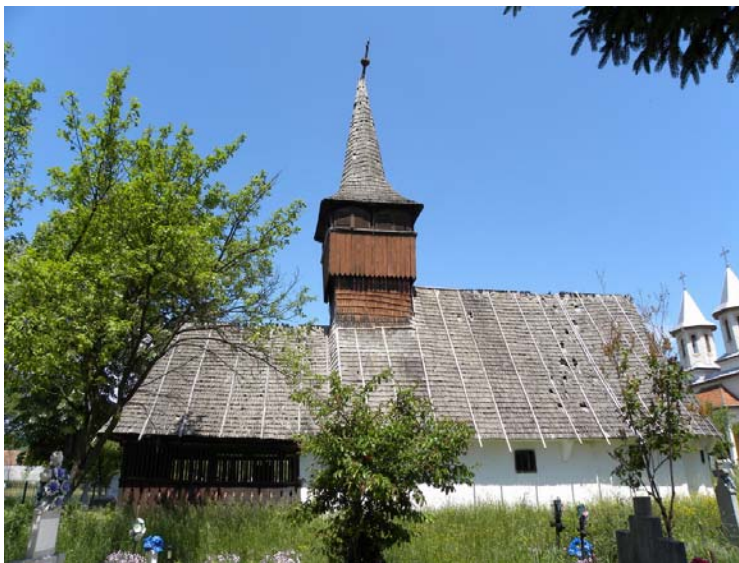
**Fig. 1.** The wooden church from Boz Village

Outside the basement is included and doubled with concrete. The sills, walls and consoles are plastered with lime and sand over cane cladding. The retreating consoles have a little lobe at the bottom. The roof height is almost two times higher than the walls. This was covered with handmade shingles from spruce, fixed in tow layers and laterally jointed (in tongue and groove). The high bell tower has a turret on consoles with a closed gallery, with splay roof covered with shingles (Fig. 1.).
