## RESTORATION AND PRESERVATION OF ARTISTIC ELEMENTS APPLIED ON ISLAMIC ARCHITECTURAL FAÇADE OF SHAHIN AGHA SEBIL, CAIRO, EGYPT

### Abstract

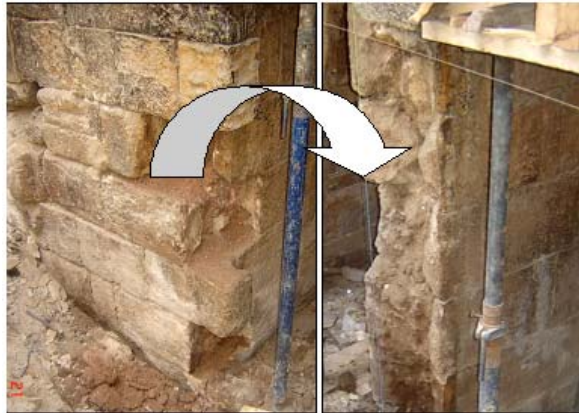
external stone block leaves with a void of varying thickness between them. The space between the two external leaves was filled with a loose low strength materials made of pieces of stone and mortar (Fig. 3). The thickness of the wall varies in the range of 450–600 mm. The artistic elements (Fig. 2) on the façade of Shahin Agha Sebil have suffered severe effects, some of them being collapsed (totally or partially) and several damage patterns were observed. The aim of this current work is to study and evaluate the current state of the stone façade of Shahin Agha Sebil, and to study the façade materials in order to identify its components and introduce a scientific study for its architectural and fine treatment.

Fig. 3. The facade wall assembly consists of a bearing limestone wall (Multiple-leaf walls)

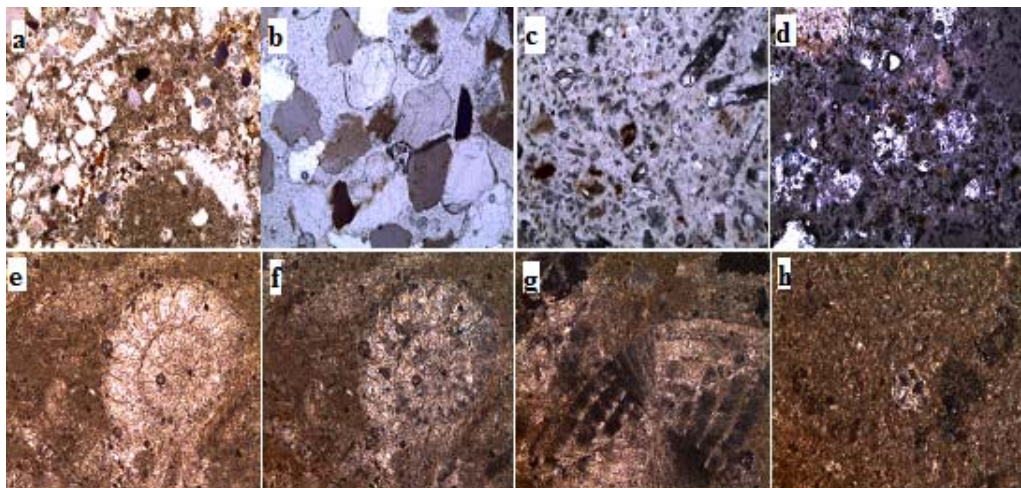
**Fig. 8.** Optical micrographs: **a** - Fine grained calcite (micrite), **b** - Quartz grains as sub rounded to angular, **c** and **d** - iron oxides and fossil fragments, **f** - Gypsum. Clay minerals and some fine grained quartz, **e:h** - Nummulite, shells and fossils fragments.

Examination of thin sections of the limestone samples under plan polarized light microscope (PLM) displayed fine-grained calcite crystals, on top of iron oxides, clay minerals and numerous grains of quartz that were also found occurring as sub rounded to angular. These

component; its increase the rate of stone decay. The study showed also Nummulite, shells and fossils fragments as shown in figure 8. Studies indicated that, the limestone used in Shahin Agha Sebil is Nummulitic limestone, which formed in the Middle Eocene from Mokkatam formation.

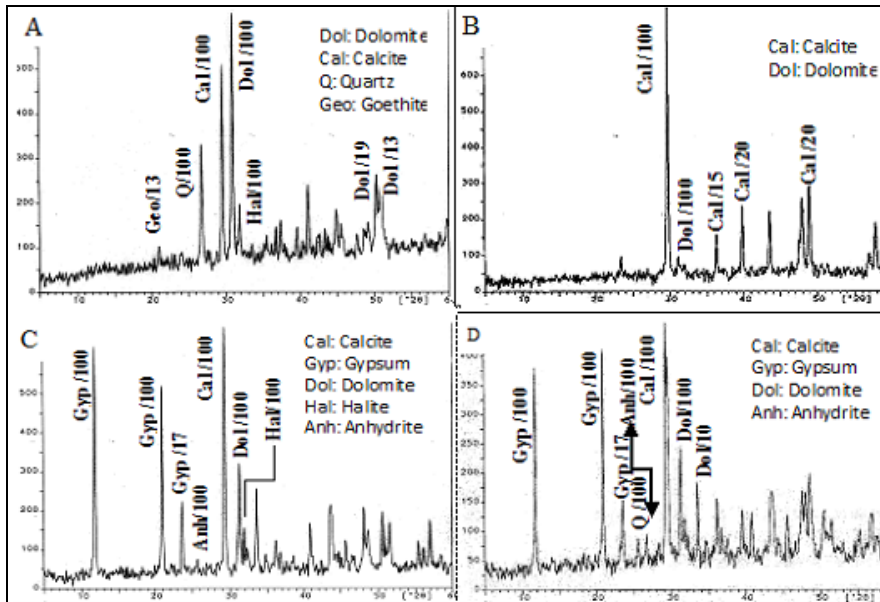
The collected limestone and mortar samples were studied by XRD in order to determine their mineralogical composition. XRD patterns of the studied samples are given in Figure 11 and Table 2, and show that the samples consists essentially of calcite  $\text{CaCO}_3$ , Dolomite  $(\text{Ca,Mg})\text{CO}_3$ , small amount of halite  $\text{NaCl}$ , Quartz  $\text{SiO}_2$ , Gypsum  $\text{CaSO}_4 \cdot 2\text{H}_2\text{O}$ , Anhydrite  $\text{CaSO}_4$  and traces of iron oxide. According to this study, we claimed that the stone in the façade consisted of calcite as a major minerals and high ratio of dolomite (Dolomitic limestone) and small amounts of Quartz and iron oxide. The presence of halite and gypsum is related to salts. The presence of anhydrate is the result of the transformation of gypsum  $(\text{CaSO}_4 \cdot 2\text{H}_2\text{O})$  by thermal weathering.

**Fig. 11.** Patterns of XRD analysis of limestone samples from the façade of Sebil shahin Agha

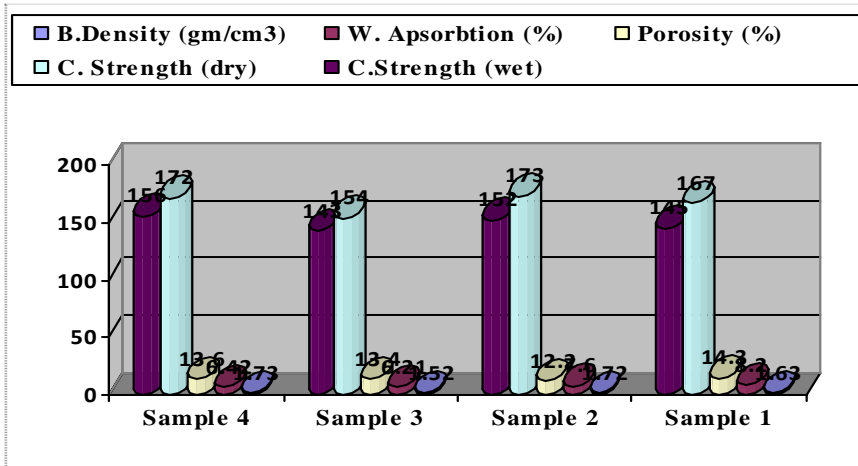
The physical properties detected that the limestone of the facade is characterized by high porosity (13.37%), which gives the stone a high water absorption rate (7.10%) and its consequent ability to absorb water with salt solution and this is the main cause of deterioration. The bulk density of the samples gives  $1.66\text{gm/cm}^3$ . The mechanical properties were measured, the results showed that the strength of limestone in the facade characterized by poor mechanical characteristics (by  $166.6\text{kg/cm}^2$  Dry and  $149\text{kg/cm}^2$  Wet). The changes of physical and mechanical properties of the stone were a result of weathering process.

Fig. 12. Physical and mechanical properties of limestone samples from the façade of Shahin Agha Sabil

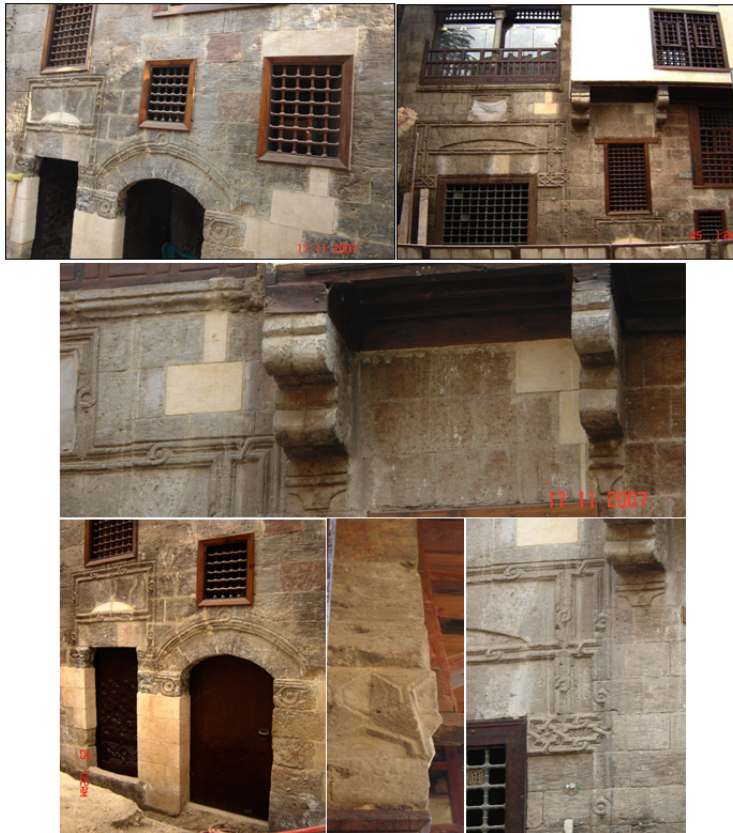
**Fig. 20.** The façade of the Shahin Agha Sebil and its artistic and architectural elements after restoration process.

- c. Completion of Missing Parts:** It was decided to proceed to complete the missing parts of the stone units, especially if they were in poor condition and in need of rapid intervention to avoid future collapse. According to the conservation principles, and architectural/constructive specification of the Shahin Agha facade, the filling and completion material of the joints between limestone blocks should meet the following demands: compatibility with the limestone by the density and thermal expansion (similar to limestone); compatibility with the lead by the expression, appearance, texture and form. The experimental study referred that the lime mortar consisted of 2 sand + 1 lime + ½ white cement + Ediobond 65 (Basic of Latex Botadin Stearin) polymer in water (20%) provides the necessary hermetic joints between stone blocks. So, this works were carried out by conservators with lime mortar. The filling material was applied with a spatula to flatten the putty and smooth it out until it comes well to the edges of the archaeological stone surface (Fig. 20). After finishing, iron oxide was used to approximate its color to the patina of the original parts.
