A CONTRIBUTION TO THE CONSERVATION OF 20TH CENTURY ARCHITECTURAL HERITAGE IN KHEDIVAL CAIRO

Ahmed ELYAMANI¹*, Mohamed Saad EL-RASHIDY²,
Mahmoud ABDEL-HAFEZ¹, Hany GAD EL-RAB²

This paper discusses the restoration works carried out to save a balcony in a historic building dating back to the beginning of the 20th c. The corrosion of the steel beams carrying the balcony resulted in severe problems and the decorative units at the balcony bottom were detached. An intervention was carried out in which the steel beams were cleaned from corrosion products and strengthened using newly added plates. As well, the decorative units were restored. For revealing the adequacy of the intervention, a static loading test was carried out. The interventions presented here represent a good example that could be applied to many other similar balconies widely found in Khedival Cairo, in specific, and other similar floors made of steel beams and concrete.

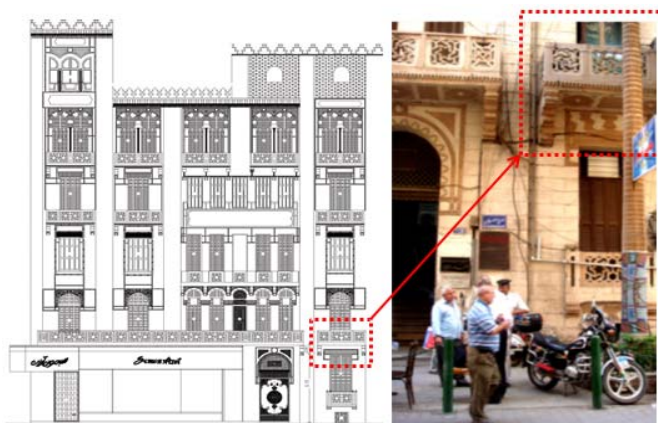
Fig. 1. Architectural documentation of the west façade of the historic building and the balcony is surrounded by red dashed rectangle (a), and old photo of the balcony before the start of the damage (b)

The building's facades are rich with decorative elements like the arched windows, the decorated parapets, and the wooden sheds. The balconies of the building, in specific, are well decorated with hunched corbels, parapets with hollow decorations and gypsum decorated units at the balconies bottom. The balcony of this research is at the west façade of the building, just to the right of the building's entrance (Fig. 1).

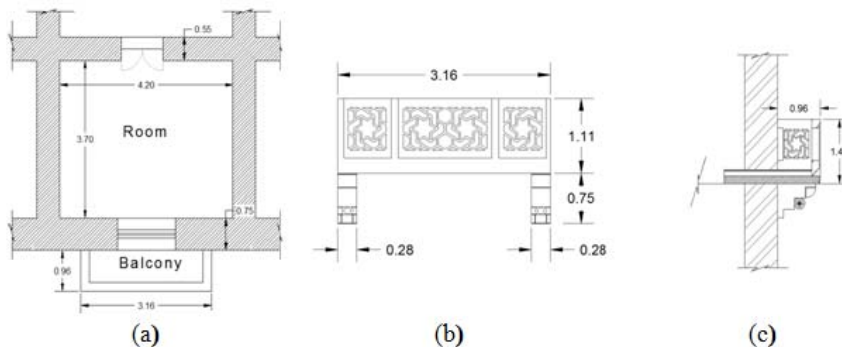
It is a cantilever with a span of 0.96m and the width is 3.16m with a parapet of 1.40m high (Fig. 2). The balcony's floor is composed of lightweight concrete made of cement, sand and slag aggregate. This concrete is supported by I-Shaped steel beams.

Fig. 2. Architectural documentation of the balcony: a. plan; b. elevation; c. side view (dimensions in meters)

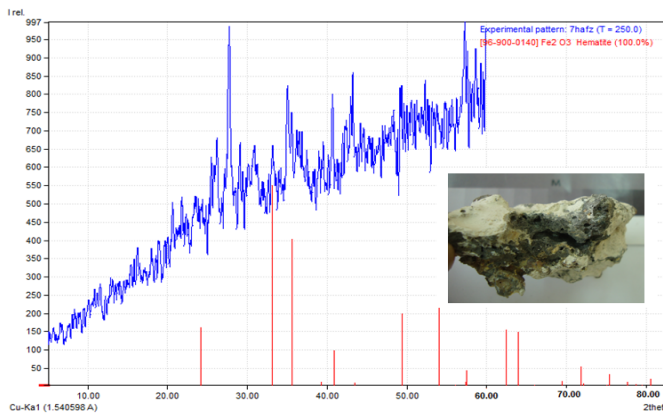
Eight samples in total were analyzed using XRD analysis method, three samples from the slag aggregate, three samples from the binding material, and two samples from the decorative units. The slag aggregate's samples showed that the main component was Hematite (ferric oxide, Fe_2O_3), as an example in Figure 7. Also, Quartz was found as filler. Calcite and Gypsum were found due to the binding material surrounded the slag sample. As for the samples of the binding material, it was found that the binder material (Fig. 8) composed mainly of Gypsum, Calcite, and Quartz. Some traces of hematite were found due to the slag aggregate existence. Due to the infiltrated water, the dehydrate was found. Regarding the samples of the decorative units (Fig. 9), it was observed that these units were composed of Gypsum, Calcite and Quartz.

Fig. 7. XRD analysis of one of the slag aggregate's samples.

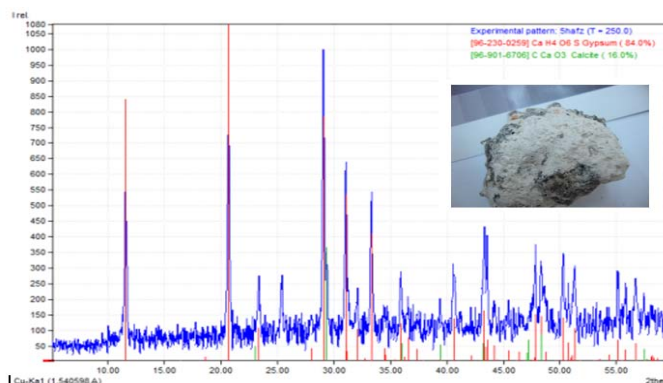
Fig. 8. XRD analysis of one of the binder material's samples.

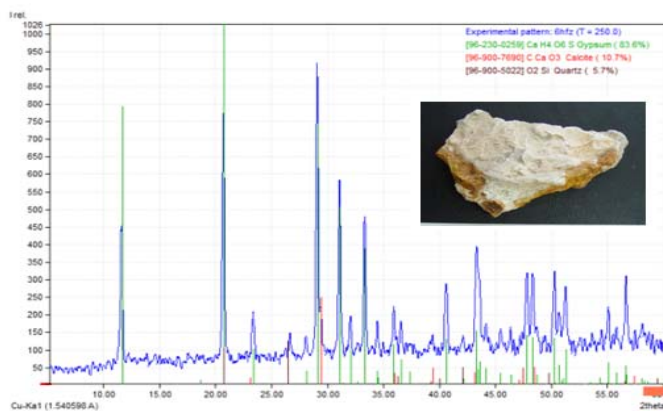
Fig. 9. XRD analysis of one of the decorative units' samples.

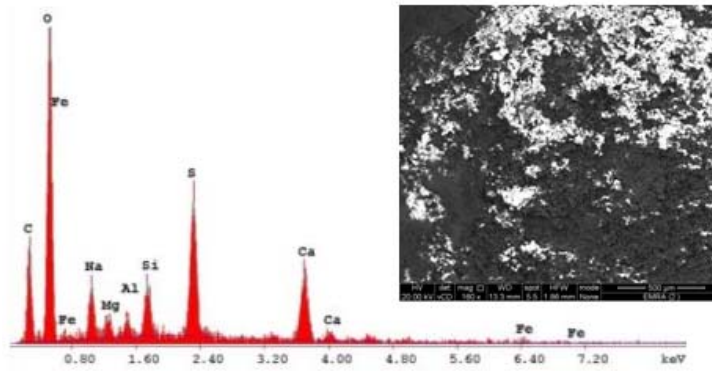
Five samples were examined and analyzed using SEM-EDX, one sample from slag aggregate, two samples from the concrete binding material and two samples from the decorative units. Table 1 reports the weight found for each element (W_i) in each sample. For the slag sample (Fig. 10), the Fe element was found and the SEM image shows the characteristic particle composition of slag. The samples of the concrete binding material showed that the Portland cement was used because of the existence of the elements of Al, Si, Fe, S and Mg,

Fig. 10. Slag sample (sample no. 1): EDX analysis, and SEM image.

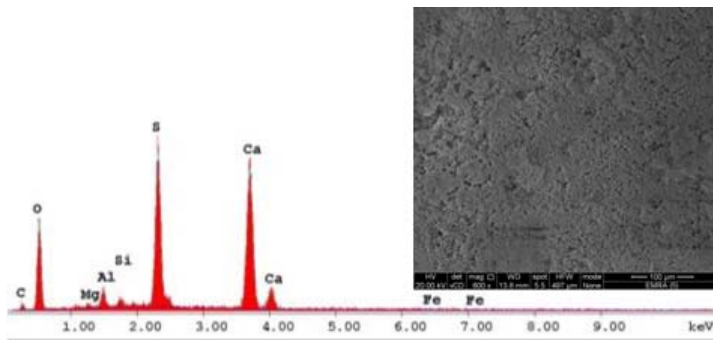
Table 1 and Figure 11. These elements are the main elements of Portland cement. As for the decorative units' samples, the corrosion products of the steel bar used in a previous intervention was evident as the Fe element was found with a high percent (Table 1). Additionally, the existence of the elements S and Ca showed that the gypsum is the main component of these units as found by the XRD (Fig. 12).

Fig. 11. Binding material in the concrete (sample no. 3): EDX analysis, and SEM image.

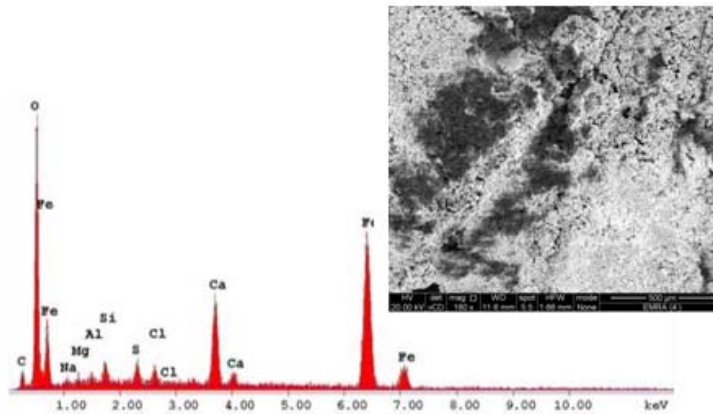
Fig. 12. Decorative units' sample (sample no. 4): EDX analysis, and SEM image.

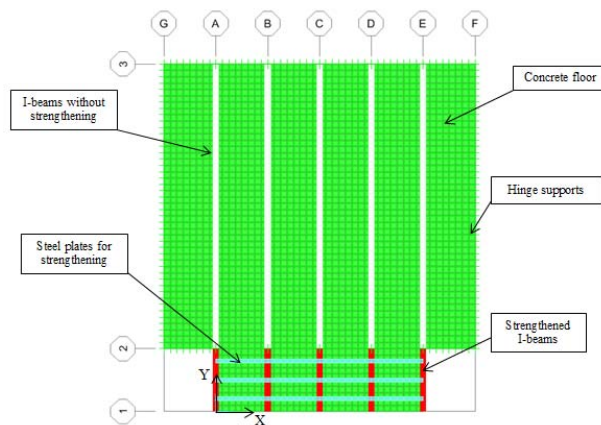
The case of the strengthened balcony was considered first. The concrete slab was modeled as shell elements. The steel beams and the steel plates used in strengthening were modeled as frame elements. The size of shell elements was about 0.09x0.09m. The model was composed of 2584 joints, 371 frame elements, and 2480 shell elements. The walls supporting the room floor were not modeled, instead, hinge supports were used (Fig. 19).

Fig. 19. FE model of the balcony and the adjacent room after strengthening

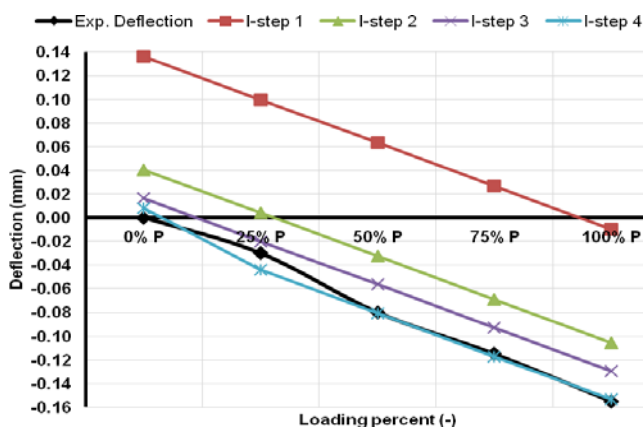
The model updating was carried out manually according to the procedure summarized in Table 3. In phase I, E was taken similar to that one of the modern concrete 20 GPa , and γ was changed from 2500 kg/m^3 (similar to modern concrete) to 1000 kg/m^3 in four updating steps. It should be mentioned here that the detached parts of this concrete had a lightweight due to the usage of slag aggregate. Figure 20 shows the results of this phase of updating. In this figure, the positive deflection is upward and the negative one is downward. The unit weight value of 1250 kg/m^3 gave a good match between experimental and numerical deflections and was therefore selected to be used in phase II of the updating process.

Fig. 20. Phase I of the numerical model updating

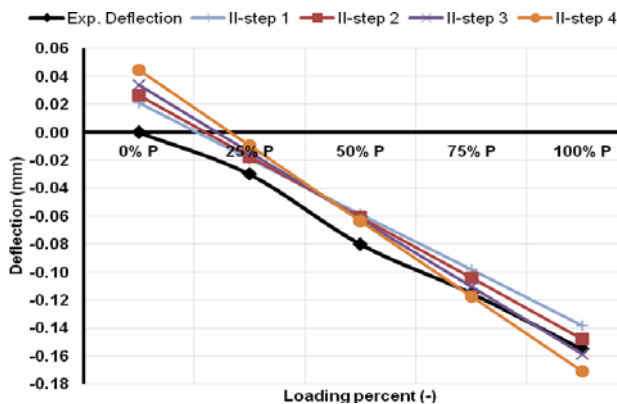
Fig. 21. Phase II of the numerical model updating

In phase II, the modulus of elasticity was changed gradually from 0.9 to 0.6 its initial value in four updating steps (Fig. 21). It was noticed that the two values of 0.8E and 0.7E resulted in numerical deflections near to the experimental ones.

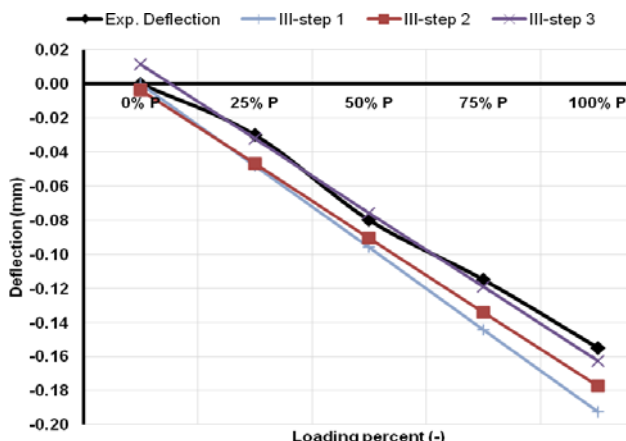
Fig. 22. Phase III of the numerical model updating

In the last phase of updating, phase III, three steps were carried out. It was found that the best values for the modulus of elasticity and the unit weight of concrete were 1.6GPa (0.8E) and 1125kg/m³, respectively. Using these values the experimental and numerical deflections were almost the same (Fig. 22).

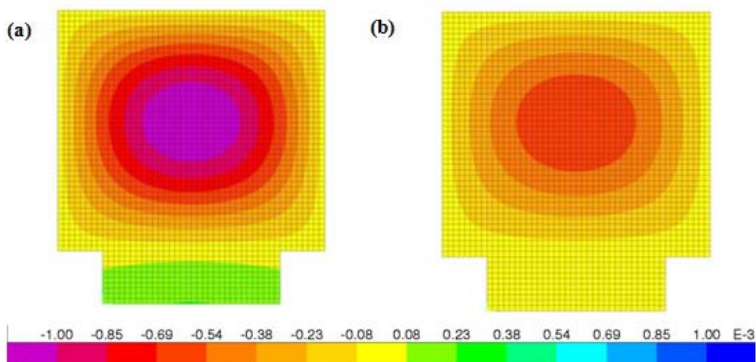
To reveal the efficiency of the intervention carried out, the model with strengthening was compared with that without strengthening. The applied loads were the slab own weight, the flooring, the parapet weight and the live load. In Figure 23, a comparison between the deflections of the two cases is shown, it can be noticed easily that the intervention resulted in a reduction in the deflection values. To show clearly the difference, the deflections of the points on the axis 1 (refer to Fig. 19) are plotted in figure 24 before and after strengthening. As observed, the maximum deflection value was reduced from about 0.24mm to 0.025mm. As well, the deflection of the points on three lines in the balcony shorter direction was plotted before and after strengthening (Fig. 25). These lines were on axes C, B and between the two axes (refer to Fig. 19). Again here, the maximum deflection value was reduced from about 0.24mm to 0.03mm.

Fig. 23. Contours of the deflection (m) of the balcony: a. Before strengthening; b. After strengthening

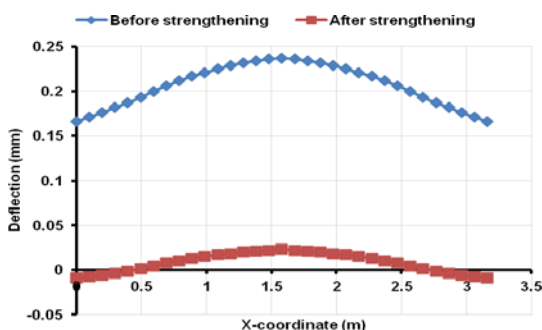
Fig. 24. Reduction of the deflection in the longer direction of the balcony after strengthening (points on axis 1 in Fig. 19).

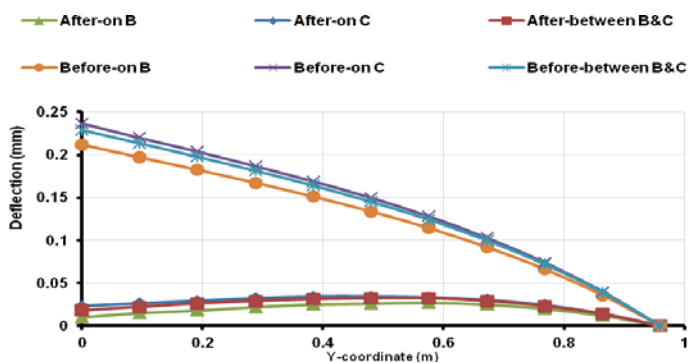
Fig. 25. Reduction of the deflection in the shorter direction of the balcony after strengthening (refer to Fig. 19 for locations of axes B and C).
