RESTORATION OF A CASELLA BROTHERS' ACOUSTICAL GUITAR AND CONSTRUCTION OF AN IDENTICAL COPY

Stylianos ANDREOU, Panagis SKLAVOS,
Anastasios A. KOKKINOS, Dionysios T.G. KATERELOS*

Applied Mechanics – Acoustics and Musical Instruments Design Lab, Department of Sound and Musical Instruments Technology, Faculty of Music Technology, Ionian Islands Technological Educational Institute, S. Typaldou ave, Lixouri, Kefalonia, GR-28200, Greece

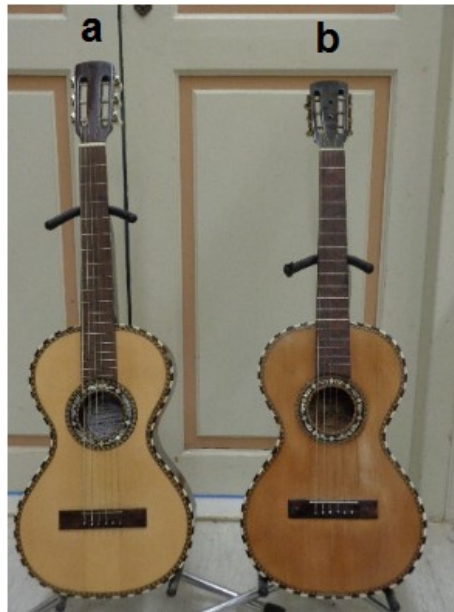
Fig. 16. (a) The original repaired guitar;
(b) The reconstructed replica guitar

The last two steps include the assembly of the neck and the placement of the keys and strings. Keys were placed in the neck prior to assembly. Then the neck was wedged on the guitar body and screwed to be stabilized. Finally, the strings were placed and the final result can be seen in figure 16. In the same figure the original guitar is also presented for comparison.

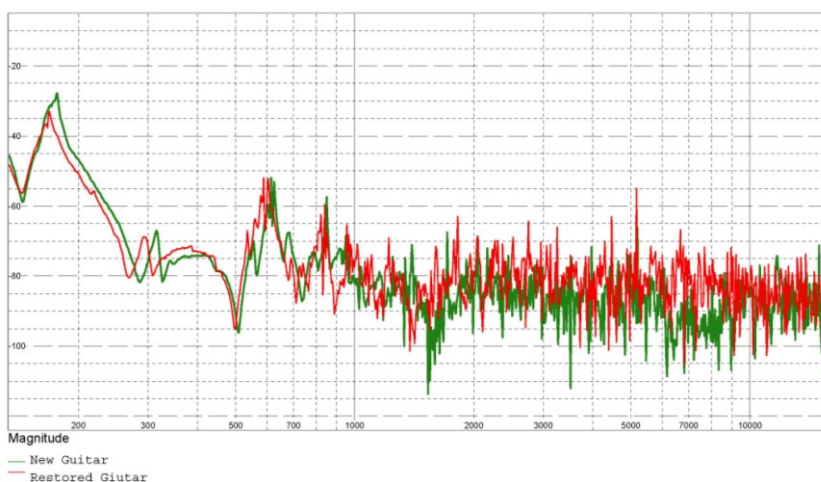
Fig. 18. Impedance curves of the two guitars. Red line represents the admittance curve of the restored original guitar, while green line represent the admittance curve of the replica

At the above picture we can see the admittance for both guitars. It seems that there is a very small difference between the two curves, which leads to the assumption that these two guitars have almost similar admittance curves at the range of 200 to 700Hz and the curve is too close in order to consider that the new guitar is a copy to the Casella's restored guitar. However, this difference could be attributed to higher mass of the top-plate, which could be reflects either on wood mass or the finishing materials mass. Nevertheless, this difference could be considered negligible regarding the acoustical behavior of the two guitars.

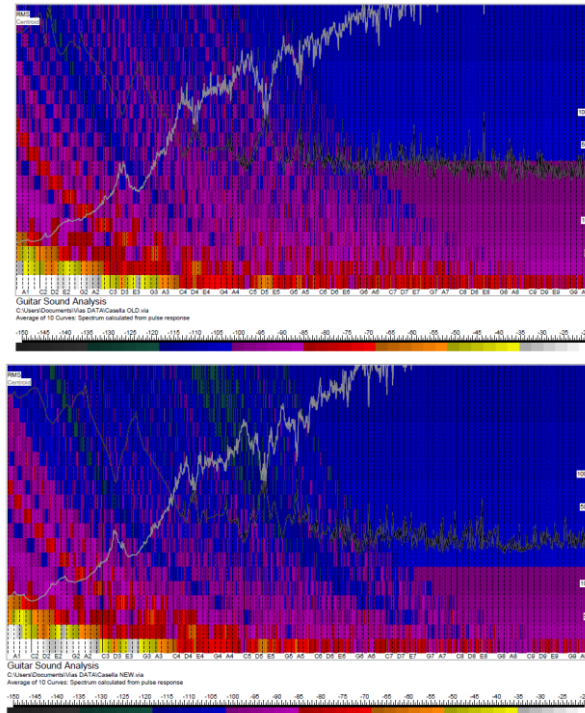
The graphs show the amplitude of each harmonic at every frequency point, in other words, the contribution of each harmonic to the sound of a playable tone. As it can be seen, figures 19a and b are quite similar and, thus, can be assumed that the replica guitar is a nice copy of the Casella's original [12].

Fig. 19. The spectrogram of the restored original Casella's guitar (a) and the spectrogram of the new identical with the restored Casella's guitar (b)
