CONSERVATION OF THE LATE ROMANESQUE SANDSTONE PORTAL OF THE CHURCH OF THE PREMONSTRATENSIAN CONVENT IN KRAKÓW, POLAND

Abstract

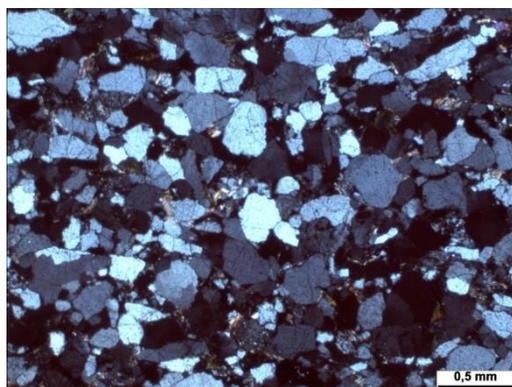
Sandstones in samples 2 and Np-2 have strongly packed clastic material, which results in numerous intrusions and intergranular contacts (Fig. 8).

Fig. 8. Sandstone from the church of the Premonstratensian Convent in Kraków (sample 2). Microphotography, cross-polarised light

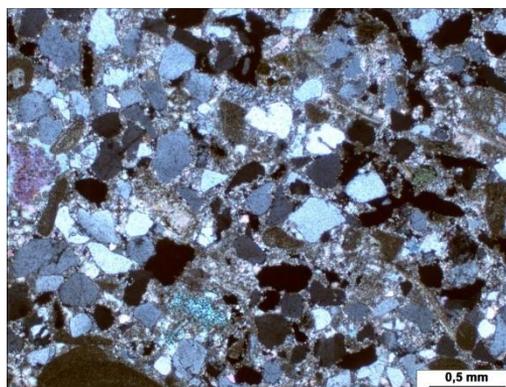
The mineral composition of these sandstones is dominated by quartz (a share reaching nearly 70%), while the other granular components constitute only a few percent, the clay cement is present in only slightly higher concentration, and carbonate cement in minimum amounts. The sandstone in sample 1 has a rich basic carbonate cement, whose share exceeds 40% and separates the clastic components (Fig. 9). It is a fine- and fairly even-grained sandstone with predominant grain size around 0.3mm and including grains of up to 1mm. Its main clastic component is quartz in sharp-edged and semi-sharp-edged grains.

Fig. 9. Sandstone from the church of the Premonstratensian Convent in Kraków (sample 1). Microphotography, cross-polarised light

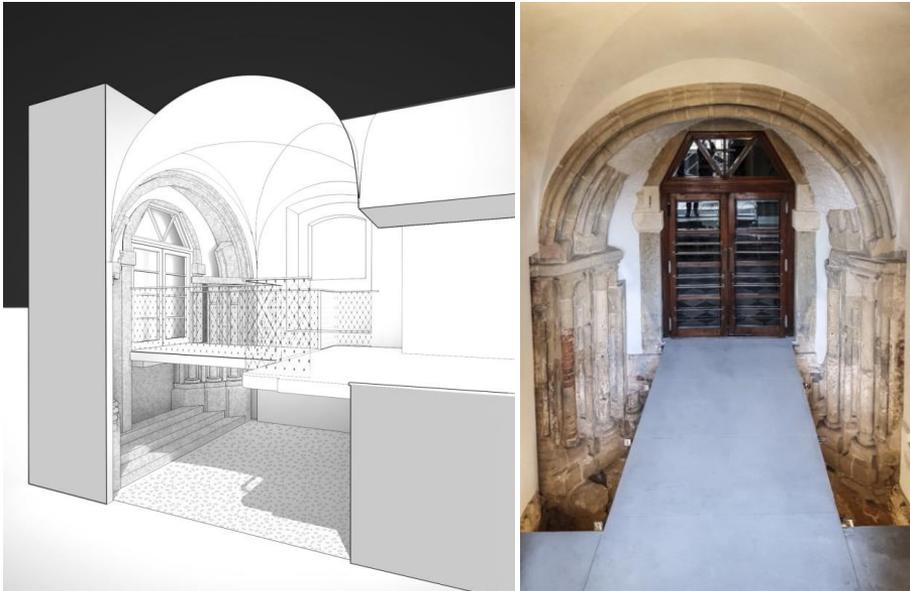
Figure 12 shows the architectural design system of how the portal will be exposed using a walkway leading to the church and the state of the portal after the first stage of conservation works and the construction of the walkway.

Fig. 12. Architectural design of how the portal is to be exposed with the use of a footbridge leading to the church

7. As the whole portal will be displayed to the view, a balustraded footbridge over the archaeological excavation will be constructed to allow access to the church and a view of the portal (Fig. 12) [37].
