EXTENDED MONITORING AS SUPPORT IN NUMERICAL MODELLING OF COMPLEX HISTORICAL TIMBER STRUCTURE

Zdzisław Mikołaj PAWLAK^{1*}, Piotr MARCINIAK²,
Ireneusz WYCZAŁEK³, Martyna ŻAK-SAWIAK¹

¹ Institute of Structural Analysis, Poznan University of Technology, 60-965 Poznań, Poland

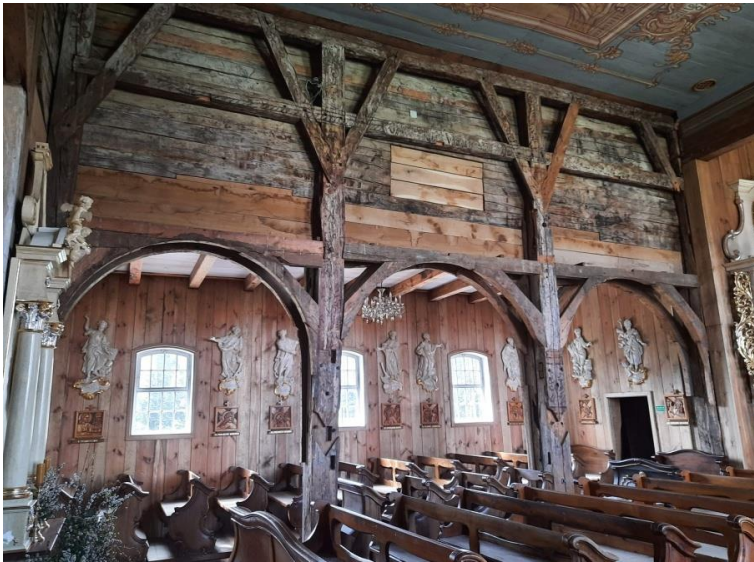
Fig. 6. View of the wall between the nave and the aisle

A slightly lower aisle was added to the nave on the southern side. Its floor-to-ceiling height is about 4.0 meters and its span is about 3.6 meters. Its single-pitched roof (queen post truss) rests on an added outer wall and on posts located at the nave's main columns (Figs. 1 and 5). Part of the log wall, up to the height of the aisle ceiling, has been disassembled (Fig. 6). The posts of the nave and aisle are connected to each other at some points, whereas the aisle roof structure is independent (queen post truss).

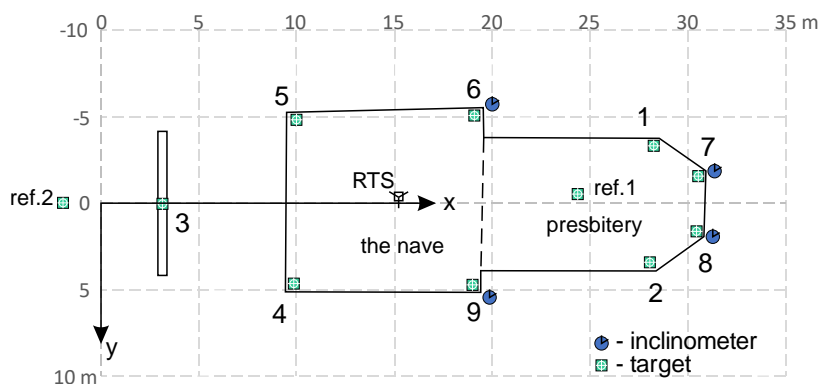
Fig. 7. Location of points for geodetic measurements

The static measurements were carried out using the tachymetric method, at 1-month intervals. They included two reference points considered stable (unchanging) and 9 selected test points. The tachymetric method was based on measuring distances, directions and vertical angles. A Leica TCRP 1201+ one-second tachymeter was used, along with targets in the form of reflective foil shields, installed between 6.45 and 6.85 meters above floor level, just below a ceiling rising just over 7.0 meters above floor level. The height of 7.0m was considered a representative level for which displacements were calculated. The authors decided to control both the vertical and horizontal displacements. Due to possible settlement of the foundations, as well as the contraction and expansion of the structure, additional vertical displacement measurement points were introduced on the posts, just above the floor (Fig. 7).

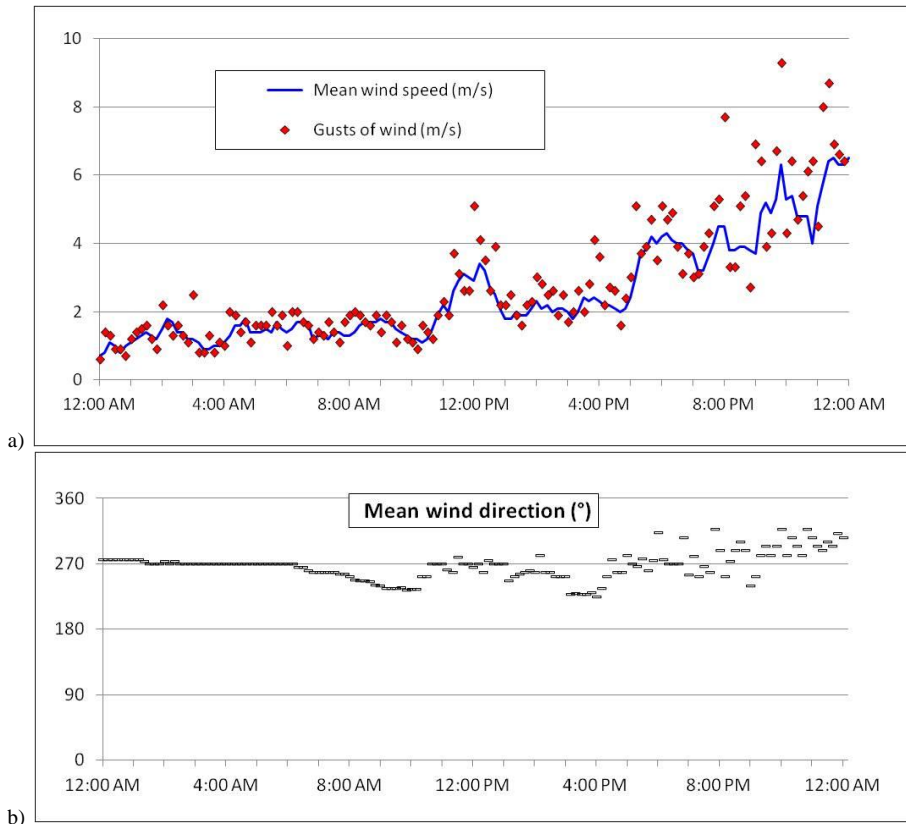
Fig. 10. Wind measurement on February 17, 2023: a) wind speed, b) wind direction.

The wind speed increased in the second part of the day and the gusts became stronger. According to the weather station's indications, a westerly wind dominated throughout the day.

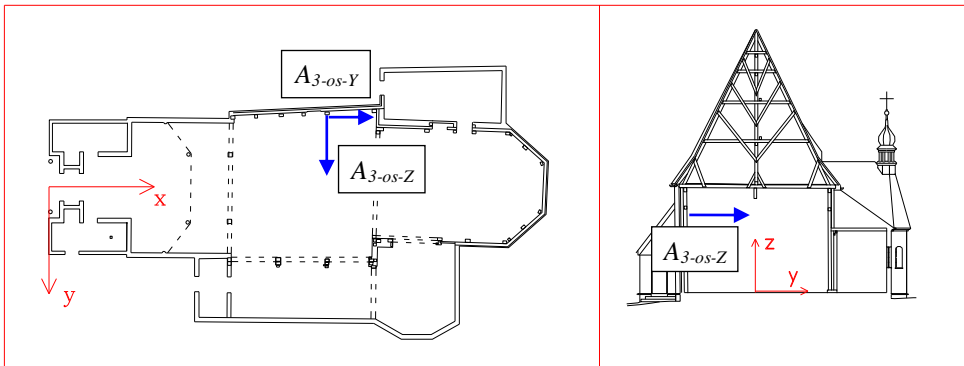
The tests were performed on February 17, 2023, during a period when the west wind was blowing at speeds of up to 10m/s, with gusts of up to 20m/s (according to the official weather station). The accelerations were measured with a triaxial accelerometer mounted on a nave post located in the northern wall (Fig. 11). The sensor was mounted at a height of about 6.0m from floor level.

Fig. 11. The position of the measurement point and directions of measured acceleration: along the building (A_{3-os-Y}) and across the building (A_{3-os-Z})

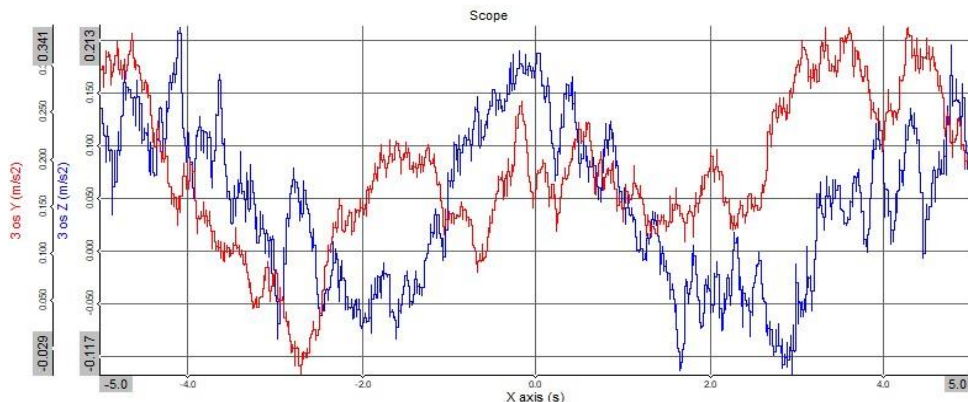
Fig. 12. Diagram of accelerations along the building (A_{3-os-Y} in red) and across the building (A_{3-os-Z} in blue)

The loading of an object by forces induced by wind gusts can be used to carry out a so-called operational modal analysis. In this analysis, the response of a structure induced by dynamic forces occurring during its regular operation is measured. However, in this case, the response of the structure, i.e. its wind-induced deformation was relatively slow. After the load vanished, the structure returned to the equilibrium position and the whole process of loading and unloading had the character of creep motion. On the other hand, the graph in figure 12 shows one complete cycle with a period of about 5 s, which may make dynamic analysis reasonable.

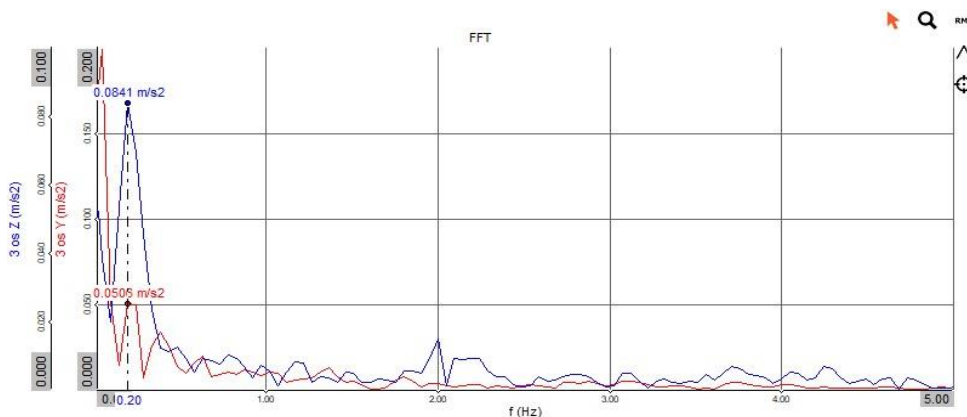
After performing a Fast Fourier Transform (FFT), a graph of the signal in the frequency domain was obtained (Fig. 13). Based on the graph obtained, it can be concluded that the dominant movement of the structure was at very low frequencies. This type of movement can hardly be considered a harmonically time-varying oscillation. Rather, the observed regularity was due to a load that operated periodically. The gusts of wind caused the short-lasting pressure that was repeated over time. The displacements were quasi-static, caused by the action of a short-term variable load. The structure moved during gusts of wind and returned to its equilibrium position.

Fig. 13. Fast Fourier Transform (FFT) of the recorded acceleration: along the building (A_{3-os-Y}) - red color, across the building (A_{3-os-Z}) - blue color

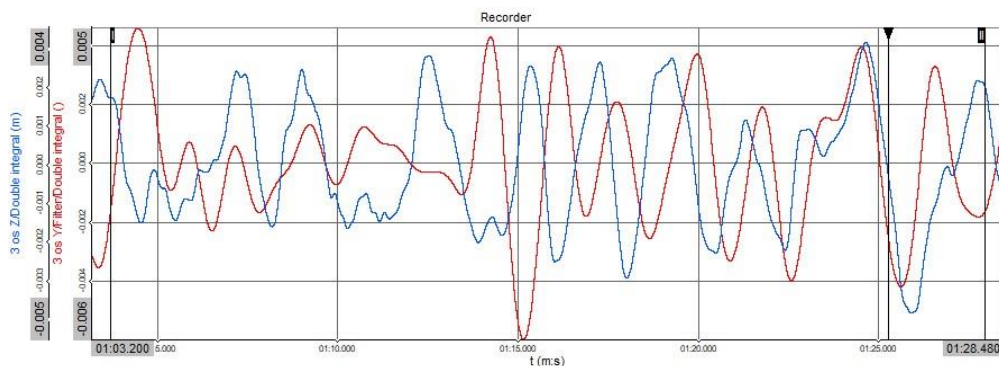
The recorded acceleration signals were subjected to further transformations. First, a low-pass filter was used to cut off the acceleration values associated with vibration frequencies that were higher than 0.5Hz. The filtered signal was then subjected to the integration procedure twice. The displacement amplitudes obtained in this way should be treated as approximate values, since the recorded signal cannot be regarded as harmonic oscillations. It is worth noting that the calculated amplitudes of displacement in the analyzed time interval did not exceed 6mm (Fig. 14).

No distinct oscillations with frequencies higher than 0.2Hz were recorded during vibration measurements of the wind-loaded structure. Therefore, it can be concluded that the structure was not dynamically excited during the measurements.

Fig. 14. Double-integrated acceleration signal: along the building (*3-os-Y*) - red color, across the building (*3-os-Z*) - blue color

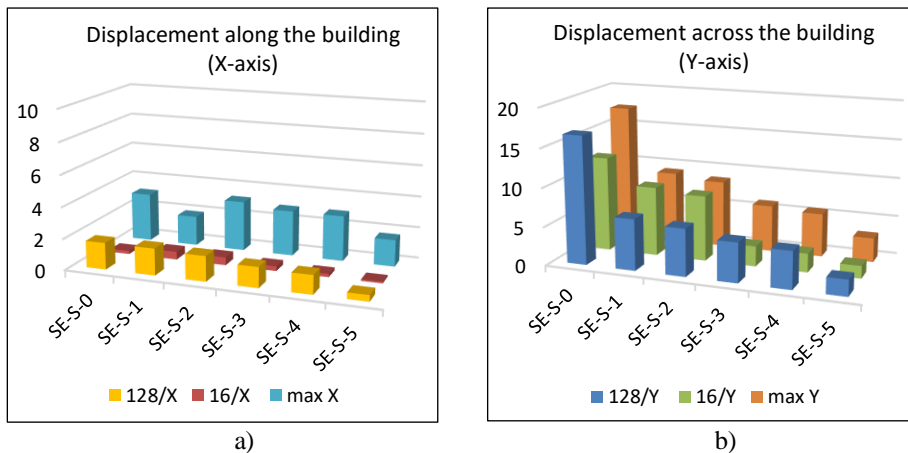
Displacements induced by the southeast wind were calculated in two directions: along the church (along the X axis) and across the building (along the Y axis). Selected values are presented, that is, the displacements calculated for node No. 128, which corresponds to the actual measurement point No. 6 (Fig. 7) and the values calculated for node No. 16, which corresponds to measurement point No. 8 (Fig. 7). The measurements of the actual displacements were discussed in an earlier chapter, the locations of measurement points 6 and 8 are shown in figure 7, while Table 3 and figure 17 show the results of numerical calculations.

Fig. 17. Displacements at selected nodes (No. 128 and No. 16) of the analysed structural models: a) along the building, b) across the building

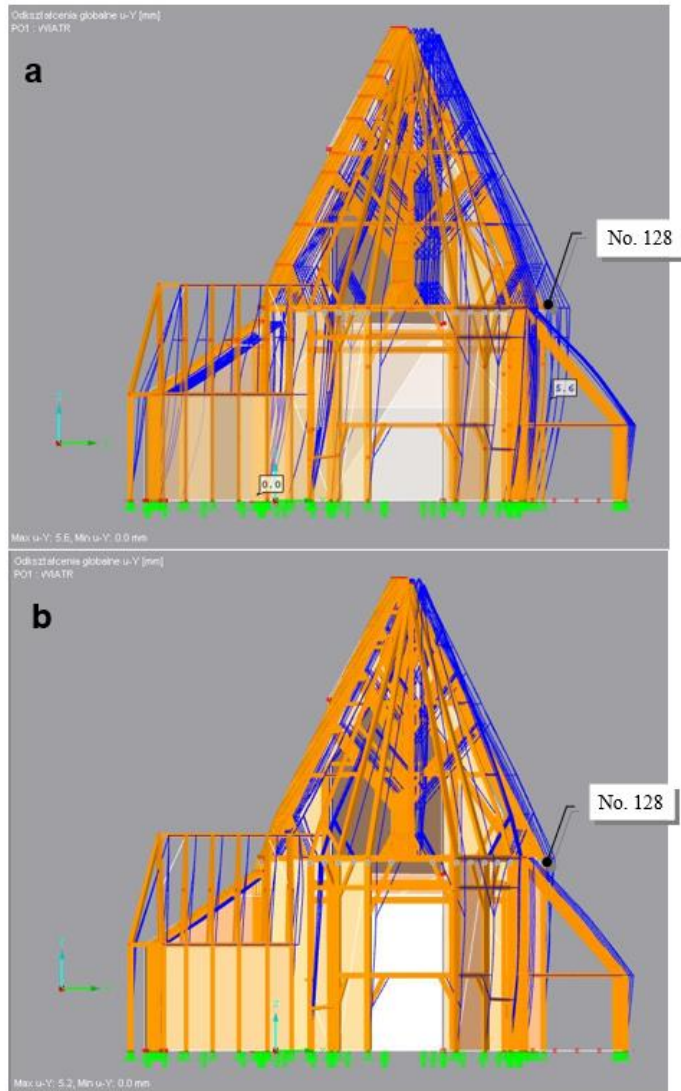
Figure 18 shows the deformations in the model in which the *T5* panels at the junction of the chancel and nave are not included (Fig. 18a, model SE-S-4) and the model in which these panels are included (Fig. 18b, model SE-S-5).

Comparing the magnitudes of the displacements in the two models, one can notice the importance of the short stiffening walls between the chancel and the nave, which were labeled *T5* in figure 16.

Fig. 18. Structural deformation caused by southeast wind: a) SE-S-4 model, without T5 panels, b) SE-S-5 model, containing T5 panels

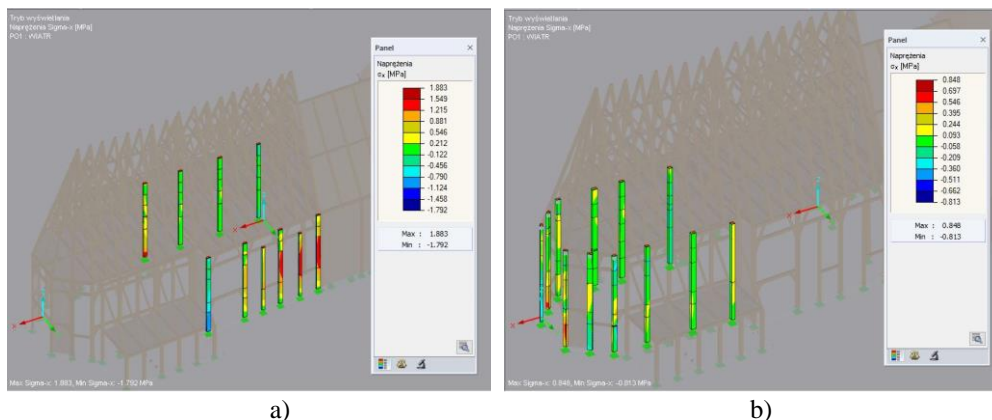
The results of the analyses showed that the load-bearing capacity of the columns in the chancel walls is very important, as the structure is sensitive to their weakening. In the bar model without stiffening panels, the weakening of the chancel columns (model SE-S-0-w2p) results in a more than twofold increase in stress values in them. In contrast, in the models with stiffening panels and weakening, the posts in the nave have a greater influence on the performance of the entire structure. The analyses show that their weakening (model SE-S-5-w1n) causes an over threefold increase in displacement and twofold increase in stress. Figure 21 shows the distribution of stress in the nave columns (Fig. 21a) and chancel columns (Fig. 21b) for the SE-S-5-w1n model.

Fig. 21. Distribution of wind-induced stresses, in the posts: a) of the nave, b) of the chancel

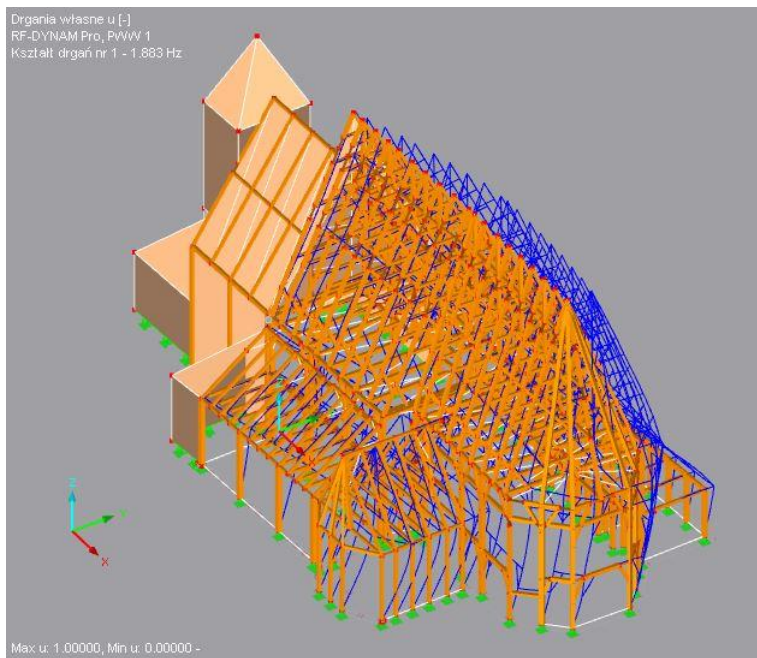
The first, fundamental vibration frequency for the bar model, which does not include stiffening panels (model SE-S-0), is related to the mode in which the entire building body moves laterally (Fig. 24). This means that the lateral stiffness in this model is the lowest. Moreover, the stiffness of the older part (i.e., the nave and chancel) is significantly lower than that of the newer part of the building.

The displacements shown in Figure 24 are in one direction, all parts of the building are in phase with each other. Subsequent vibration modes for this model are also dominated by lateral displacements over the entire structure, but for higher frequencies, displacements appear in opposite phases (Fig. 25).

Fig. 24. Vibration mode related to the fundamental frequency $f_1 = 1.883$ Hz for the SE-S-0 model

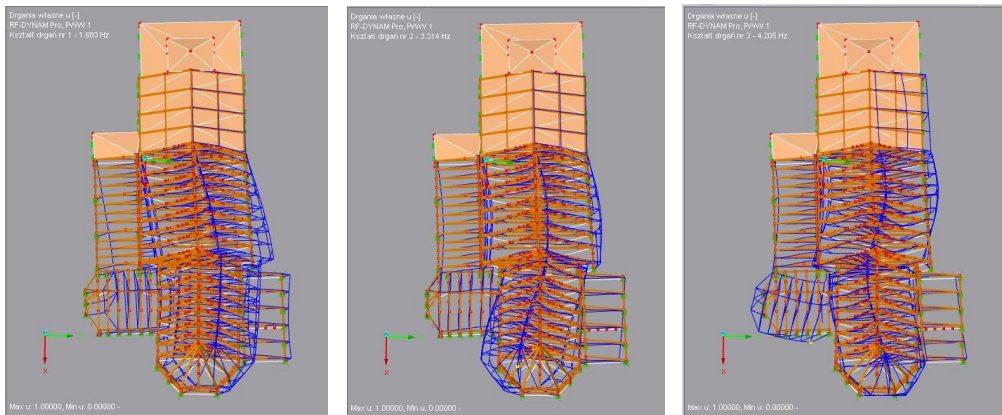
Fig. 25. Comparison of the first three modes of natural vibrations for the SE-S-0 model ($f_1 = 1.883$ Hz, $f_2 = 3.314$ Hz, $f_3 = 4.205$ Hz)

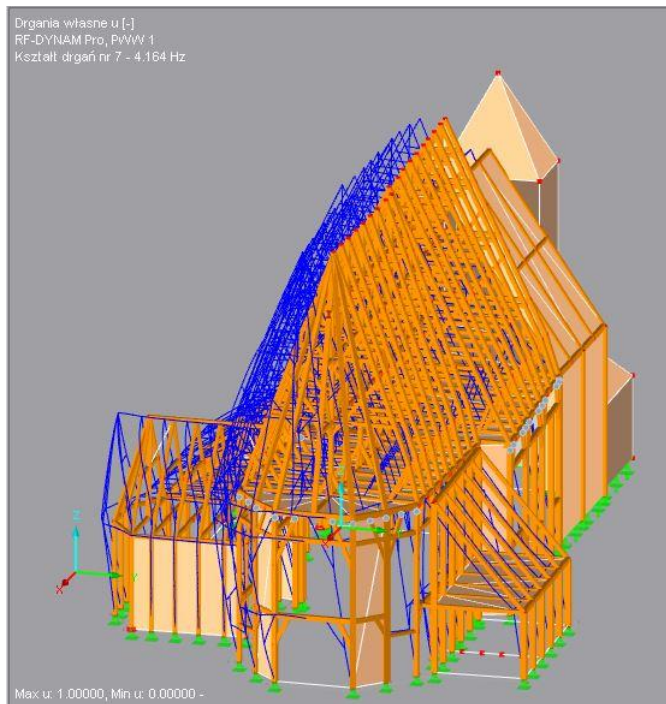
In the model with stiffening panels (model SE-S-5), the calculated initial natural frequencies concerned the vibrations of only certain parts of the structure. These were mainly lateral vibrations of the stiffening panels alone. Only the seventh calculated resonant frequency was related to the mode where the entire structure moved laterally (Fig. 26).

It is worth noting that in all the models, with and without stiffening panels, the frequencies that excite the whole body of the building (Table 7) are much higher than the

frequencies recorded during wind gusts in the actual structure (Fig. 13), which were described above in the "Measurement of accelerations at a selected point" section. It can be concluded that wind gusts are unable to induce dangerous resonant vibrations in the studied building.

Fig. 26. Vibration mode related to the lowest natural frequency ($f_7 = 4.164$ Hz) for the SE-S-5 model, which excited the entire building body
