RENOVATION AND ADAPTATION OF A HISTORIC MODERNIST FACILITY TO CONTEMPORARY FUNCTIONAL AND UTILITY NEEDS

This article aims to present the practical aspects of the renovation of historic modernist buildings on the example of a villa from the 30s of the twentieth century, located in Częstochowa, in the historical areas of the city. The renovation process, which included both the building itself and its surroundings, was presented in the context of activities to organize historic urban fabric. The concept of adapting the building and its external space to the contemporary requirements of cultural functions was also discussed. The case study shows the effective cooperation of institutions and people involved in the conservation and renovation process, being an example of a coherent approach to the protection of architectural heritage in the changing socio-cultural reality. The legal basis for the rules of conduct in the field of protection of tangible heritage is the Act on the Protection and Care of Monuments of 2003, as amended and the Construction Law [3].

The subject of the opinion is the historical building, the so-called "General's Villa" at 30 Wyzwolenia Street in Częstochowa (

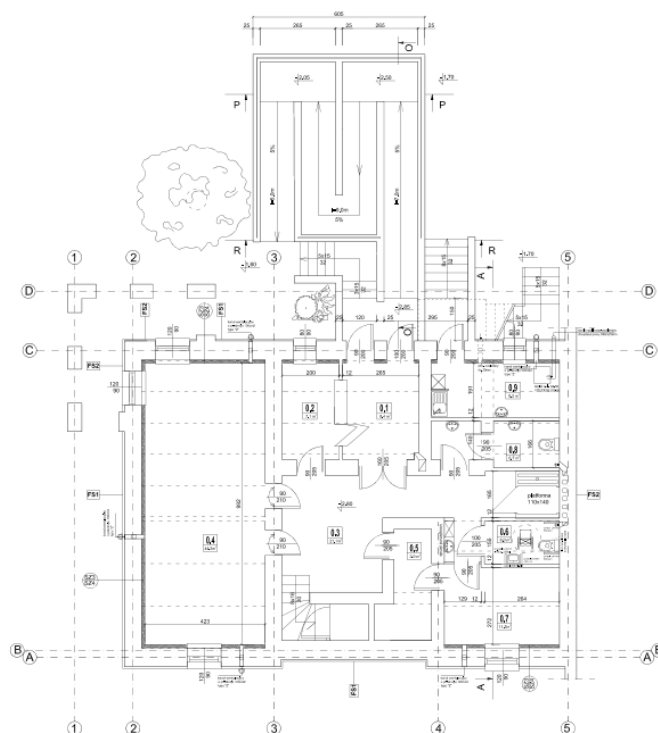
Fig. 20. Basement plan (author of the design: architecture Nina Sołkiewicz-Kos; construction: Jarosław Paluszyński and Andrzej Kysiak). To make the building accessible to the disabled in wheelchairs, a ramp was designed – an exit to the basement floor from the west. Access for the disabled people to all other floors of the building will be provided by an internal elevator adapted to the transport of disabled people

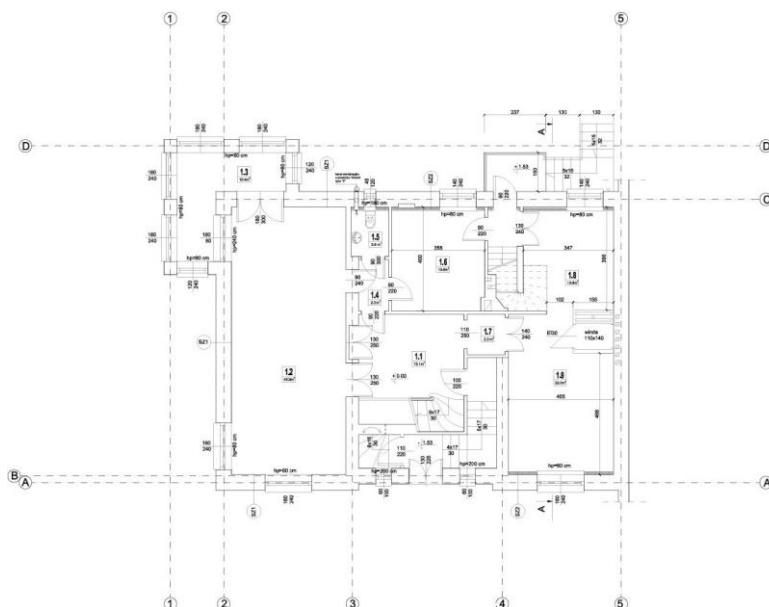
Fig. 21. Ground floor plan of the building - construction design (author of the design: architecture Nina Sołkiewicz-Kos; construction: Jarosław Paluszyński and Andrzej Kysiak). On the ground floor of the building, there will be an exhibition space for exhibitions, conferences and meetings of environmental groups. There is also space for a library related to the history of Częstochowa

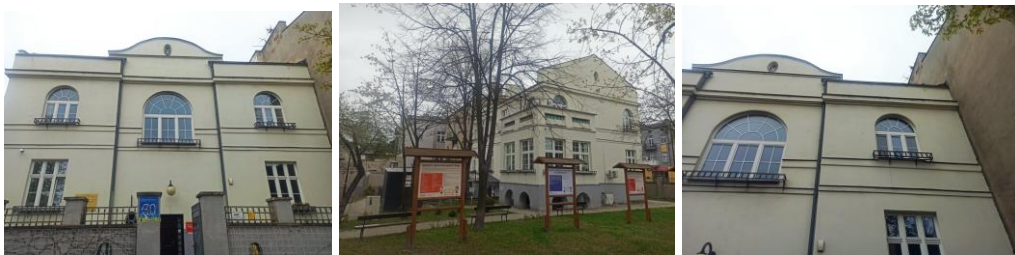
Fig. 28. Building elevation after renovation – preserved historical character of the building
(author's photos: N. Sołkiewicz-Kos, M. Tubielewicz-Michalczuk)

Given these considerations, the method of external insulation was formally excluded based on conservation requirements outlined in a statement issued by the Voivodeship Office for Heritage Protection on August 25, 2008. Only the thermal modernization of essential building components was carried out—exceeding standard requirements—including the application of enhanced thermal insulation layers to the roof slopes, attic floor, ground-level floor, foundation walls and basement walls (Fig. 28).
