SEISMIC EVALUATION AND RETROFIT PROPOSALS FOR A REINFORCED CONCRETE BUILDING IN CULTURAL HERITAGE AREA

Abstract

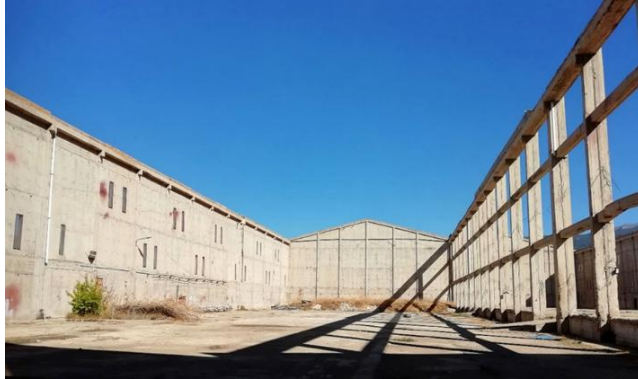
Fig. 7. Photograph of the building under study

Over the years the building has deteriorated mainly due to environmental factors, as it has been exposed without any paint or roof for protection. In addition, a part of the structure between the joints is leaning outside (Fig. 8). The last sections of this article present the building's damages and provide recommendations for their repair.

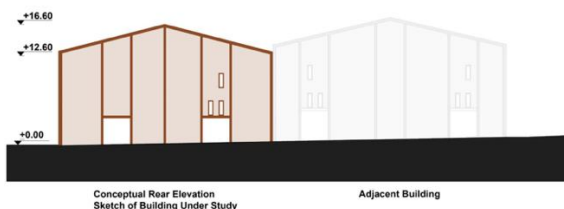
The dimensions of the building are 92.5×31.5 meters in plan and 16.60 meters in height. It consists of solid walls, columns, and beams made from reinforced concrete [16]. Details of the building’s layout are presented in figures 9 and 10. According to the existing technical report on which the building was constructed, and for buildings of its age, its remaining concrete’s strength can be considered 9 MPa and the yield stress of the reinforcement 240 MPa. The building was analyzed using a linear-elastic approach in accordance with current codes for new buildings. These codes account for nonlinear structural behavior indirectly using reduction and modification factors. Since the codes represent the most up-to-date developments in structural safety, applying them provides a reliable basis for evaluation. This approach allows the identification of areas of high stress that may be susceptible to damage during an earthquake, thereby helping to prioritize interventions in the most vulnerable parts of the structure. Moreover, using codes for new buildings standardizes the evaluation process and facilitates comparison with other structures.

Fig. 9. Elevation sketch of building under study

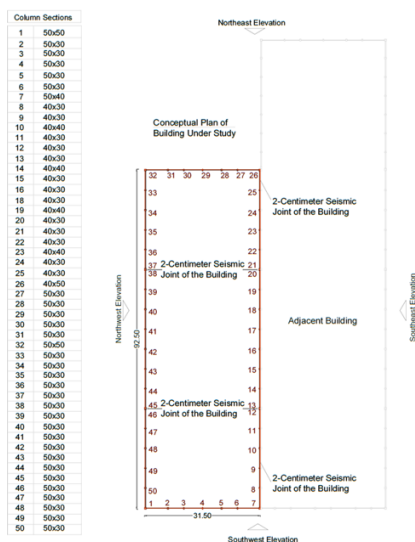
Fig. 10. Plan of the building under study. The dimensions of the building are in meters and of the columns in centimeters

In addition, due to the significant height of the columns located on the shorter side of the building and the large displacements that can be developed under earthquake loading in the Z-direction, one of their dimensions was increased by 20 cm with reinforced concrete, perpendicular to the direction of the walls. The columns whose dimensions were increased were columns 3-5 and 28-30 (Fig. 10), and their total cross-sectional dimensions became 30×70 cm.

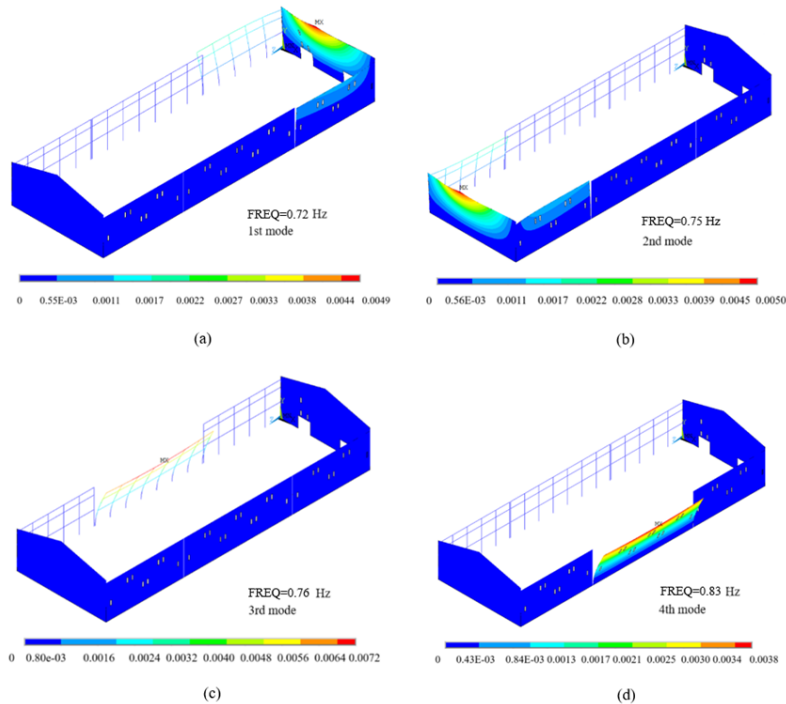
The natural frequencies and modes of the building were determined. The first twelve natural frequencies were 0.72, 0.75, 0.76, 0.83, 0.91, 0.92, 0.94, 0.96, 0.97, 1.03, 1.47, and 1.51 Hz. The cumulative mass fraction exceeded 90% when considering up to the 9th mode in the X and Y directions and by the 13th mode in the Z direction. The highest ratios of effective mass to total mass occurred in the Z-direction for the 1st and 2nd modes, and in the X-direction for the 4th mode, with values of 0.11 for the 1st and 2nd modes and 0.12 for the 4th mode. The X-direction is parallel to the shorter side of the building, while the Z-direction is perpendicular to it. The first four modes are presented in figure 11. It can be observed that the fourth mode causes out-of-plane displacement of the middle walls, which are not supported perpendicular to their plane. This movement can be associated with the leaning wall shown in figure 8.

Fig. 11. The first, second, third and fourth mode shapes of the building

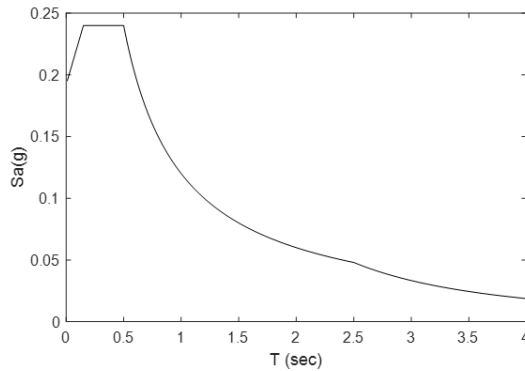
The seismic behavior of the building was examined using response spectrum analysis. Based on Eurocode 8 [16] and the building's location, the design spectrum shown in figure 12 was used for the seismic analysis. The structure was subjected to the earthquake load (in the form of a response spectrum) in both the X and Z horizontal directions. The results are presented as contour plots of the maximum displacements (in m) and maximum principal stresses (in Pa), using the SRSS method. Figures 13 and 14 present the maximum displacements and principal stresses, respectively, when the structure was subjected to earthquake loading in the X-direction (parallel to the building's short side) and the Z-direction. Under X-direction loading, the highest displacements occurred at the top of the middle wall and the frame perpendicular to the earthquake direction (Fig. 13a), while the maximum principal stresses appeared at the bottom of the same middle wall (Fig. 14a). Under Z-direction loading, the highest displacements occurred at the top of the walls perpendicular to the earthquake direction (Fig. 13b), while the maximum

Fig. 12. Design spectrum used for the seismic analysis

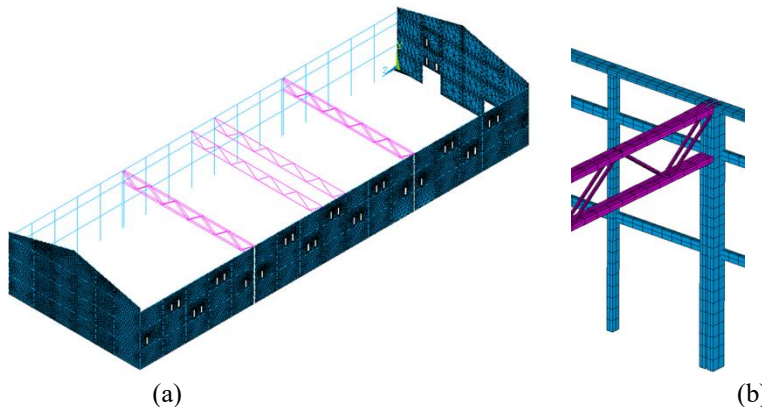
Fig. 15. Finite element model of the building after the interventions. (a) Overall model of the structure (line mode); (b) detail of the column-to-truss connection

The structure, without any interventions, can support its own weight, as there is no roof or additional gravitational load that needs to bear. It needs, though, additional stiffness and strength to avoid permanent out-of-plane deformations (like the leaning wall) and to be able to withstand the earthquake loading according to the current codes. Before any other major interventions, the leaning wall needs to be brought back to an upright position. Suggestions of how to do this are presented later in the section of strength and damage assessment. If the wall can be returned to its upright position, it is essential to ensure that it does not lean again in the future. This can be achieved by making sure the wall behaves not as a separate unit, but as an integral part of the rest of the structure. For this reason, steel trusses connecting the wall to the frame on the opposite side were introduced in the finite element model. These trusses were placed at both ends of the wall next to the separation joints, as well as in the middle. Additional trusses were also installed on the opposite side of the joints, creating three interconnected parts of the structure (Fig. 15). The columns that the trusses were attached to were enlarged in the direction perpendicular to the direction of the wall.

The density, modulus of elasticity, and Poisson's ratio of the steel trusses were 7850 kg/m³, 210 GPa, and 0.3, respectively. The steel truss members were considered beam elements in the analysis. The connections between concrete and steel elements were modeled by sharing nodes at the joints. This approach is appropriate for beam and column members, and our model included only this type of connection. The software assumes continuity of displacements and rotations at the shared nodes. Clearly, this represents a simplified structural analysis method intended to evaluate the global structural response (e.g., deflections and stresses), rather than to capture detailed material interactions such as cracking, bond failure, or debonding effects.

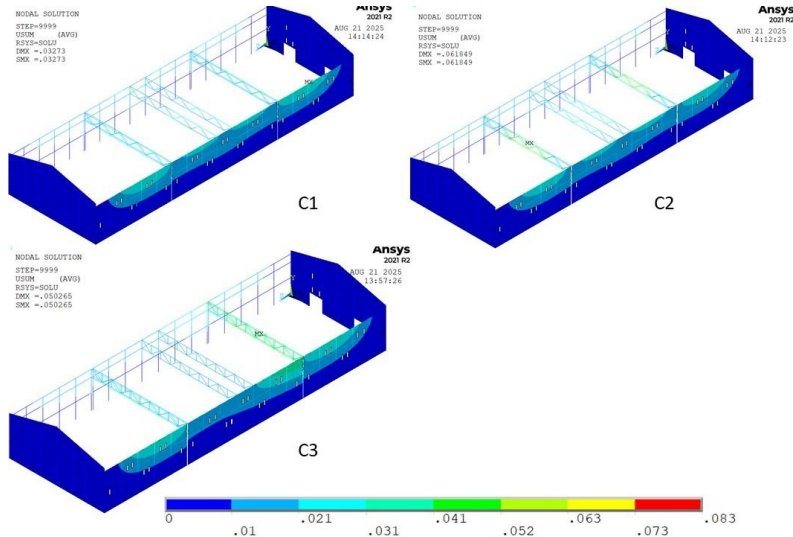
The building, with one truss configuration applied at a time, was analyzed under earthquake excitation in the X-direction, which appeared to be more critical for the leaning wall. The maximum displacements and principal stresses obtained are shown in figures 16 and 17, respectively.

Fig. 16. Maximum displacements (in m) developed in the structure by earthquake excitation in the X-direction

Among the cases considered, configuration C1 resulted in the smallest displacements and significantly lower stresses compared to the original structure. This configuration was therefore selected for further analysis of the building. To enhance the overall stiffness and strength of the structure, and thereby reduce the principal stresses and displacements caused by earthquake excitations, the dimensions of columns 12, 13, 20, 21, 37, 38, 45, and 46 were increased, giving them a total cross-sectional size of 30×70 cm. These are the columns that support the truss.

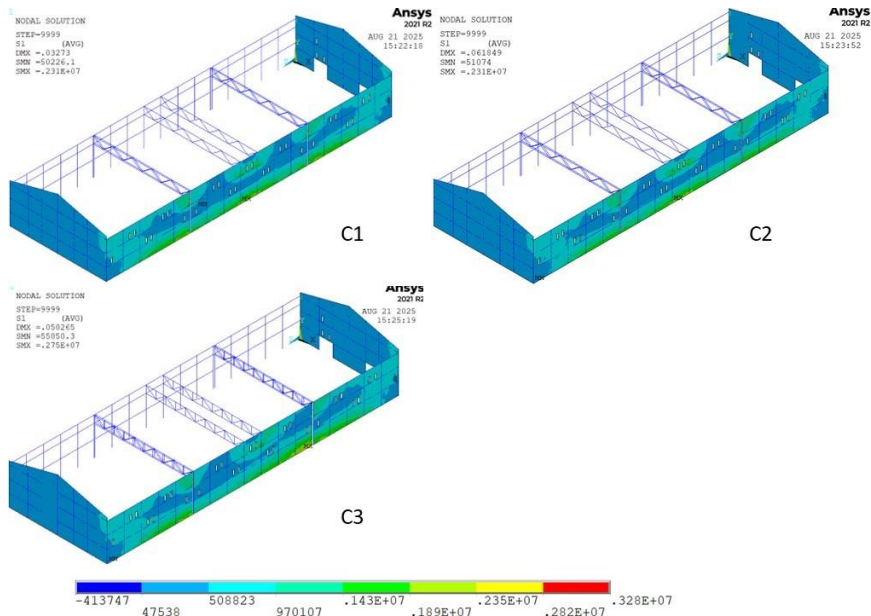
Fig. 17. Maximum principal stresses (in Pa) developed in the structure by earthquake excitation in the X-direction

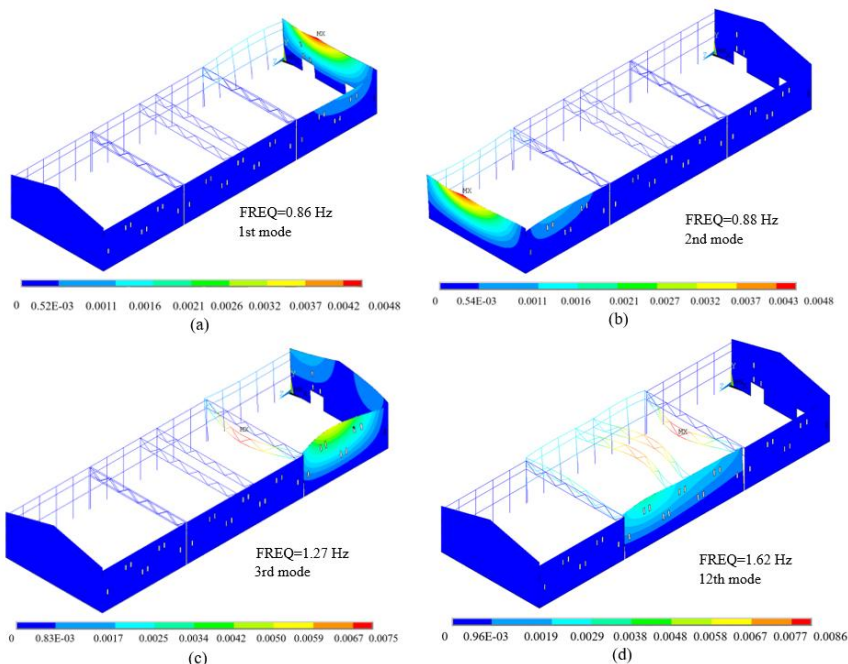
The modal analysis performed on the building, including the chosen interventions, showed an increase in the natural frequencies due to the increased stiffness. The natural frequencies of the model both without and with the interventions are presented in Table 1. The cumulative mass fraction exceeded 90% when considering up to the 12th mode in the X and Y directions and by the 17th in the Z direction. The highest ratios of effective mass to total mass occurred in the Z-direction for the 1st and 2nd modes, and in the X-direction for the 12th mode, with values of 0.12 for the 1st and 2nd modes and 0.10 for the 12th mode. The first three modes and the twelfth mode are shown in figure 18.

Fig. 18. The first, second, third and twelfth mode shapes of the building after the interventions

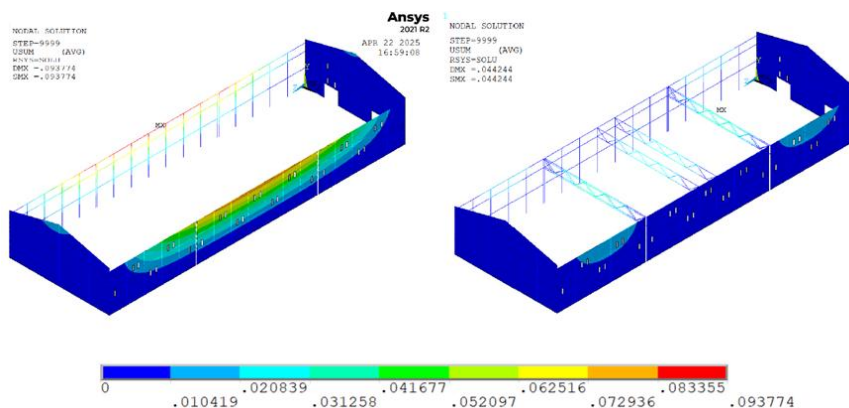
The seismic behavior of the building, after the interventions, was examined using response spectrum analysis based on the design spectrum of figure 12. The structure was subjected to the earthquake load (in the form of a response spectrum) in both the X and Z horizontal directions. Figure 19 presents the maximum displacements before and after the interventions, when the structure was subjected to earthquake loading in the X-direction (parallel to the building’s short side). A significant reduction in maximum displacement (up to 89%) was observed after the interventions, particularly at the top of the central wall perpendicular to the direction of excitation. Following the interventions, the location of maximum displacement shifted to the walls adjacent to the central wall, on both the left and right sides, although the values remained very small. This reduction is highly effective in preventing the recurrence of permanent displacements, such as the leaning of the wall.

Fig. 19. Maximum displacements (in m) developed in the structure by earthquake excitation in the X-direction

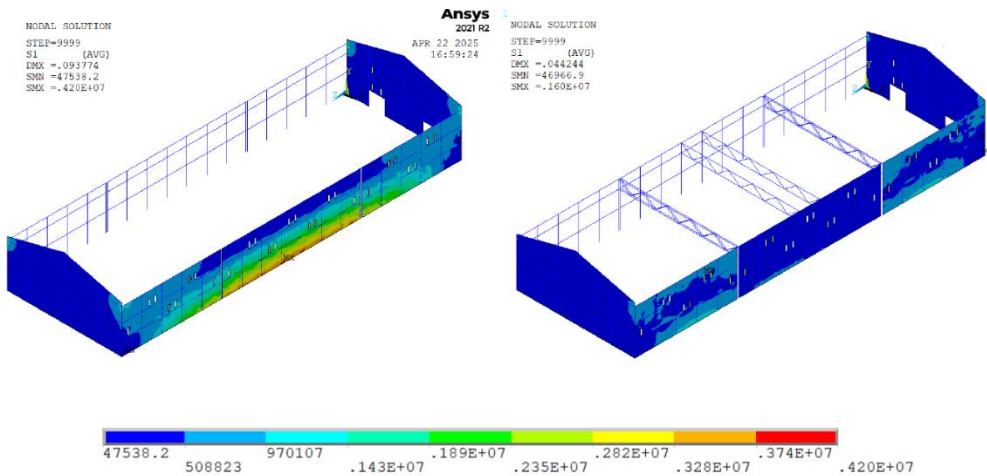
The maximum principal stresses occurred at the center of the wall perpendicular to the X-direction. A considerable reduction, up to 88%, of the maximum principal stresses occurred after the interventions (Fig. 20). The minimum principal stresses were small, less than 1 MPa, for both cases examined.

Fig. 20. Maximum principal stresses (in Pa) induced in the structure by earthquake excitation in the X-direction

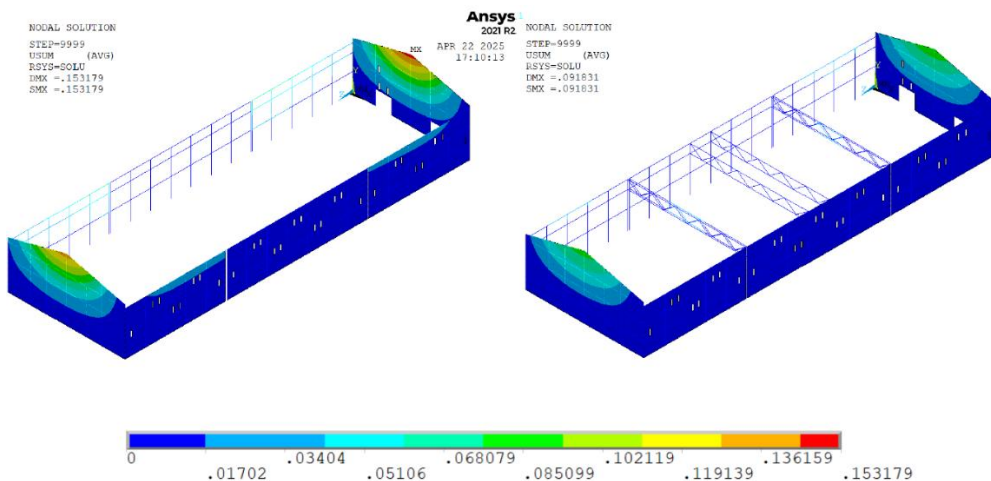
Response spectrum analysis was also performed in the Z-direction (perpendicular to the building's short side). The implemented interventions were effective in reducing both maximum displacement and principal stresses, although not to the same extent as the reductions observed under excitation in the X-direction. Specifically, the maximum displacement at the center of the wall perpendicular to the direction of the excitation was reduced by 40% (Fig. 21), while the maximum principal stresses in the same were reduced by 32% (Fig. 22). In addition, the minimum principal stresses were also reduced by 40% (Fig. 23).

Fig. 21. Maximum displacements (in m) developed in the structure by earthquake excitation in the Z-direction

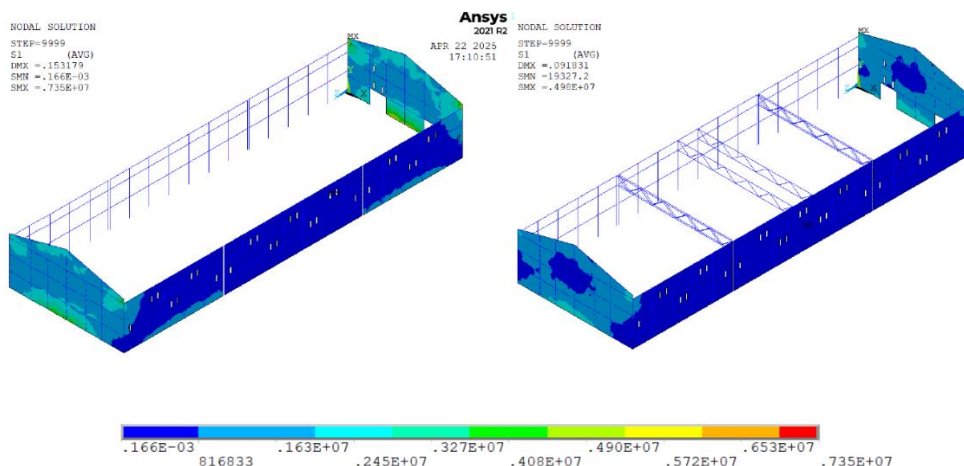
Fig. 22. Maximum principal stresses (in Pa) induced in the structure by earthquake excitation in the Z-direction

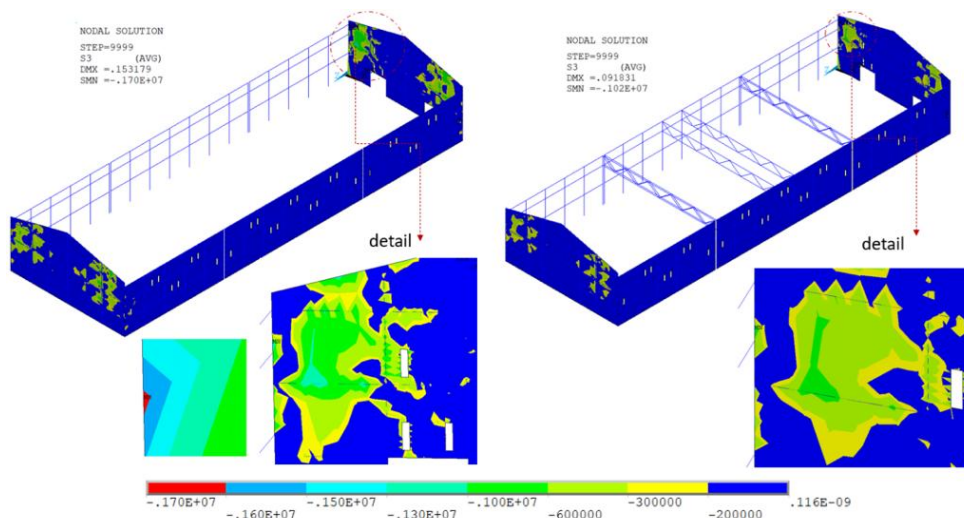
Fig. 23. Minimum principal stresses (in Pa) induced in the structure by earthquake excitation in the Z-direction
