## THE RECONSTRUCTION AND RESTORATION OF THE FORMER JEWISH HOSPITAL IN KROPYVNYTSKYI

*The article analyzes the experience of reconstructing and restoring one of the former buildings of the Jewish hospital in the city of Kropyvnytskyi. This object is an architectural monument, built in 1910–1914 in the eclectic style with elements of modernism, in interiors with motifs of the traditional "Jewish" style. It is significant that, during its existence, the hospital was used for its intended purpose; however, some buildings were rebuilt and lost part of their original decor. As of the beginning of the restoration work, building No. 2 had signs of disrepair. The article highlights the history of the object, its style characteristics, and characteristics of the original structural roofs and materials. The stages and content of the restoration project are described.*

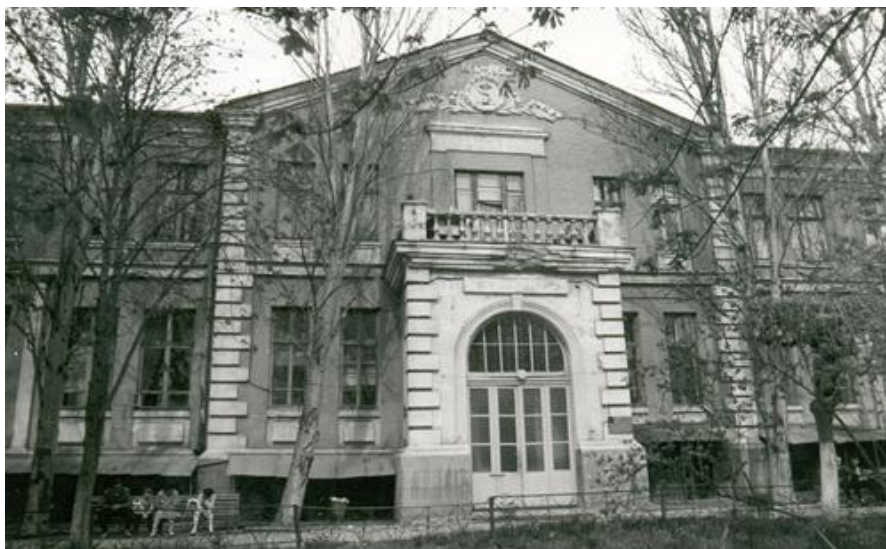
The facades of the old volume of the building have a high degree of preservation, but most of all, in the 1950s, during the reconstruction, the decorative elements of the crown cornice and the stucco decoration of the pediments were lost (Fig. 2). The original authentic interior decoration was not preserved; the heating stoves, which were located in the rooms of the basement and first floors, were lost, and a room for filling coal was preserved in the basement.

**Fig. 2.** Main facade of treatment building No. 2. Archival photo from the 1950s
