PRESERVING AUSTRALIA'S TIMBER HERITAGE – SOME PRELIMINARY GUIDELINES FOR THE CONSERVATION OF SLAB HUTS

Tomasz TOMASZEK^{1,*}, Caroline FRY²

Keywords: Slab hut; Wooden building; Conservation; Assessment; Vernacular architecture

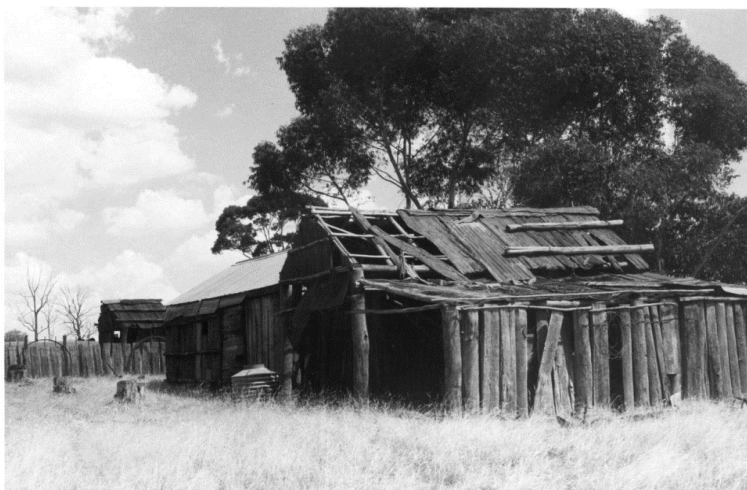
Fig. 1. “Bark and slab cottage at Barkly”, author: John T Collins, Mar. 11, 1974, gelatin silver; 8.8 x 12.5cm. approx., J.T. Collins Collection, La Trobe Picture Collection, State Library of Victoria, Australia, accession no: H90.100/1136.

Two styles of construction for slab huts are recorded. The first used long straight pieces of timber erected vertically, fitting into a chiseled groove in a base plate or sleeper, and held in position with horizontal wall-plates (Fig. 1). This form of construction guaranteed a firm solid structure. The second style of hut used slabs of shorter length, which were placed horizontally and fitted into slotted vertical supports spaced regularly around the external perimeter of the house (Fig. 2). This type of construction was a relatively easy method to build and was widespread [2].

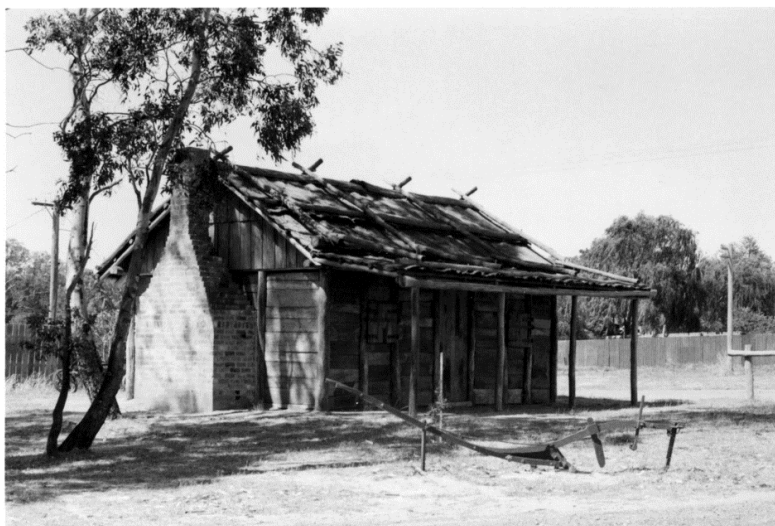
Fig. 2. "Broadford. Slab hut Historical Society Main St.", author: John T Collins, Dec. 17, 1977, gelatin silver; 8.8 x 12.5cm. approx., J.T. Collins Collection, La Trobe Picture Collection, State Library of Victoria, Australia, accession no: H90.100/2619.

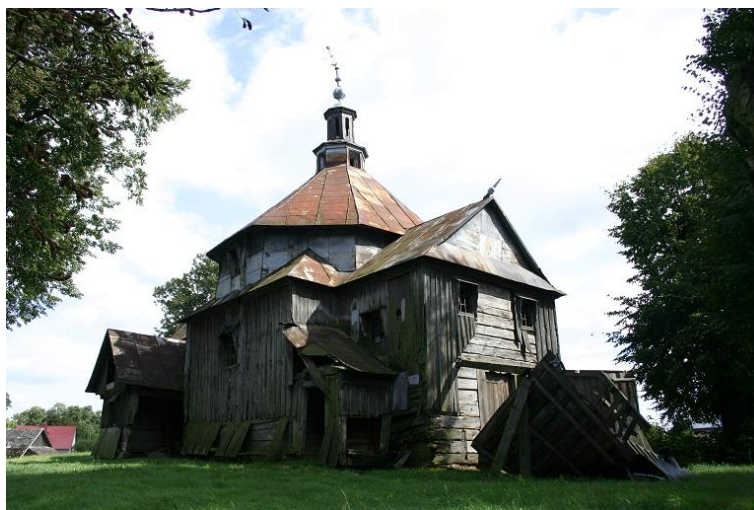
Fig. 3. The Orthodox Church in Mięksiz Stary (condition of July 2020)

As it was mentioned above, the Resistance Drilling Method has high efficiency in assessment of the condition status and vulnerability of cross-sections of elements in an historical wooden structure. An example of the application of this method, prepared by the author [T. Tomaszek], is outlined in the case study in determining the conservation methodology for the Orthodox Church in Mięksiz Stary (Fig. 3). This church is located in south-eastern Poland. It is a unique example of wooden Greek Catholic built heritage in this part of Europe. The church in Mięksiz Stary has not been in use since the end of the World War II and it remains in an advanced state of ruin [25]. Thus, the data collected and the treatment undertaken represents the conservation issues typical for wooden structures in similar state.

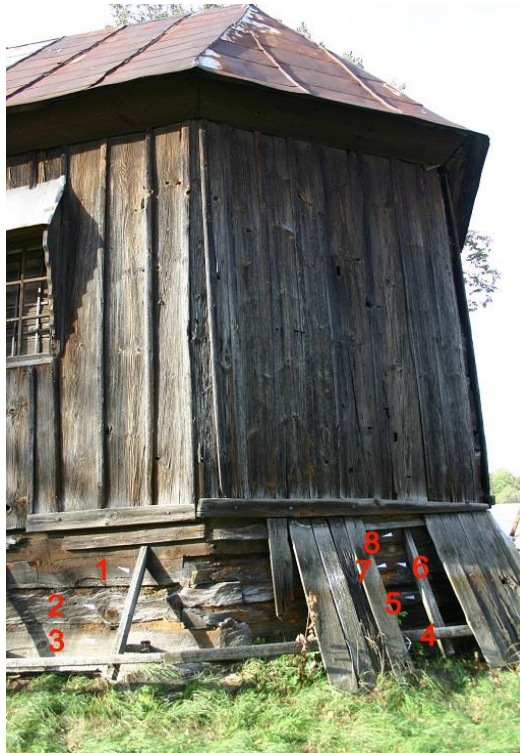
Fig. 4. The Orthodox Church in Miękiszy Stary. Sanctuary (south-east corner) – the spots were Resistance Drilling analysis were carried out shown by corresponding white arrows with numbers

In order to identify the condition status of wood tissue in cross-section of wooden structural elements of the walls of the Orthodox Church in Mięksiz Stary the Resistance Drilling analysis was obtained *in situ* using the resistograph IML-RESI F400-S. The sample graphs shown below displays the results of these analyses conducted on the lower elements of the part of church called Sanctuary (south-east corner) (Figs. 4-8). The following color code was adopted for the graphs (Table 1).

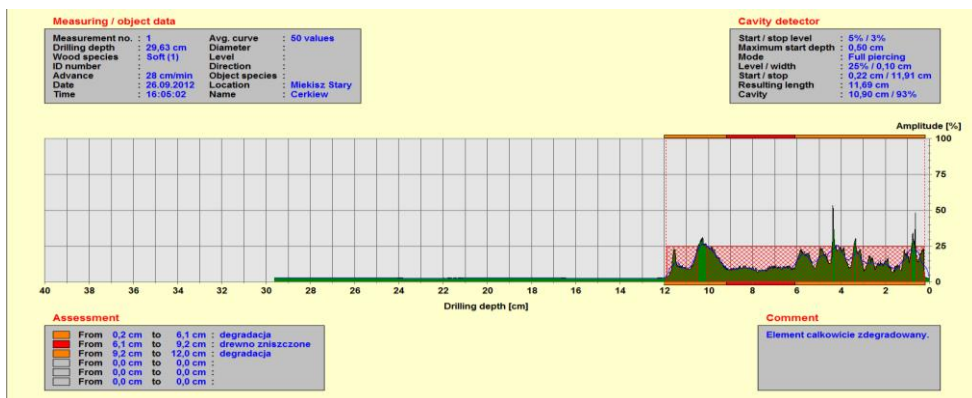
Fig. 5. Chart showing relative resistance over the drill path – Measurement 1 (see Fig. 4 for location of measurement spot); result: completely degraded element
