## ASSESSMENT OF CRACK INJECTION METHODS IN THE RESTORATION OF HISTORIC BRICK BUILDINGS

*The article is devoted to studying the modern repair materials used for eliminating cracks in brick walls by injection, the main repair method for cultural heritage sites, ensuring maximum preservation of their authenticity. Experimental studies were conducted to determine the possibility of using modern repair materials (high-flow cement mortar Stabilcem and polymer compositions Epojet and Edmok) to repair brickwork cracks. The best results were observed in polymer compositions. The possibility of restoring the cracked samples' bending strength after the repair mortar's injection was tested. After injecting a crack with an opening width of 2-3 mm (for polymer compositions) and 6-8 mm (for cement composition), the restored samples' bending strength was 125.6% of the previous for Stabilcem, 182.5% for Edmok, and 315% for Epojet. When the cracks were previously filled with coarse quartz sand with an opening width of 4-5 mm (for polymer compositions) and 10-12 mm (for cement compositions), the repaired samples' bending strength was 67% of the previous for Stabilcem, 174.9% for Edmok, and 161% for

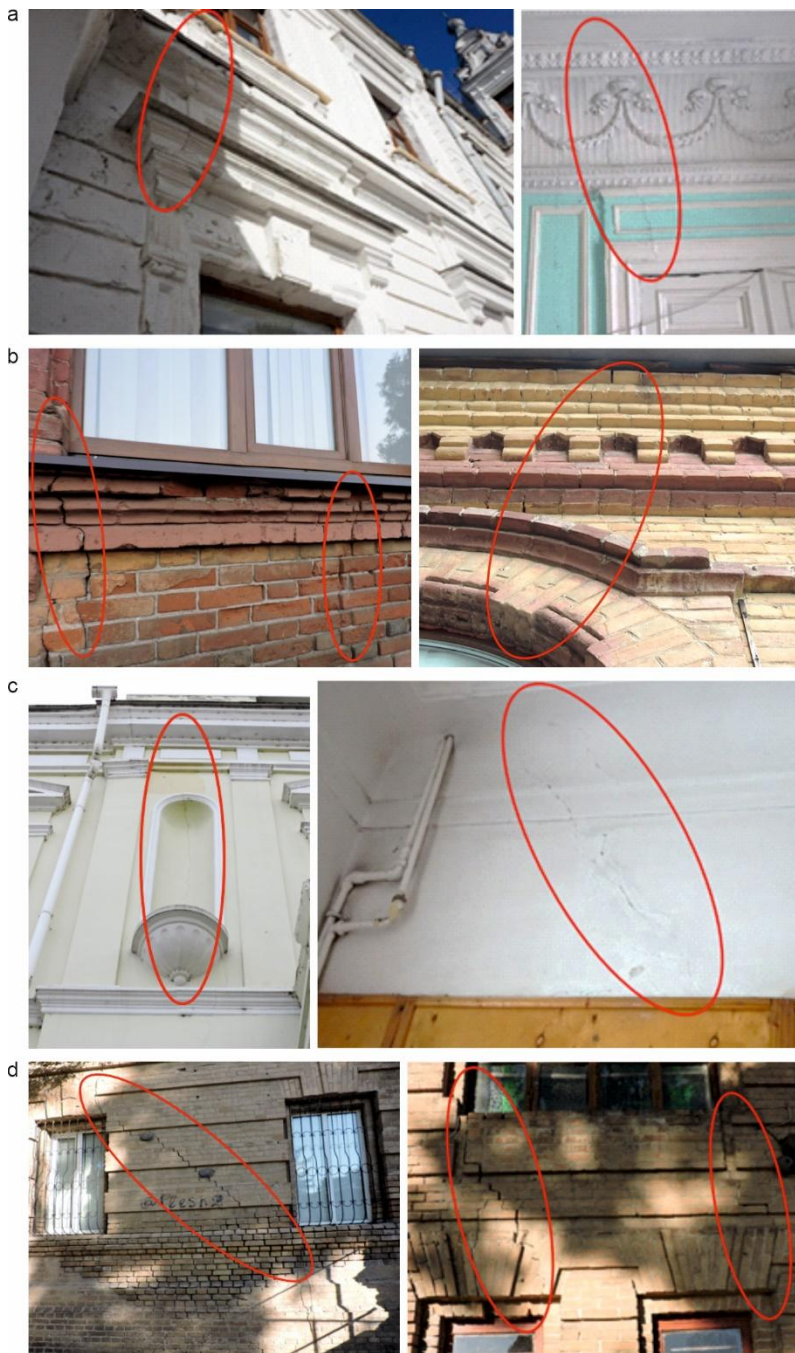
**Fig. 2.** Examples of historical buildings' cracked walls: a – Andrushivka Lyceum No. 1 with a primary school (Zhytomyr region); b) Balta Oles Gonchar Lyceum No. 1 (Odesa region); c) Izmail Lyceum No. 1 (Odesa region); d) Izmail Gymnasium No. 2 (Odesa region).

According to the results of the survey of a large number of both historical and modern buildings, it was found that the most common damage to brick walls is cracks (Fig. 2). Cracks in structures primarily affect the overall aesthetic appearance of buildings and the comfort of people staying in them. However, from a technical point of view, cracks in structures can lead to a decrease in their load-bearing capacity and the possibility of further damage or even destruction of the structure itself or the whole building.

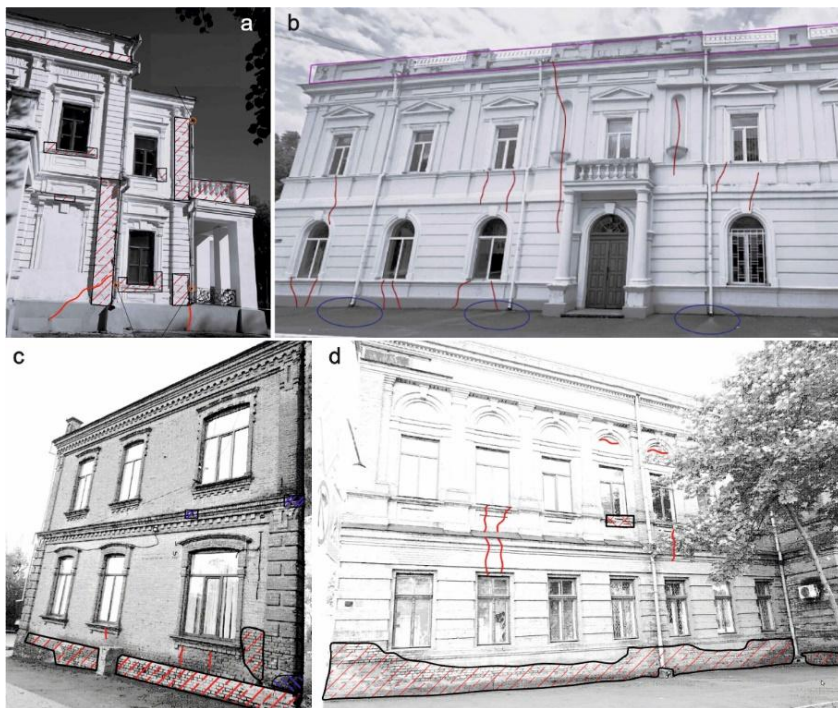
**Fig. 3.** Excerpts from inspection reports of damaged buildings, where red lines show cracks and red hatching shows masonry destruction: a – Andrushivka Lyceum No. 1 with a primary school (Zhytomyr region); b) Balta Oles Gonchar Lyceum No. 1 (Odesa region); c) Izmail Lyceum No. 1 (Odesa region); d) Izmail Gymnasium No. 2 (Odesa region)

As an example, excerpts from technical inspection reports with separate descriptions of defects and damage to facades for the above-mentioned buildings are provided, recording all existing damage (Fig. 3).
