# HISTORICAL TIMBER HEALTH RESORT ARCHITECTURE. CONTEMPORARY CONDITION AND STATE OF CONSERVATION

This paper discusses present the types of conservation measures used to protect historical timber health resort architecture in spa towns. The subject is presented on the example of historical wooden buildings in the Polish, Slovak and Ukrainian health resorts. The approach to conservation the historical substance and preserving the architectural expression of the object is presented on the individual examples of historic buildings, mainly spa villas. Efforts towards renewing damaged, transformed and ruined buildings can contribute to maintaining the value of the cultural landscape of localities, the identity of health resorts and their educational value.

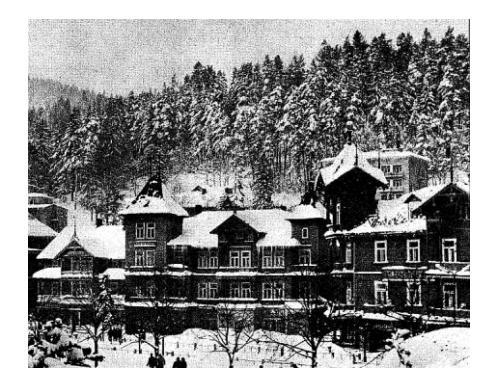
Fig. 3. "Tatrzańska" and "Witoldówka" villas seen from Dietla Boulevards in 1977. Traces of remodelling are visible in the different forms on the guesthouses' ground floors—they were adapted for commercial use [24]

In the 1970s and 80s, a series of fires damaged wooden guesthouses and ornamental villas in the centre of Krynica's health resort. The villas named "Litwinka", "Tatrzańska" from 1855 or "Stefania" from 1886 burned down completely, while "Korona Węgierska" from 1880 or "Witoldówka" from 1888 suffered damage. The "Witoldówka" Villa, occupying an exposed site near Dietla Boulevards along the Kryniczanka Creek (Fig. 3), and which used to be a treatment facility of dr Bolesława Skórczewskiego, was severely damaged by a series of fires. After long discussions within the conservation community in the middle of the 1980s, it was decided to rebuild it with masonry walls, with wooden cladding and a recreation of its facades following surviving patterns. The wooden siding, the roof truss structure and furnishings were proofed against fire (Fig. 4).

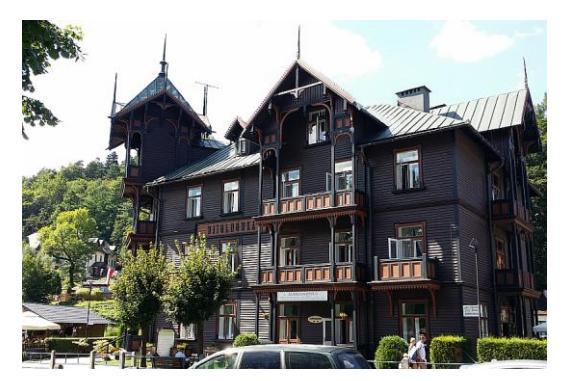
Fig. 4. The "Witoldówka: villa seen from the side of the Kryniczanka post-reconstruction, 2018 (Photo by M. Wdowiarz-Bilska)

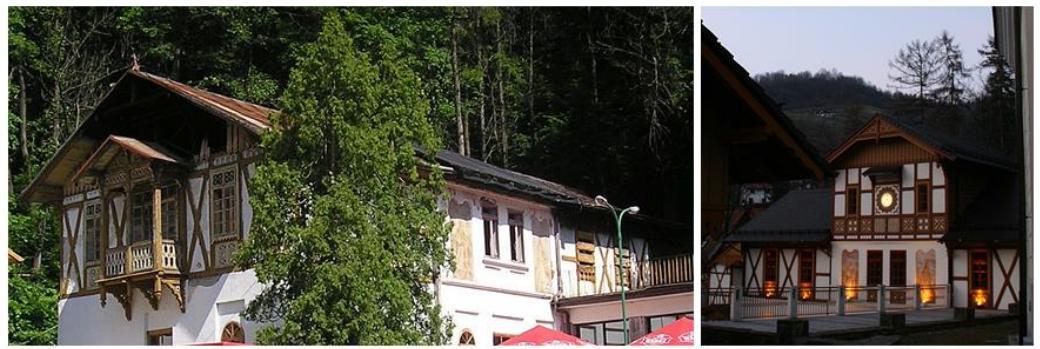
Fig. 5. The Main Pump Facility, as seen after the Mańkowski family's reclamation of the resort - view from Dietla Square 2005, (on the left) and present-day state after renovation - view from the Park Górny- 2010 (on the right) (Photo by M. Wdowiarz-Bilska)

In 2007, work began on the renewal and reconstruction of the complex of the Main Mineral Water Pump Facility, the "Holenderka" and the previously rarely used walking hall. After a fire in 2002, the pump house had a completely burnt dormer and damaged roof structure. The building was rebuilt, carefully reconstructing the detail and ornamentation characteristic of 19th-century architecture of Szczawnica (Fig. 5). Renovated buildings created a functionally and spatially attractive walls of the now-restored Dietla Square. Two years later, a new wing of the "Holenderka" was opened for use, which had been built on the site of the former water bottling plant and in which a Health Resort Museum was established. The facility

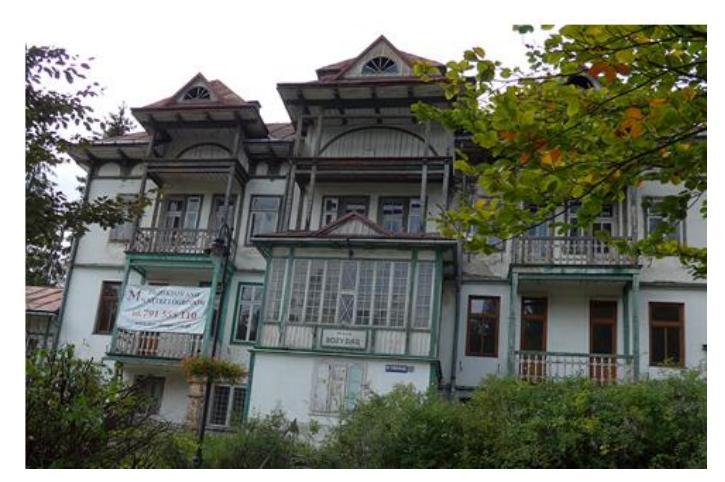
Fig. 6. Villa 'Boży Dar' one of monuments under strict conservation that have not been used or renovated, 2018 (Photo by E. Węcławowicz-Bilska)

Processes of rebuilding and reconstructing historical timber architecture are accompanied by intense development of new hotel and guesthouse buildings maintained in a contemporary version of the Swiss and Tirol style. At the same time, original nineteenth-century and turn-of-the-century wooden villas, which are listed in the monuments register and placed under strict conservation, remain on the sidelines of this process (Fig. 6).

Some of them, such as the "Marta" Villa, or the villas by Szalay, are used as hotels, guesthouses or tourist homes and are regularly renovated or maintained in good technical condition. However, in the case of monuments that have not been used or renovated for years, such as the "Świerki" sanatorium, the "Limba", "Boży Dar" or "Wanda" villas, the process of the deterioration of wood and their respective structural systems and general ruination is progressing increasingly quickly. There are fears that, in a few years from now, there will not by any of their historical substance left to save, and these beautiful buildings, each of great significance to identity and cultural wealth, shall be rebuilt using concrete.

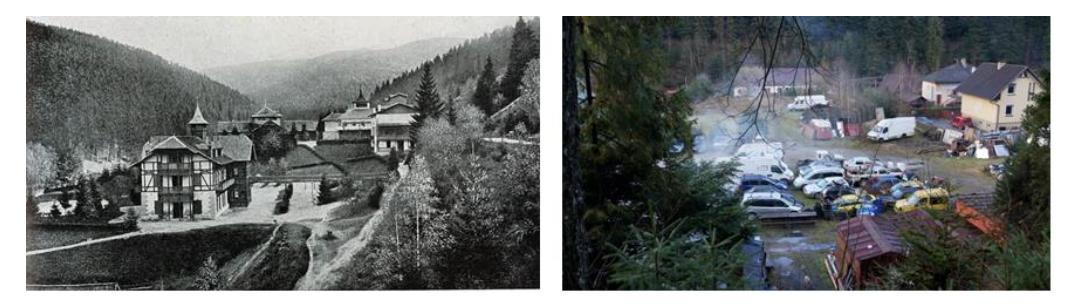
Fig. 7. The spa in Novoveská Huta, on the left in 1908, source: [24, p. 131] and the current state of the spa area replaced by new family houses since beginning of the 20th century on the right, 2021 (Photo by M. Vaščák)

Novoveská Huta is a specimen of destruction of a traditional health timber resort "Iglofüred" (Fig. 7) situated in Spiš region in the eastern part of Slovakia. This small climate spa was established in 1892 after the decline of mining industry. The whole complex consisted of seven hotel buildings. They all were characteristic in a distinctive wooden architecture with timber and timber-framed constructions with brick fillings. Several attractive villas were designated for accomodation of spa guests which were included in the original health resort. In 1944 the spa was plundered and been never use for spa purpose. Afterwards, in 1948 a pioner camp had settled into *Vila Kozákova*. The historic spa buildings gradually collapsed due to lack of maintenance. In 1989 they were completely demolished. On the site of the former spa were built new family houses. Only a small wooden chapel and two of spa villas have remained. Both 'Villa Kozákova' and 'Lovecký zámoček' are used for private events.

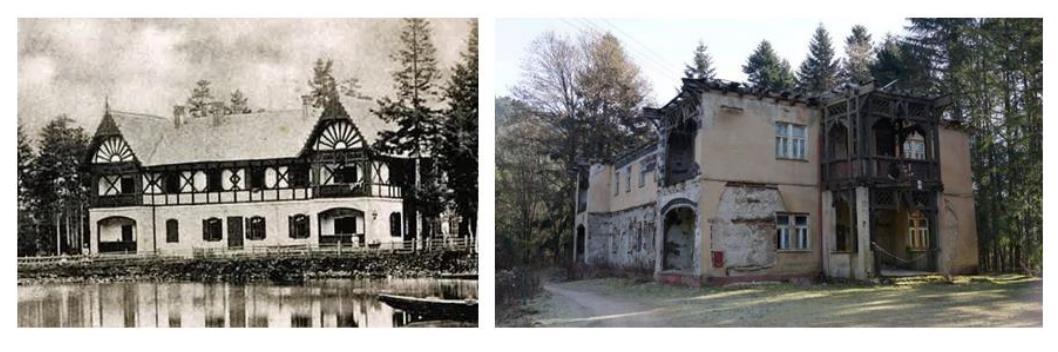
\Fig. 8. The spa Villa Thurzoház in 1901, source: [25, p. 112] on the left side and the current state condition due to lack of maintaince and after the fire in 2021 on the right side (Photo by M. Vaščák)

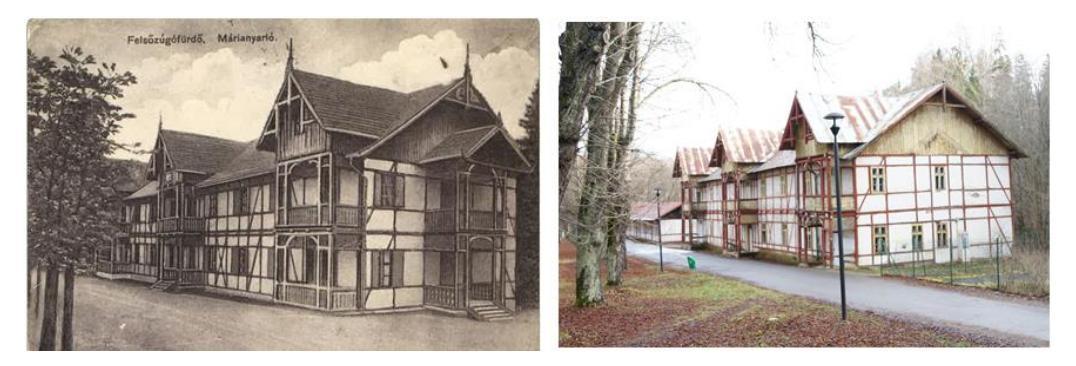
Fig. 11. The spa Mária on the left side on a postcard around 1910, source: [26, p. 86] and on the right in 2021. (Photo by M. Vaščák)

In Vyšné Ružbachy, also other traditional timber spa buildigs are listed in the National register of monuments e.g. the wooden altan dated back to the 1890s, the spa house 'Kriváň' with a timber structure completely plastered, the villa "Mária" (Fig. 11) and the spa hotel "Dukla" features by great wooden balconies on façade. The spa house "Kriváň" is currently in a reconstruction process, but lacking the complex solutions of humidity, sanations and installations etc., exception are the new replaced windows in traditional appearance. Majority of the building's structure is in a bad technical state.

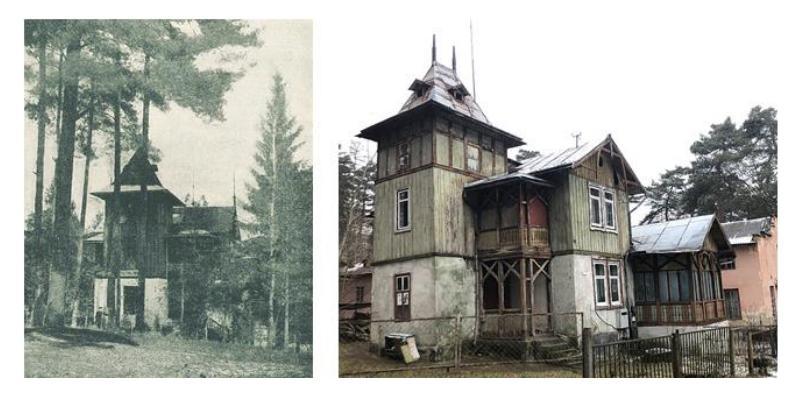
Fig. 14. Villa Bogomyluvka until 1914 [28] and in 2021 (Photo Y. Kryvoruchko)

Despite its small size, the villa has a very extensive form. Its two-storey core is connected with a three-storey wooden towers covered with a hipped roof and a one-storey veranda with decorative details carved out of boards. a two-story openwork porch with an ornamented wooden structure leads to the building. The current technical condition of the villa is bad, due to the destruction of wooden elements, loss of decorative details, damp walls and missing plaster revealing the timber construction (Fig. 15). Renovation works carried out in part of the villa do not ensure proper preservation of the historical substance.

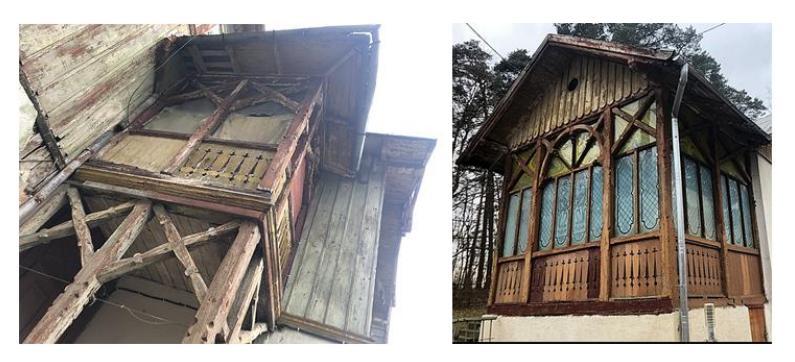
Fig. 15. Destruction of external wooden elements of the Villa Bogomyluvka, 2021 (Photo by Y. Kryvoruchko)
