GLASS USE IN RE-USED HISTORICAL BUILDINGS: THE CASE STUDY OF TRABZON KIZLAR MONASTERY

İrem BEKAR¹, İzzettin KUTLU^{2,*}

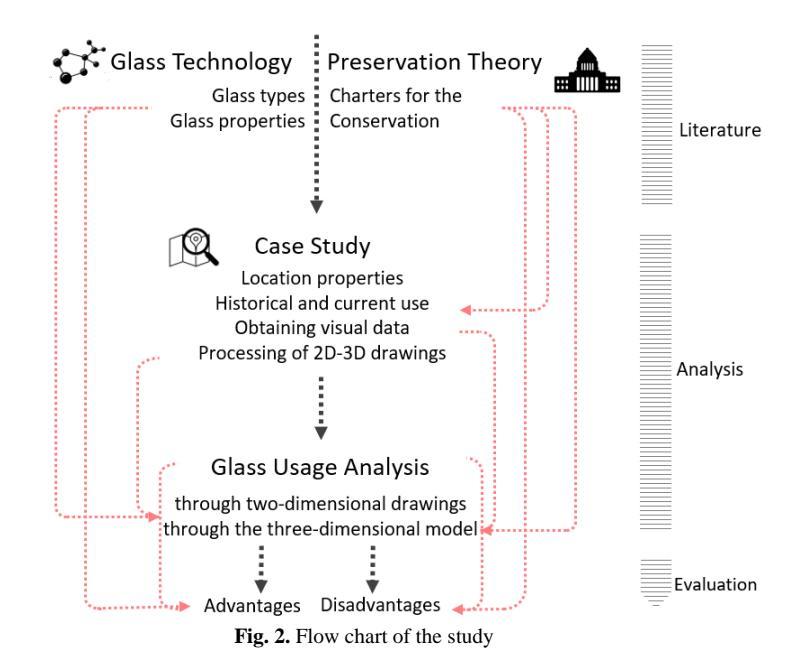
Within the scope of this study, the use of glass materials in the process of re-using historical buildings was investigated through the example of the Trabzon Kızlar Monastery. The study consists of 3 stages (Fig. 2).

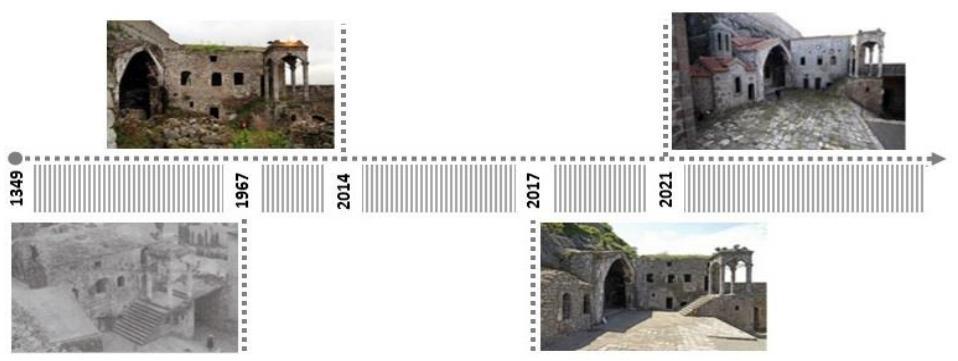
Fig. 4. The evolution of the Kızlar Monastery's southeast courtyard over time (images by Anadolu Agency).

Until 1843, the rock church, with frescoes depicting Alexios III with his mother and wife, some individual buildings and a ruined hall formed monastic structures. Small buildings in the northeast were added in 1843 [46]. The original top cover of the building, which was abandoned after being used until 1923, has not survived. In 1970, the monastery was re-used as a children's hospital [47]. The Republic of Turkey's Ministry of Culture and Tourism recognized the monastery's historical and tourism potential and began renovation work on the structure [46]. Restoration of the historical rock church, which was neglected for a long time, and the monastery, which includes rare frescoes, began again in 2014. The timeline showing the change in the structure in 2014 and after 2014 is given in Figure 4.

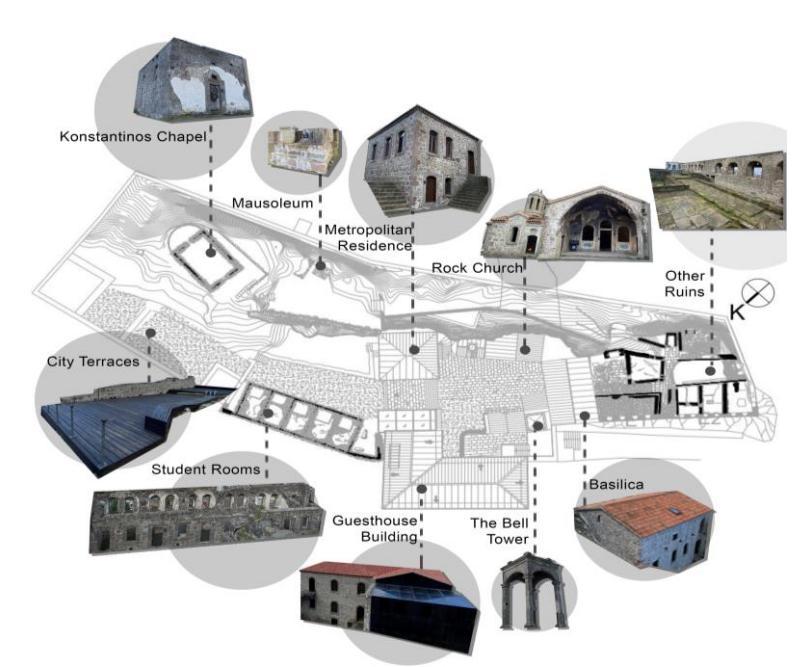
Fig. 5. The spaces in Kızlar Monastery and their location in the structure.

First of all, the rock church with holy water in the south, the chapel at its entrance and a few cellars, then the metropolitan residence, monk rooms, guesthouse, dining hall, a second church, bell tower, mausoleum and five service buildings of different sizes (only the ruins of the service buildings have reached the present day) were constructed (Fig. 5). The buildings at the entrance, the monastic cellars, the church with a single apse on the east side and the second terrace, and the "baldaken" (column and covered with a small dome) tomb belong to the 19th century [48].

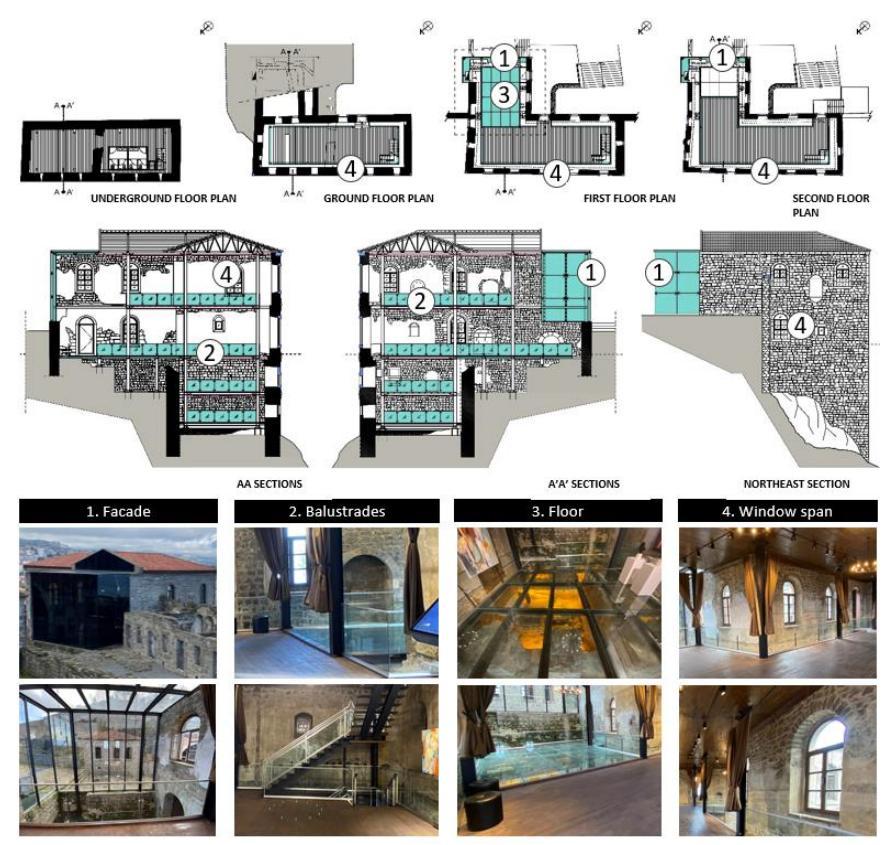
Fig. 6. Kızlar Monastery – Processing the use of glass on sections and appearance (Restoration drawings obtained from Envar Architecture).

It was observed that glass materials were used intensively during the restoration process of the Kızlar Monastery, which started in 2014. It has been clearly determined that the glass in the spans of window in all the buildings in the monastery is also used for different functions, especially in the Guesthouse Building. Glasses, which were determined to be used as floors, roofs, railings, and walls, were processed on the plan, section, appearance, and 3D model of the building (Fig. 6). When the glass materials used are considered on the plan plane, it is observed that glass is used in the flooring of the first floor of the L-plan type Guesthouse Building. In the floor where unbreakable tempered glass is used, the loads are transferred to the floor with steel columns, and the glass blocks are brought together with the spider mounting arm. Thanks to the glass flooring used, the historical ruins on the ground floor under the flooring are visible to the visitors. This comfort has been continued on the upper floors, with the gallery space arranged in the area where the glass floor is located in the secondfloor plan. When the use of glass is considered in terms of sections and elevations, it is seen that the floors supported by the steel structures re-created in the building are not fixed to the original stone walls, and therefore a railing is required for the opening to be formed between the wall and the new flooring. As seen in the ground floor, first floor, and second floor plans and sections, this situation was solved by using glass railings. In addition, in the L-plan type building, it was seen that the original wall of the building was completely destroyed at the southeast end, and it was completed as a spider glass facade with tempered unbreakable glass. The new glass mass is designed at the same height as the original height of the building and is covered with the same glass material.

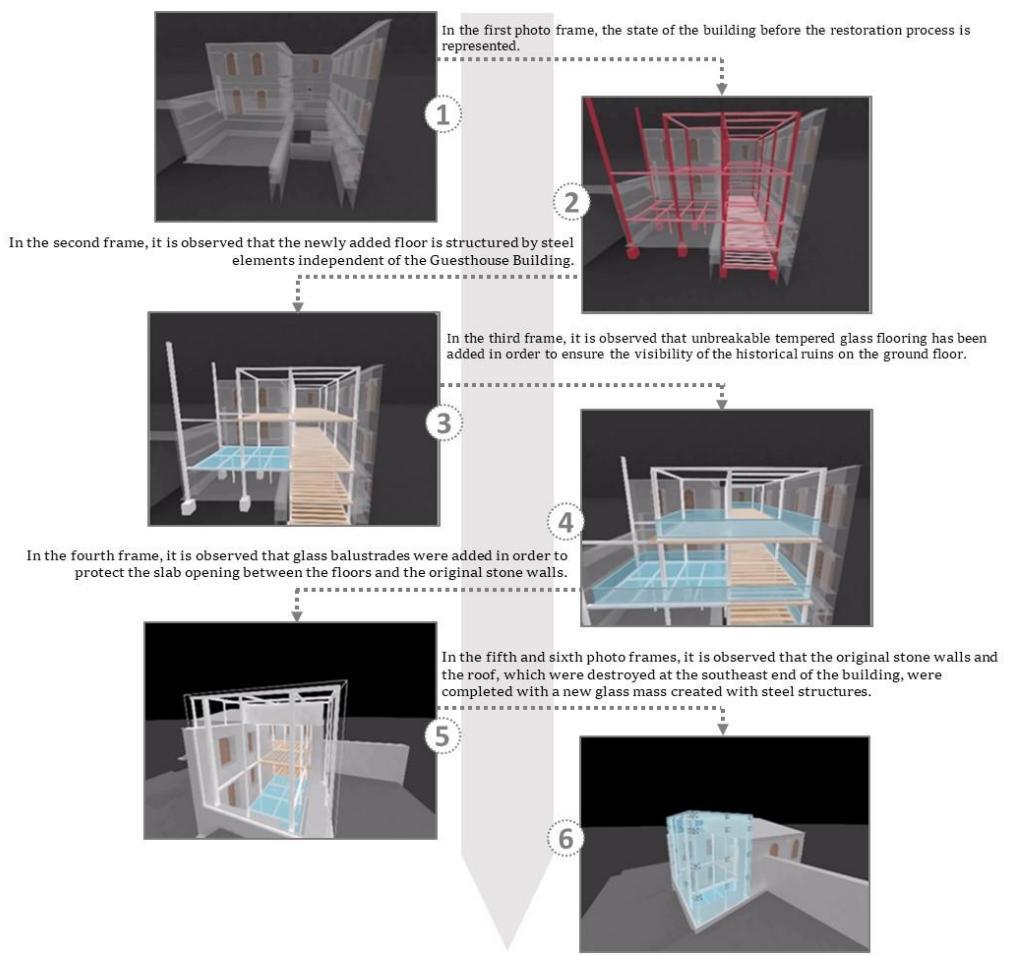
In the 3D model (Fig. 7) created within the scope of the study, the use of glass flooring, railings, walls, and roofs can be seen in the Guesthouse Building.

Fig. 7. Kızlar Monastery - Processing the use of glass on 3D model (Created by the authors).

- Thanks to the use of glass in the flooring, the historical ruins on the ground floor are visible from the first and second floors. This has been achieved with the use of transparent materials like glass and a disassembleable steel structure system, without damaging the original values of the historical building. The use of glass in flooring with the development of technology has shown that glass can be used in situations that may be exposed to high pressure over time. It is clear that glass, which was used only for window openings until a few years ago, is a material open to development in building technology.

- The addition of a new mass with unbreakable tempered glass, replacing the destroyed original stone wall and roof, shows that the building was completed with a contemporary material, distinguishable from its original state and respecting the original state of the building. The outer boundaries and height of the original walls of the building, which was completed with a glass mass, were preserved and referenced
