RESTORATION OF A FISHERMAN'S HOMESTEAD IN THE OPEN-AIR MUSEUM IN OPOLE

The paper addresses the issue of contemporary reconstruction and reconstruction of wooden architecture in open-air ethnographic museums, focusing on the example of the Opole Village Museum in Opole. The reconstruction process of three buildings -a cottage, a cottage building and a barn forming a fisherman's homestead – was analysed and the paper describes in detail the conservation methods applied, the adaptation process and the technological and ideological challenges involved in this kind of undertaking. The study emphasises the value of integrating traditional construction techniques with modern solutions, enabling the faithful reproduction of historic architecture while adapting it to new educational, exhibition and training functions. The analysis includes an assessment of the technical condition of the preserved materials, methods for their reuse and the impact of advanced monitoring technologies on the preservation and durability of the reconstructed buildings. It also highlights limitations of biological degradation of wood and the challenges of restoring authenticity in changing spatial conditions. The

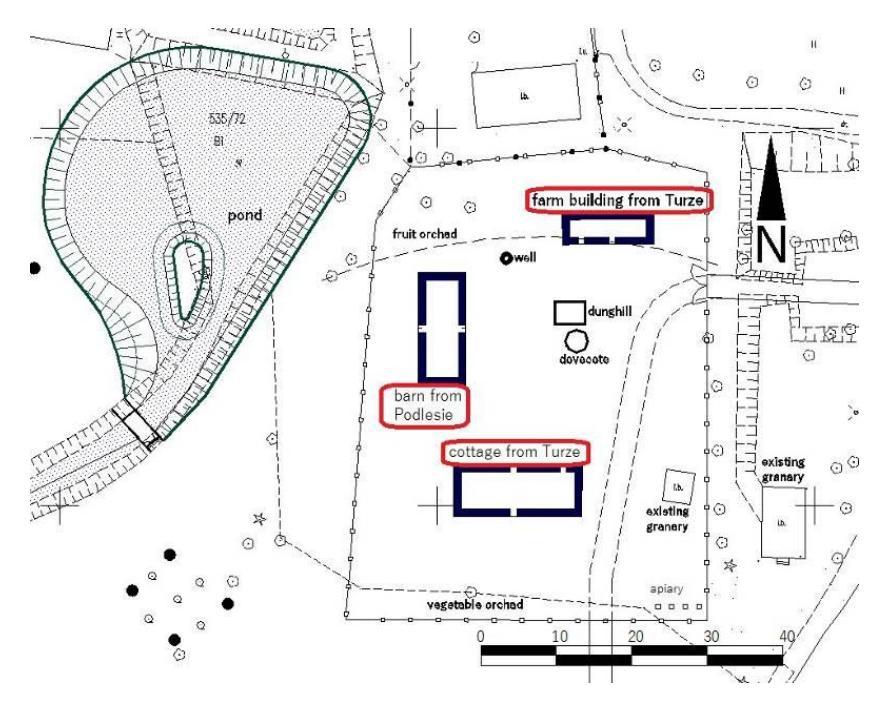
Fig. 1. Site development plan with localization of the analyzed buildings

The reconstruction of the fisherman's homestead was planned on the clearing in the southeastern part of the plot of the Opole Village Museum in Opole, which was an important element of broadening the museum exhibition and restoring the traditional settlement layout typical for the region (Fig. 5). A fisherman's homestead was reconstructed in the southern part of the clearing, giving it the characteristic features of rural buildings connected with fishing. The barn was placed in the western part, preserving the traditional building technique and the farm building, performing complementary functions, was located in the northern part of the clearing.

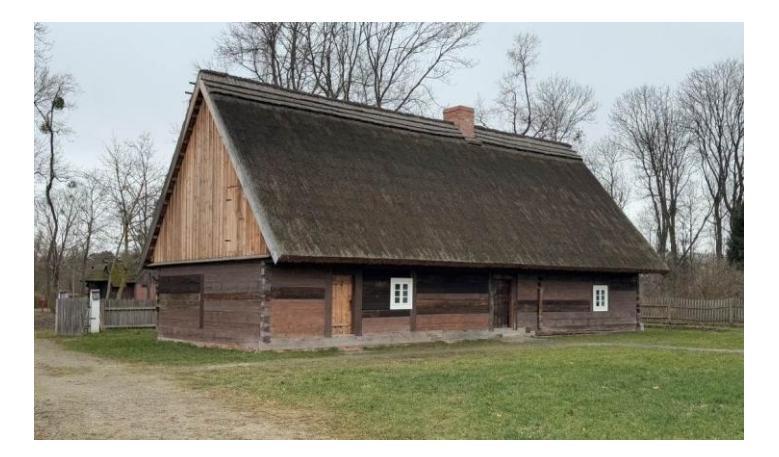
Fig. 2. A cottage building from the village of Turze

The cottage was built around 1814 in the village of Turze near Racibórz in the south of Silesia (Fig. 6). The structure was demolished in the 1980s and the wooden elements were transported to the Opole Village Museum in Opole, protecting them from the weather.

The building consisted of several rooms in a typical functional layout for this type of building. On the western side, there were two rooms with a single entrance from a spacious hallway. In the hallway, at the junction with the living rooms, a baker's oven with a smokebox was located. In the eastern part of the cottage, there was a kitchen and a chamber connected to it. A chicken coop and a chamber were adjacent to the kitchen and the chamber was on the north side [9].

The body of the cottage is of mixed timber construction. The rafter-collar roof truss was reinforced, supplemented and rebuilt in many places. The roof was thatched. The gables of the cottage were boarded with vertical boards. Traditional carpentry joints were used in the roof construction. The ceiling was made as a wooden chamfered beam. A plank floor was made on the ceiling beams and a clay covering was made on top of it. A well-preserved ceiling beam with an inscription of the date of the cottage's construction - 'Anno 1814' - proved to be a valuable artifact.

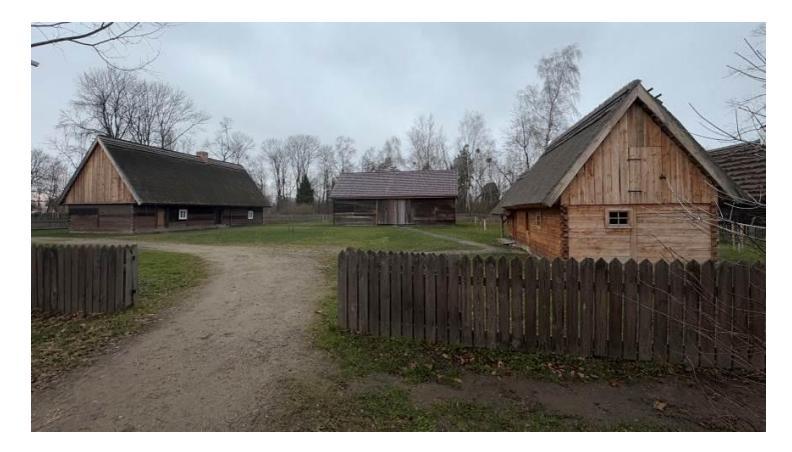
Fig. 5. Reconstructed fisherman's homestead

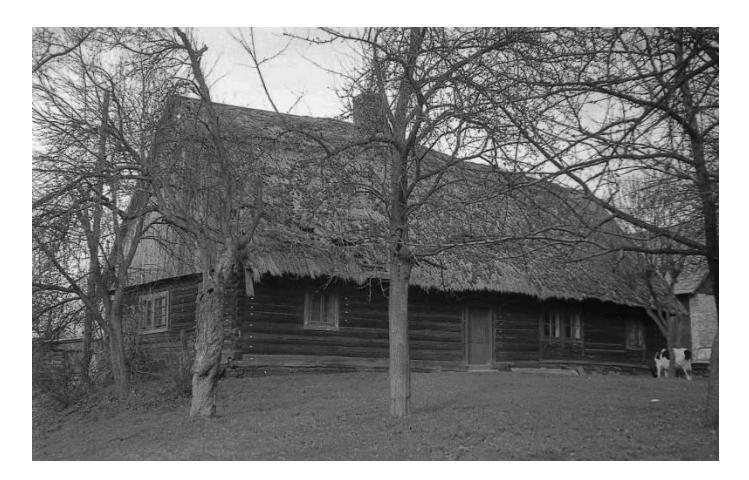
Fig. 6. A historic cottage building from the village of Turze

The only surviving elements of the window joinery were the window jambs. Part of the jamb-mounted element allowing the door to be bolted was preserved, as well as individual iron elements, the wrought iron hooks of the door joinery, which served as a model for their

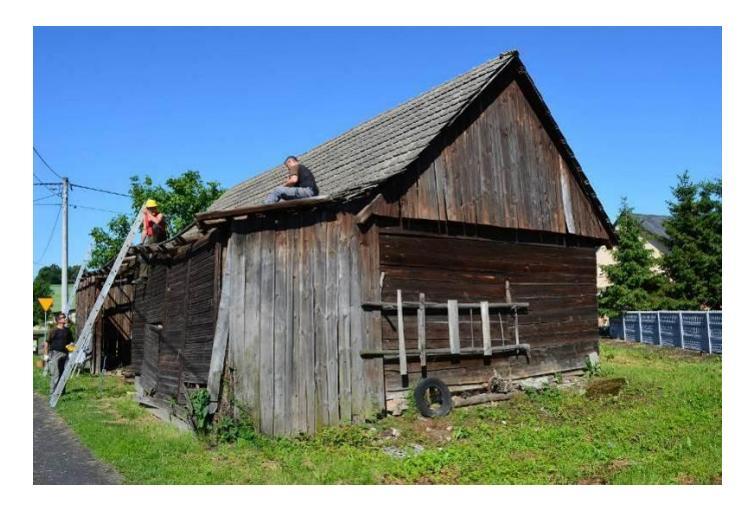
Fig. 7. A historic barn from the village of Podlesie

The barn was built in the 19th century in Podlesie (Fig. 7). The structure was dismantled in 2015 and transported to the Opole Village Museum in Opole [10].

A barn of simple, compact form, constructed in timber frame construction. The symmetrical, gabled roof was covered with a grey embossed tile in a near-square shape. The tile was similar in form to the so-called Muldenfalziegel with double overlap, manufactured at the Siegersdorfer Werke Friedrich Hoffmann in Zebrzydów near Bolesławiec (formerly Siegersdorf). Classic carpentry joints were used in the erection of the building. The construction elements were pre-treated with an axe and smoothed with an axe. The wooden parts of the

The roof construction is a timber purlin system without rafters. The gables of the barn were boarded with vertical boards. On the basis of the preserved photographic documentation, it was found that over the years the boarding of the walls and gables, in the place of previously destroyed wooden elements, was repeatedly replaced and supplemented. The interior of the building was functionally divided into three parts - the central pass-through part and two side parts used for storing grain and hay. Two gates, about 5.0m wide, led to the passage part.

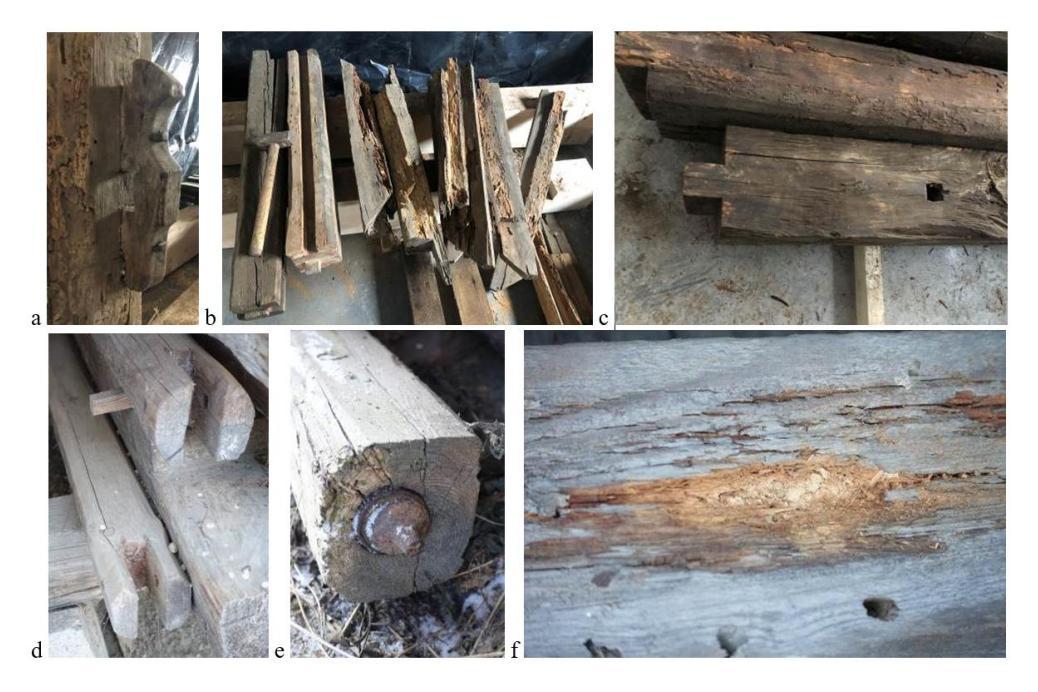
Fig. 8. Artifacts from a cottage from the village of Turze (a, b, c) and from a barn from the village of Podlesie (d, e, f)

All decisions regarding the choice of materials and technology were based on a detailed assessment of the state of preservation of the buildings and their structural elements. The measures taken were aimed not only at preserving but also at enhancing the durability of the buildings so that they could fulfill their functions in the future. The preservation of building materials that had historical value was a priority and their use for reconstruction was subject to a detailed assessment in terms of load-bearing capacity and technical condition (Fig. 8).

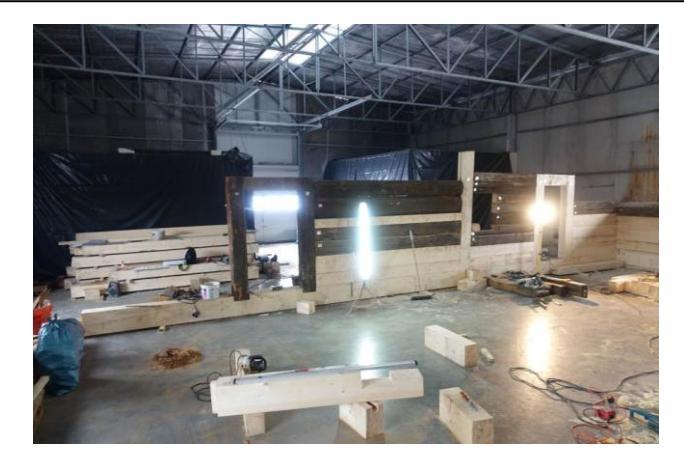
Fig. 9. Reconstruction of a cottage building from the village of Turze in a storage hall

1. During the demolition of the cottage and subsequently, all wooden elements were numbered twice and divergently. In addition, the number plates identifying the individual elements were corroded, making it impossible to read them correctly.

- 2. The building inventory of the cottage was not carried out very carefully. The width of the building actually turned out to be more than 0.5 smaller than that assumed from the 1970s inventory.
- 3. During the trial assembly of the cottage, significant displacements of elements in the joints, visible deviations from the verticality of the wall columns and bulging of the external wall sections were found (Fig. 10).
- 4. Biological degradation of the stored structural timber appeared to be much more advanced than assumed prior to the documentation [15].
- 5. Limitations of the reconstruction of the cottage were the incomplete preserved material of the original substance, including structural and non-structural timbers, floors, boarding, window and door frames, ironwork, bottle cooker, heating cooker and plinth building blocks.

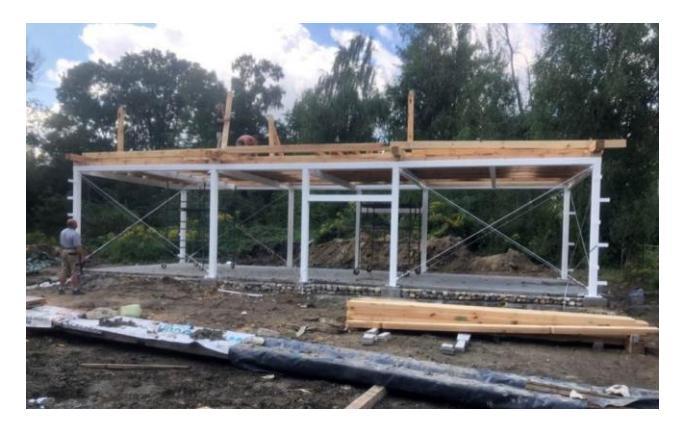
Fig. 10. An internal steel structure independent of the external "layer," which is a barn from the village of Podlesie

Due to changes in function and the need to adapt to modern standards, the barn was rebuilt in a simplified form, without the extensions that had previously been located on its eastern side. Inside the building, a spacious multi-purpose hall was designed with a steel, self-contained structure (Figs. 9 and 10). The room's partitions are made of materials that provide adequate acoustic and thermal insulation to improve comfort. The hall also houses an aquarium with a capacity of approximately 7m³, which forms part of the modern educational exhibition.
