## HYDROPHILIC ORGANOSILICONE RUBBER: THE NEW ORGANIC-INORGANIC HYBRID CONSOLIDANT FOR ANCIENT EARTHEN ARCHITECTURES

*Organic-inorganic hybrid material used as consolidant for earthen relics was synthesized by adding silica nano particles into polysiloxane with the presence of surfactant. This composite material is less hydrophobic than other polymer consolidant, which can avoid the preservation damage caused by the incompatibility between the hydrophobic consolidant and the hydrophilic soil. The tensile strength of the synthesized consolidant is close to other rubbers, which can relieve the stress between consolidant and soil within the expansion-shrinkage process when environmental conditions change. The product was applied on ancient Liangzhu city wall and its effectiveness was examined.*

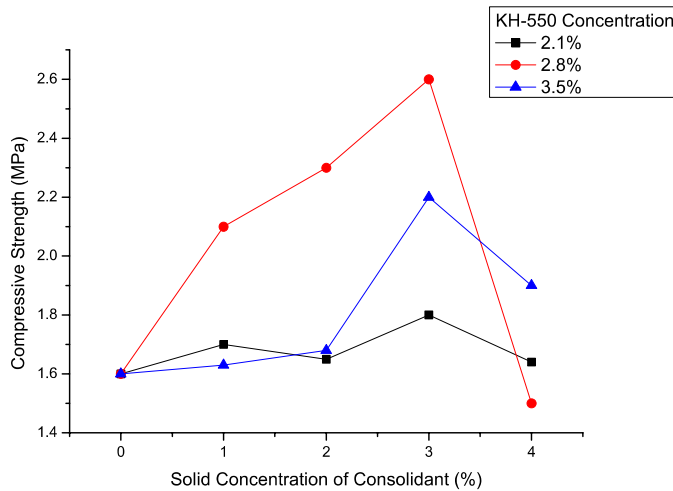
The consolidant emulsions with four different solid concentrations of 1%, 2%, 3% and 4% were prepared using three different KH-550 concentrations (i.e., 2.1%, 2.8% and 3.5%). These emulsions were added in the simulated earthen test blocks and their 7-day compressive strengths were measured (Fig. 2). It can be seen that the concentration of KH-550 has obvious influence on the compressive strength. The best strength result was obtained when KH-550 concentration was 2.8%. On the other hand, when the solid concentration of consolidant was 3%, the consolidation efficiency was better.

**Fig. 2.** Compressive strength values of the test blocks when treated with different concentrations of synthesized organosilicone rubber using mixing method.

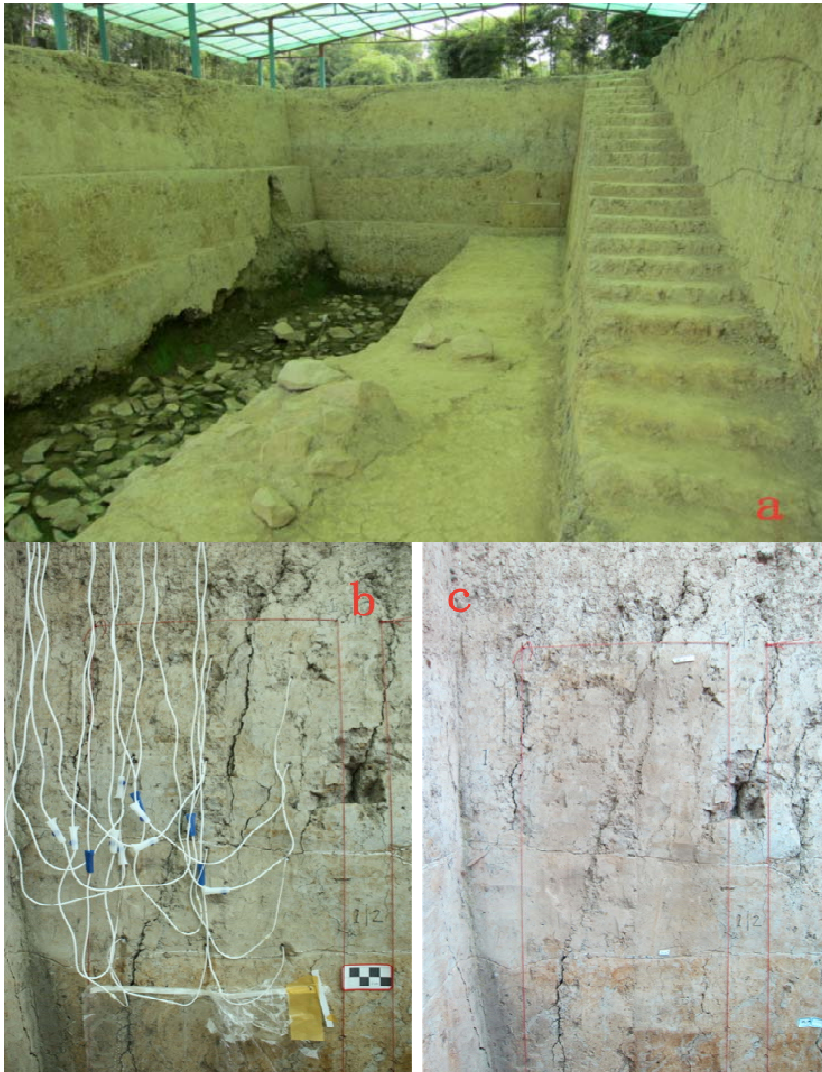
The organosilicone rubber emulsion with the solid concentration of 2% was used to consolidate the earthen wall of ancient Liangzhu City with about 5000 years history, located in the south region of Yangtze River Triangle. Before the consolidation, we drilled 8 holes on the experimental wall area with the length of about 8 cm. The emulsion was injected into the holes by perfusion tubes (see Fig. 5).

**Fig. 5.** Pictures of ancient Liangzhu city wall consolidation work: a - north city wall relic of Liangzhu, where the consolidation work was performed; b - Injecting the consolidant using perfusion tubes; c - the consolidation area one month after the treatment.

Stop injection until the emulsion can not penetrate into the soil. Then fill the holes with the mixture of soil and consolidant. Finally, spray the consolidant onto the wall surface using sprayer. One month later, the examination of the consolidation results revealed that the consolidant didn't alter the appearance of the wall. Seven days after the treatment, surface hardness values of 8 spots around the holes were recorded (see Fig. 6). The increase of surface hardness indicates that the consolidant can reinforce the earthen wall. In the future work, the consolidation effect of organosilicone rubber on the earthen wall of Liangzhu city will be monitored and assessed regularly.
