ANCIENT INDIAN PAINTING RECIPES AND MURAL ART TECHNIQUE AT AJANTA

Abstract

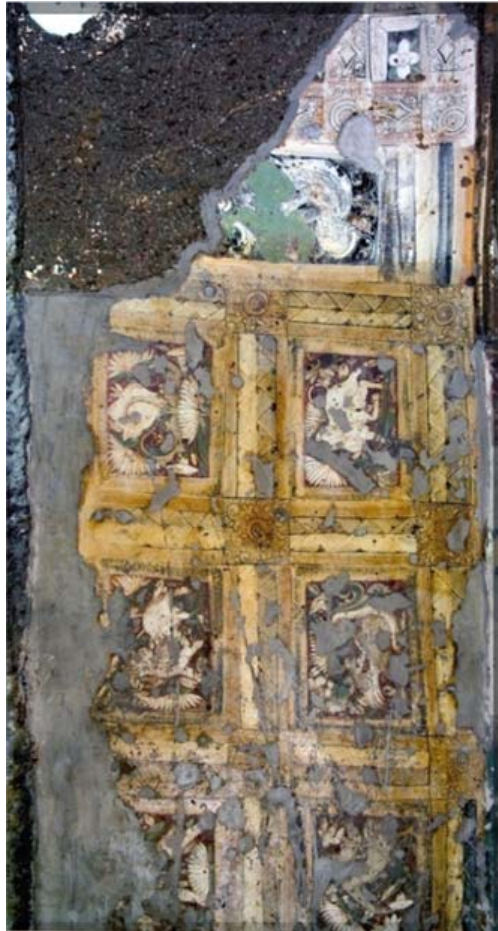
Fig. 1. Painted mortar of Cave no.19, Ajanta applied with shellac varnish

The major scientific preservation of murals of Ajanta was carried out in 1920 by Italian conservators when the cave was under the domain of Nizam of Hyderabad State. Besides filling the gaps and lacuna with Portland lime, most of the painted surfaces were applied with unbleached shellac varnish as preservative coating.

The shellac in the Indian climate has oxidized to reddish orange color masking the clear view of the paint layer. Besides it has also hindered the breathability of mud mortar and paint layer thereby causing ridges, gapes and sometimes loss of paint/mortar layers. Figure 1 shows the view of the painted mortar applied with shellac varnish. One of the primary tasks of Ajanta conservators is to slowly remove the varnish layers previously applied during the course of conservation. The most ancient 2nd BCE caves 9 and 10, Ajanta were copied in 19th century by applying different kind of varnishes under the light of an oil lamp causing extensive deposition of many kinds of varnishes admixed with soot and grime. There were also problem of graffiti by visitors when the cave was not under the control of Archaeological Survey of India (ASI), and Figure 2 show one such view from cave no. 10. Besides, some of the painted caves of Ajanta were under worship during 3-4th century A.D. and deposition of soot on the painted surfaces is noticed due to burning of incense Sticks.

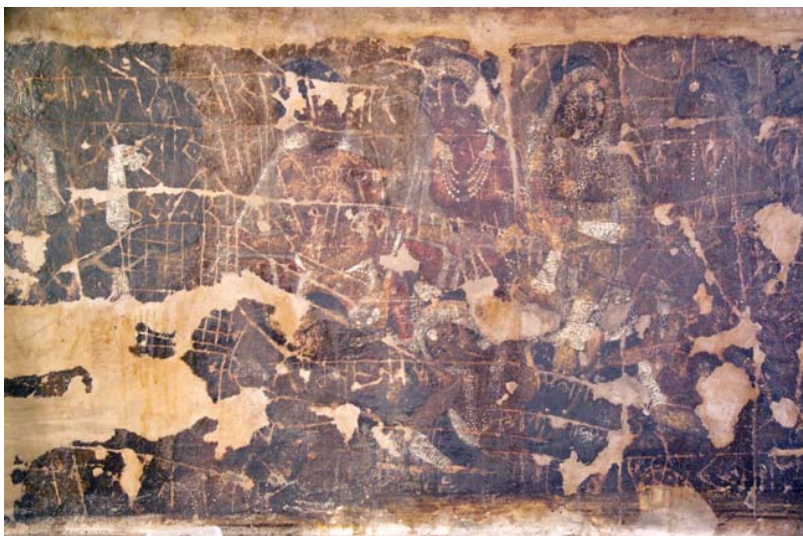
Fig. 2. Showing graffiti on painted mortar of cave no.10, Ajanta

The major causes of deterioration and degradation of Ajanta murals are variation in temperature and humidity, increase in flow of visitors inside the caves, seepages of waters, insect activity within the mud mortar, human vandalism (graffiti) and urine and excreta of bats. Presence of old varnish coatings used for copying the paintings by earlier artists is also a major conservation issue at Ajanta.

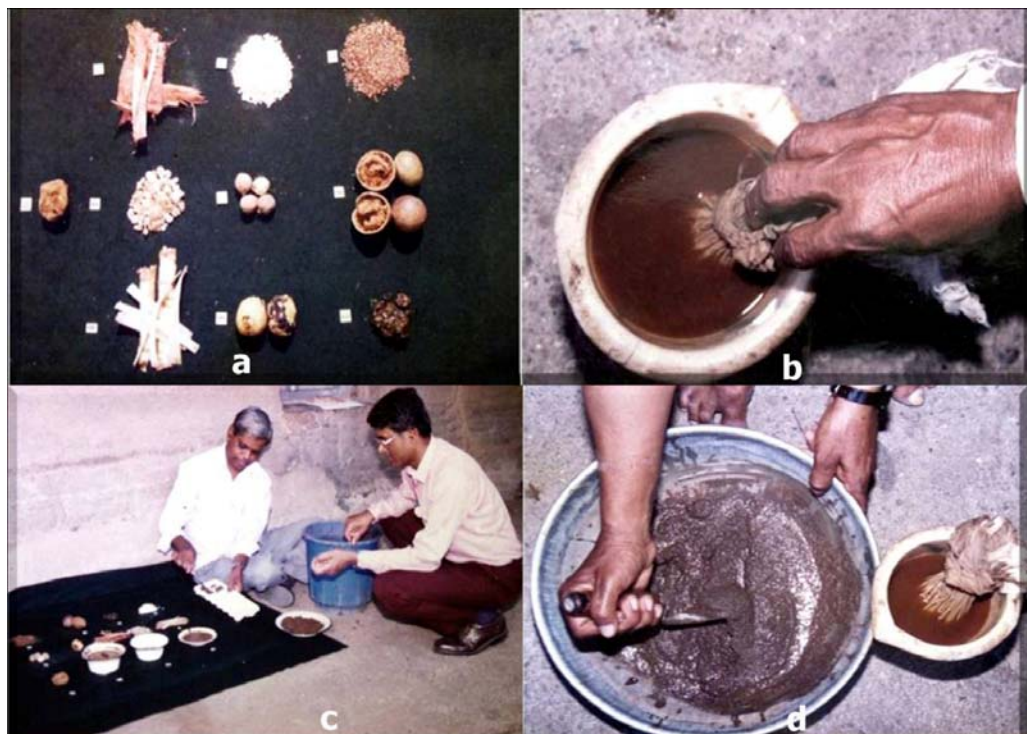
Fig. 3. Shows various steps in the preparation of mud mortar as per ancient recipe: a - ingredients for the preparation of mud mortar, b - preparation of adhesive extract, c - preparation of soil + lime + aggregates mixture, d - final step showing the preparation of mud mortar)

An attempt was made to prepare mud mortar at Ajanta as per ancient recipes reflected in the ancient text as above. First, the river bank soil from Waghura River just in front of Ajanta caves was collected and mixed with about 15% lime, 10% of sand and 15% of aggregates in different grain sizes.

In the second experiment different plants or parts of the plant were collected and cut into small pieces: Guggul (*Boswellia serrata*), Behada (*Terminalia pellerica*), Jaw (*Linum usitatissimum*), Bargad ka ped (*Ficus recemosa*), Urad ki Dal (*Vigna mungo*), Roots of ladies finger (*Abelmoschus esculentus*), Kale sawar (*Bombax ceiba*), Bel or bilva (*Aegle marmelos*).

The aforementioned plants in equal ratio were cut and tied in a cotton cloth and dipped in water for about a month. This process ensures complete oozing out of all gummy adhesive material into the water solution. The process was continued for about a month by keeping the container in a dark place.

The extract from these plants were mixed with the mixture (soil + lime + aggregates) prepared in the first step and some rice husk (*Oryza sativa*) was also added to this mix in minimum quantity. The plant extract mixed in the soil + lime + aggregate is as per requirement avoiding any excess pouring. Figure 3 shows various steps applied in the preparation of mud mortar at Ajanta as per ancient recipes.

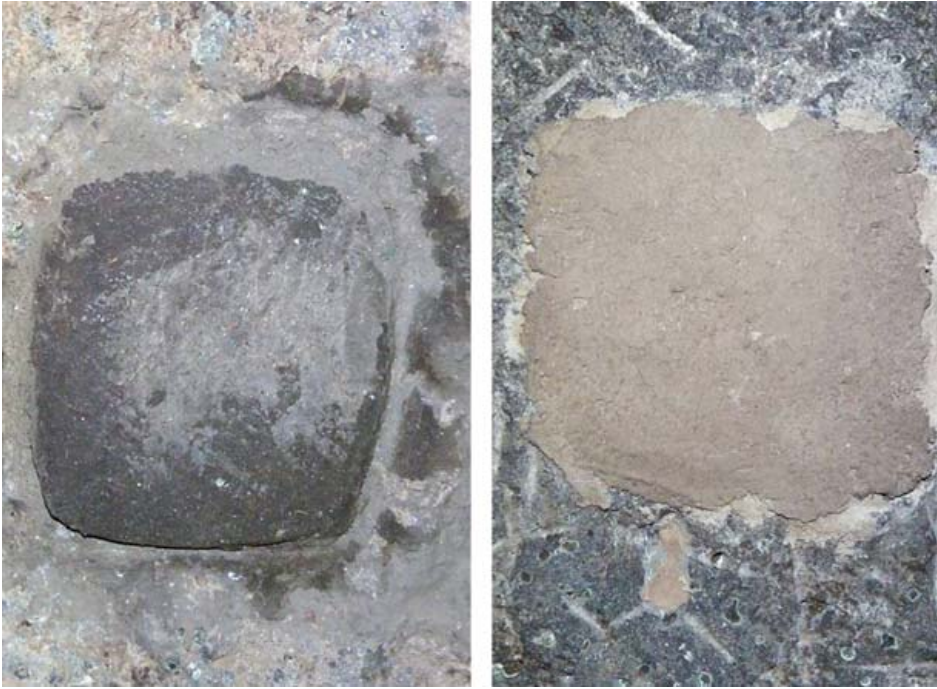
Fig. 4. Application of mud mortar on basaltic stone

For the application of mud mortar on the wall, the basaltic stone surface was previously prepared. It was dry brushed and plant extract juice was applied with paint brush on the required area. Thereafter, the mortar mix was applied on top of the surface with care and precautions. The thickness of the mud mortar layer was kept to about 1 to 1.5 cm. Figure 4 shows the experimental area where mud mortar was applied for testing on basaltic stone surface as per ancient recipes. The mortar is being observed since about 15 years for its behavior in the identical environment. The shrinkage observed in the mortar after drying in the cube was negligible.

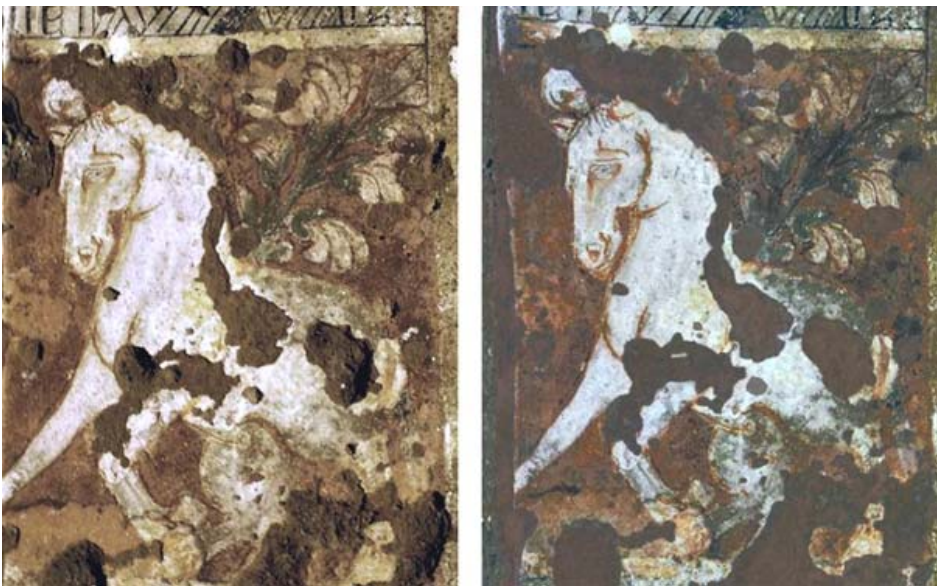
Fig. 5. Consolidation of paintings with newly prepared mud mortar

For application of this mortar mix during scientific consolidation, the edges of the old mortars were first secured with the plant extract juice and the prepared mud mortar mix was filled in the gaps following all norms of consolidation of painted mortar. Figure 5 depicts an area consolidated with mud mortar mix at Ajanta. It was observed that mortar has properly

adhered within the filled area of gap in the painting where loss of earlier mud mortar was observed on the painted surface. Such filling not only ensures continuity of the similar material but also show similar aging effect.

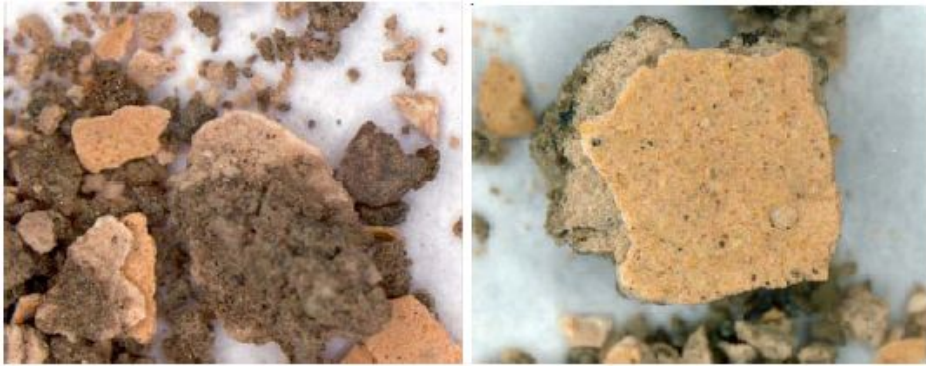
Although ancient Indian painting text were written after Ajanta, it is worthwhile to explore where what is written in the text are in consonance with the technique employed at Ajanta. Further, it is also interesting to explore whether the technique of Ajanta painting remained same in all the caves or it differs. As the sampling is a problem, only two samples extracted from cave 15 and cave no.1 were photographed with stereomicroscope and recorded with video microscope. On observing the sample of cave no. 15 under stereomicroscope Figure 8, it appears to be made up of thin layer of yellow ochre color (IV) with occasional red particles, below it is a thin white layer (III).

A thicker pinkish yellow preparatory layer (II) can be observed below white layer (III) with black granular impurities, the deeper layer of grey color represent preparatory layer (I) within the granular mass. On observing the sample under stereomicroscope after attack with 10% hydrochloric acid solution, effervescence develops and pinkish yellow layer dissolves completely indicating a carbonic composition. It is also observed that grey mud mortar (I) does not dissolve but loses aggregation due to the reaction of acid to the traces of lime present in mortar. The layer IV and III do not react with the acid.

Fig. 8. Stereomicroscopic image of painted mortar of cave no. 15, Ajanta

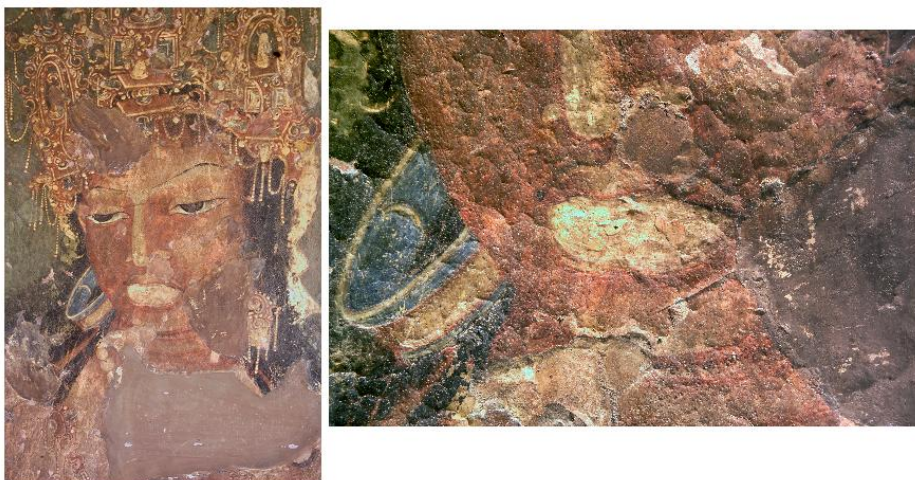
Figure 11 shows one such view where inner pigment layer are seen due to the loss of fraction of outer pigment layer. Perhaps, the reasons for application of succession of pigment layers is to get very good depth to the paintings.

Fig. 11. View of inner pigment layer due to loss of fraction of outer layer, cave no.1, Ajanta
