CONSERVATION AND REVITALIZATION OF SACRED ARCHITECTURE IN THE SECOND HALF OF THE 20th CENTURY

Aleksandra REPELEWICZ^{1,*}, Izabela MAJOR¹, Kinga JEŻ¹

¹ Czestochowa University of Technology, Faculty of Civil Engineering, Department of Civil Engineering, Akademicka Street 3, Czestochowa 42-218, Poland

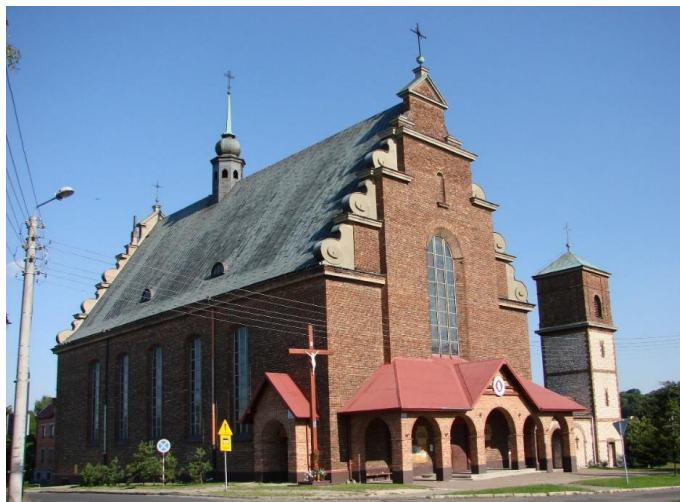
An example of a not-so-successful reconstruction is the Church of the Exaltation of the Holy Cross (Fig. 1). This church, erected in 1949-56, was designed by engineer Sachse (the designer's first name could not be established) in a convention reminiscent of the Renaissance style. It is a building with a rectangular floor plan, covered with a gabled roof. In the side façades, tall, slender windows are capped with flat arches. The front and rear façades were varied with masonry projections and horizontal cornices, as well as spiral volute tracery. In 2018, a large canopy over the main entrance and a smaller one over the side entrance were added to the church's front façade.

Fig. 1. Front and side façade of the Church of the Exaltation of the Holy Cross

The investor's motives are understandable - to protect the front door and worshippers entering the church from rain and this function is indeed fulfilled by the new element of the building. In turn, the form and, in particular, the materials used are completely mismatched with the style of the building. What is particularly striking is the use of red corrugated sheet metal, juxtaposed with the noble patina of the copper sheet covering the main body of the church. Even the light color of the new bricks stands out unpleasantly against the dark red of the old brick façade. Practical considerations completely predominated over the desire to preserve the original style of the original building.

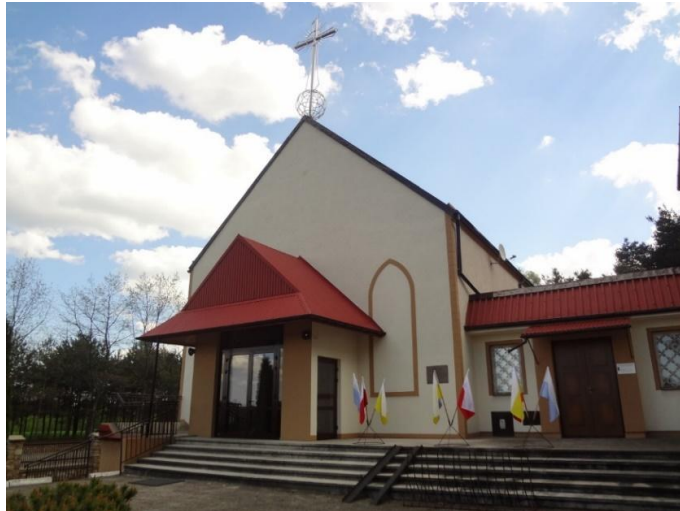
A similar example is the church of St. John the Baptist in Libidza (Fig. 2). Designed in 1983 by Henryk Cekiera, this small, single-nave building with a very simple, proportional form was expanded ca. 2009. A porch was added to the front façade, topped with a half-gable roof. The typically modernist body of the building is now adjacent to a porch whose gabled roof does follow the angle of the slope of the main building, but its style refers to regional construction, disrupting the stylistic uniformity of the building.

Fig. 2. Front and side façade of the church of St. John the Baptist in Libidza

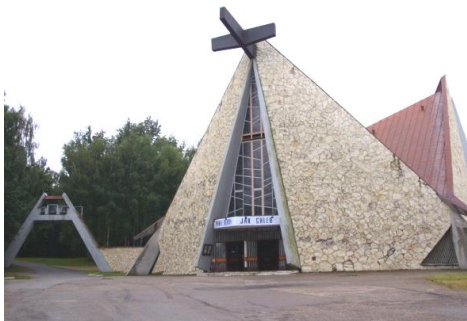
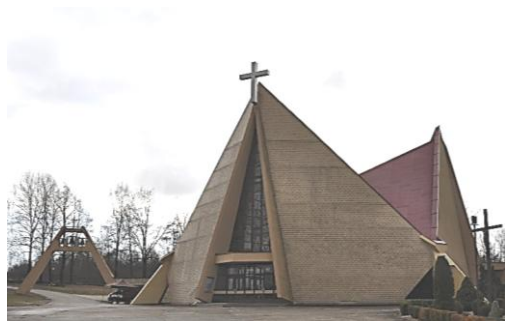
Fig. 3. Front façade of the church of the Most Holy Body and Blood of Christ in Wrzosowa before renovation (a) and after renovation (b)

The Church of the Most Holy Body and Blood of Christ in Wrzosowa was the first one in the diocese of Częstochowa to receive a building permit after 1970. Marian Ficenes was the designer and construction was carried out from 1974 to 1978. It is an example of late modernism with a roof-and-wall configuration. The body of the church consists of three parts, resembling open tents meeting in the middle of the temple (Fig. 3). Stained glass windows were placed in the openings. In the entrance section, a massive cross was placed diagonally at the original highest point, on an extension of the ridge, which appeared to support the entire structure. The entirety symbolizes the three tents of Mount Tabor.

The sloping walls of the building were covered with local limestone, a characteristic of the Kraków-Częstochowa Upland. Due to the slope of the walls, moisture was appearing in the interior, so the decision was made to replace the front wall cladding. Rectangular façade tiles were used and on this occasion the diagonal cross was removed and replaced by a smaller vertical one. This cross no longer symbolically supports anything, which has impoverished the symbolism of the entrance area. The renovation work has completely changed the expression of the temple. It should be added that the new façade, after several years of use in the lower parts of the walls, is already damaged; some of the tiles have fallen off, while others are splintered.

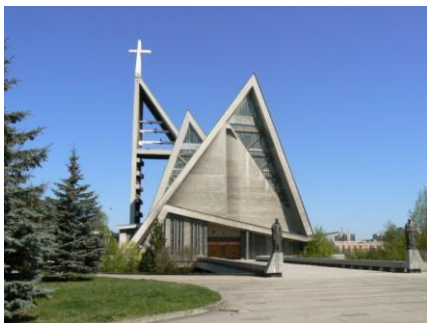
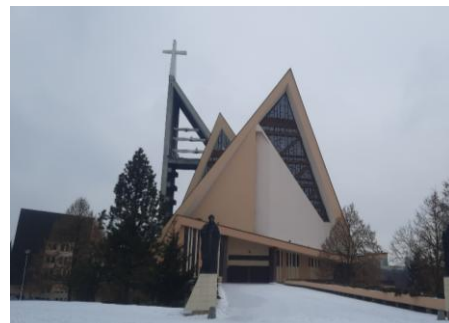
St. Adalbert's Church is one of Częstochowa's most distinctive religious buildings (Fig. 4). Designed in 1975 by Antoni Mazur, it was built in 1977-1985. The concept of this modernist building was based on the offset of the unequal triangular prisms that mark the arch divisions. Lighting of the interior is provided by openwork planes, which were created by shifting the solids against each other. They are filled with glazed latticework. The roofs have varying slopes, which can be interpreted as a symbolic reference to "M," as in Mary. The renovation of the façade of St. Adalbert's Church, carried out almost 40 years after the building was put into use, was combined with a change in the color scheme. The use of warm shades of beige slightly changed the austere expression of the formerly white and later white-gray, walls. It is certainly debatable whether this is a beneficial change.

Fig. 4. Front façade of St. Adalbert's Church in Częstochowa before renovation (a) and after renovation (b)

St. Adalbert's Church is affected by yet another upgrade, related to the use of too much space for the current needs of the parish. According to the project's data, the volume of the entire facility is 24,000m³ and the development area is 1,400m². The ground floor area of the building, which includes the nave and chancel, is about 940m². The building has a full basement and there is a large chapel under the nave. The sacral part is connected to a six-story catechetical building. Since then, 3 new parishes have been established in the "Północ" district to fully meet the needs of the district's residents. Two new churches were built in the

“Tysiąclecie” district, within the boundaries of the parish of St. Adalbert. As a result, the number of parishioners was significantly reduced. The cost of maintaining such a large facility fell on a relatively small number of believers. In search of additional uses for the currently too-large space, the catechetical building currently houses a community elementary school and physical therapy offices have been organized in part of the ground floor. The use of additional space for educational and health-related purposes does not conflict with the primary function of the structure. Nor does it affect the exterior form of the building.

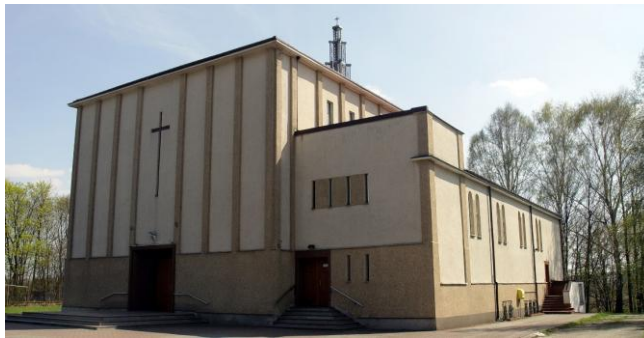
An example of a renovation that preserves the original character of a building is the façade of the Church of Divine Providence in Częstochowa (Fig. 5). Renowned Częstochowa architect Edward Usakiewicz designed the church building in functionalist style in 1948 and construction was completed by 1950. The church has a two-nave structure with the nave and a smaller side aisle on the west side. The body is made up of cuboids of varying heights and widths, covered by two-sided and single-sided roofs with a slight slope. From ground level, these roofs are invisible, enhancing the impression of simplicity and cubic form of the building's body. The rows of narrow rectangular windows in the nave are characteristic of Usakiewicz's work. Simplicity of form and its subordination to function were his hallmark. The church has already been plastered in the 21st century with great respect for the original form and preservation of the color scheme. No additional element was added to any of the façades. The last example is the Church of the Immaculate Heart of Blessed Virgin Mary in Czarny Las, designed in 1984 by T. Krzyrkowski as a catechetical building (Fig. 6).

Fig. 5. Front and side façade of the Church of Divine Providence in Częstochowa

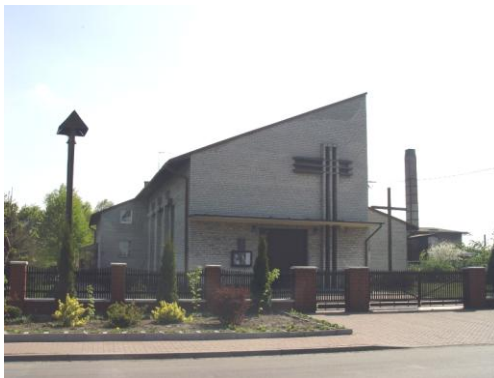
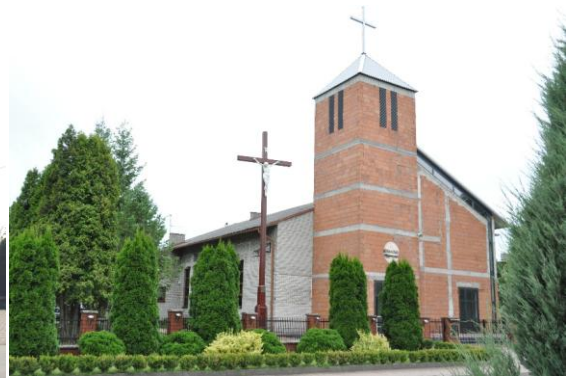
Fig. 6. Front and side façade of the Church of the Immaculate Heart of the Blessed Virgin Mary in Czarny Las, before expansion (a) and after expansion (b)

During construction, the conversion of the catechist chapel into the nave and the adjacent catechist room into the chancel was introduced by removing the partition wall between these rooms. This type of treatment was deliberately introduced at the time of obtaining a building permit, as it was then easier to obtain a permit to build a so-called “catechism point” than a church. In addition to its sacred role, the building also has a residential function; the living quarters are located above the chancel, which seems rather unusual.

The multitude of functions determined the shape of the building, in which it is difficult to discern a particular architectural style. In the 1920s the church was expanded, with a porch located in the entrance area and a tower above it, giving the building a religious character. The tower is not yet plastered; construction work is ongoing. The tower is a simple prism shape with a hipped roof and narrow openings at the top. It refers to the Romanesque style. The expansion appears to be to the benefit of the building, the exterior appearance of which had previously not emphasized its proper function. The building was given a sacred character.
