LEISURE ARCHITECTURE OF THE 1960s and 1970s AS AN EXAMPLE OF POST-WAR MODERNISM

Abstract

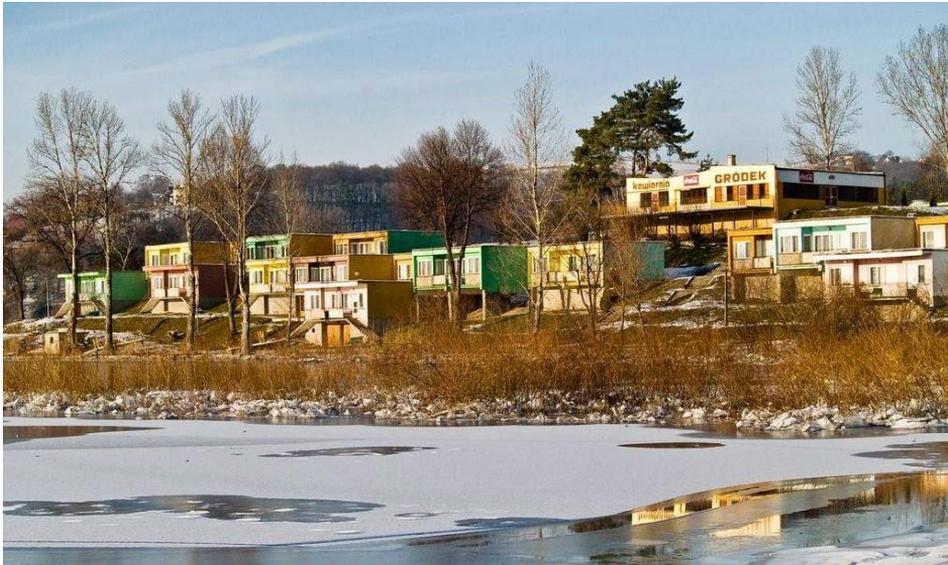
Fig. 1. Resort in Gródek nad Dunajcem - historical photo, source of the photo:

Lemon Resort Spa in Gródek nad Dunajcem is an example of successful revitalization of a post-war recreational center originally built in the 1970s as a typical holiday facility for workers of one of Kraków's industrial plants (Fig. 1). The complex is located picturesquely on the shores of Lake Rożnowskie, surrounded by greenery and the hilly landscape of the Rożnowski Foothills, which from the beginning supported rest and integration with nature.

The original complex was distinguished by thoughtful modernist architecture – it consisted of several pavilions with clear, simple forms and a low building scale. The buildings were designed with functionality and harmony with the surroundings in mind. Positioned in terraces on a slope, they naturally blended into the terrain. Characteristic features were horizontal

bands of windows and wide balcony doors, which not only provided excellent interior lighting but also established a connection between users and the landscape of the lake and green hills.

The spatial arrangement of the objects was simple, logical, and functional, referring to typical solutions used in recreational architecture of the 1960s and 1970s. The constructions were based on a skeletal system, mainly reinforced concrete, with flat roofs and minimalist façades. The materials originally used were primarily concrete, glass, steel, and local façade materials, complemented by prefabricated elements. Altogether, this created a coherent and modern complex for its time, well connected with the natural environment.

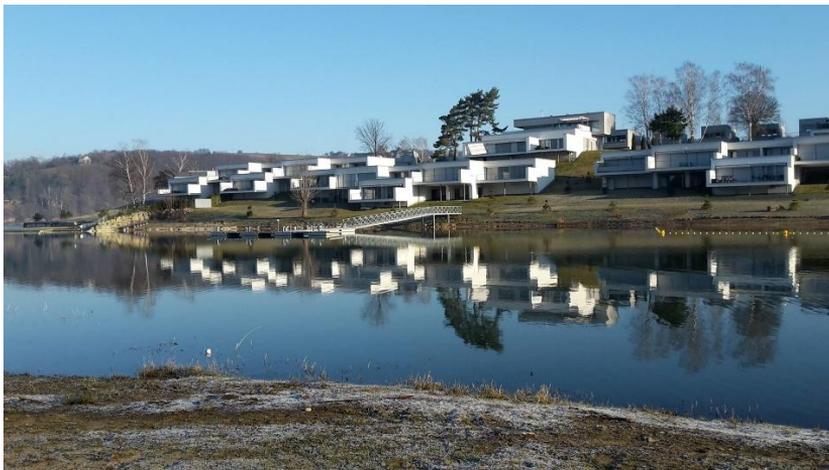
Fig. 2. Hotel Lemon Resort Spa, source of the photo:

Over time, the facility gradually lost its appeal, and its technical condition deteriorated. A turning point came in 2012 when the entire complex was taken over by a new investor who aimed to preserve its modernist character while adapting it to contemporary hotel standards. The revitalization was based on respect for the original architectural fabric – existing volumes and spatial layouts were preserved, and glazing was enlarged to enhance the connection with the landscape.

Technological improvements included new heating and ventilation systems, energy-efficient windows, and ecological finishing materials such as wood, Corten steel, and stone. The interiors were renewed in a minimalist spirit with subtle allusions to the 1970s, giving the whole a historical and aesthetic coherence.

Thanks to these measures, Lemon Resort Spa retains the architectural identity of the original center while gaining new function and quality (Fig. 2). This example demonstrates that recreational architecture from the Polish People's Republic era – well-designed and rooted in the landscape – can today be a valuable resource for creative revitalization rather than merely a relic of the past. It is worth noting, however, that the complex itself is rarely associated with 1960s and 1970s architecture and is more often seen as a modern, luxurious complex, which may indicate that social perception of this era remains ambiguous and does not necessarily involve appreciation of its architectural heritage.

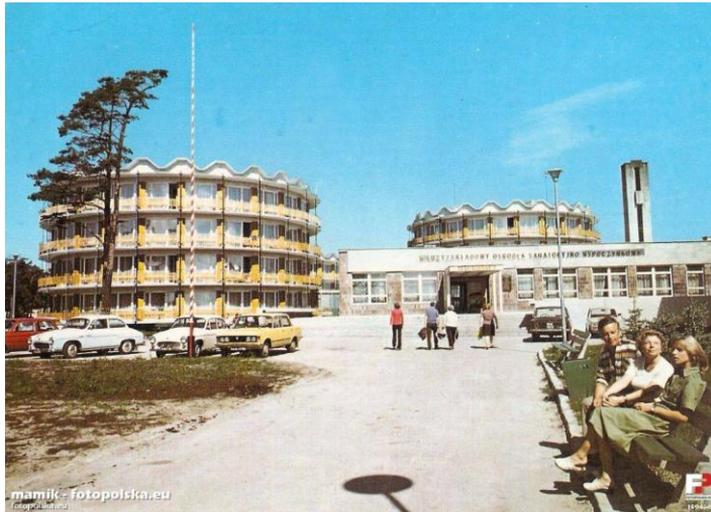
Fig. 3. Resort "Lucień" in Miąkówkę - historical photo, source of the photo:

The "Lucień" Resort in Miałkówek is a distinctive example of recreational architecture from the Polish People's Republic era, established in the second half of the 1970s at the initiative of the Żyrardów Linen Industry Plants (Fig. 3). The complex is located by Lake Lucieńskie, surrounded by forests, providing an environment close to nature for the relaxation of workers and their families. The project was designed by engineer-architect Stanisław Różga and includes four round hotel buildings connected by glass corridors, along with an L-shaped service and office pavilion and supporting facilities. The resort offered over 120 rooms with bathrooms, a dining hall, conference rooms, playgrounds, and extensive sports infrastructure, making it one of the most modern facilities of its kind in the region.

Their unique form and location continue to attract interest from researchers, architects, and enthusiasts of history and industrial tourism. The characteristic geometric forms of the round buildings and the functional spatial arrangement, with glass corridors connecting the segments, reflect modernist efforts to integrate interiors with the surroundings and provide users with contact with nature. The complex's location amid forests and near the lake strengthened the relationship between architecture and landscape, while panoramic glazing and terraces allowed appreciation of natural values, aligning with contemporary design assumptions. The buildings were constructed using a reinforced concrete frame technology with prefabricated elements, consistent with industrial building trends during the Polish People's Republic era. The use of flat

roofs, wide glazing, and ceramic cladding reflected modernist aesthetics. Interiors were finished with natural materials such as wood and stone, complemented over time by elements typical of the 1970s, including synthetic floor coverings and decorative fabrics.

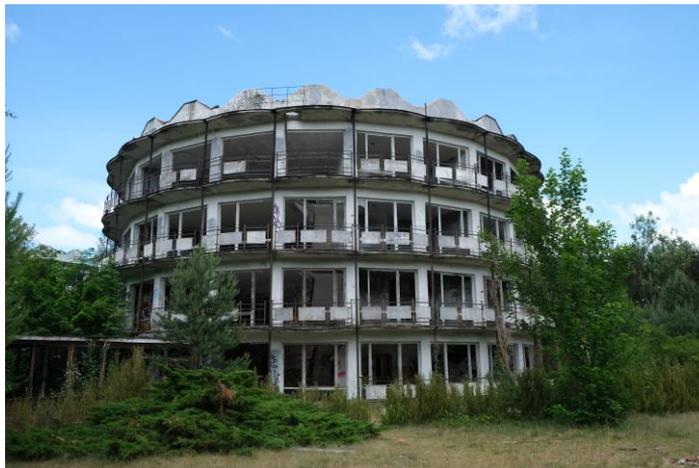
Fig. 4. Resort "Lucień" in Miąkówkę—current condition

After a period of intensive use related to the operation of the linen factories, the resort passed into private hands following the company's bankruptcy in 1997. Despite attempts to continue tourism activities by successive owners, rising maintenance costs, an outdated heating system, and lack of investment led to the gradual deterioration of the facility's technical condition and a decline in guest interest. Ultimately, in 2007, the resort was closed and has since steadily fallen into ruin, becoming an example of forgotten post-war recreational architecture heritage. In recent years, the resort has been put up for sale several times, but due to its poor technical condition and high renovation costs, no restoration efforts have been made. Despite ongoing degradation, the resort in Miałkówek remains an important testimony to the architecture and culture of 1970s leisure time (Fig. 4).

Contemporary technical assessments of the building show advanced degradation, including reinforcement corrosion, concrete cracking, and destruction of original details, resulting from years of neglect and exposure to adverse weather conditions. The lack of ongoing repairs led to the loss of many authentic elements, such as concrete reliefs and mosaics, posing significant challenges for future restoration work. Modern approaches to adapting such objects should combine reconstructing historic details with using modern, energy-efficient building

materials and technologies such as thermal insulation panels and ecological heating systems, enabling functional restoration while preserving heritage value.

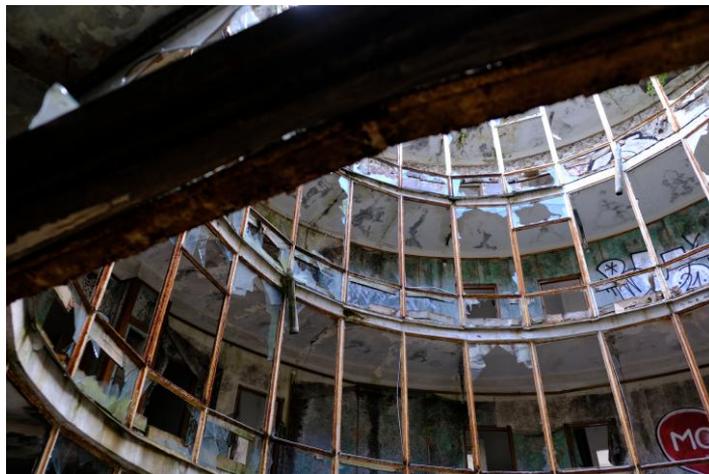
Fig. 5. Resort "Lucień" in Miąkówka—current condition

Urban analyses and evaluations of architectural and landscape relationships indicate that "Lucień" harmoniously fits into its environment thanks to well-thought spatial solutions such as pathways and greenery promoting recreation (Fig. 5). Despite its ongoing degradation, the spatial layout and unique form of the object have preserved adaptive potential and serve as an important reference in studies on the heritage of post-war modernism in Poland.

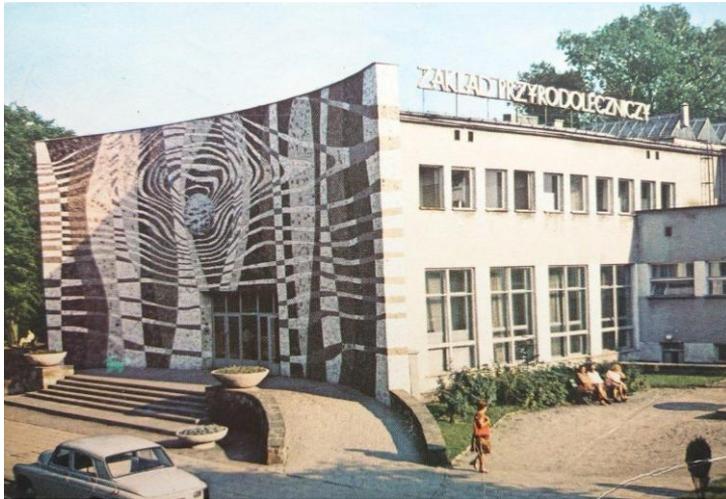
Fig. 6. Resort in Kołobrzeg - historical photo, source of the photo: <https://vivarium.com.pl/www/pliki/produkty/7cde7b6641e6068560a3d55bc57275c2.jpg>, date of access: 05.09.2025

The resort in Kołobrzeg, also known as Sanatorium Mewa V, is one of the most representative examples of modernist spa architecture in Poland, built in the second half of the 1960s. Designed by Tadeusz Cwierzdzński and Zofia Eldring, it was commissioned in 1968 as part of the development of the state medical and recreational infrastructure. The facility is located in the heart of the Kołobrzeg Spa District, bordered by the streets Rafińskiego, Ściegiennego, Zdrojowa, and Konopnickiej, providing convenient access to urban infrastructure and proximity to parks and green areas conducive to relaxation and therapy (Fig. 6).

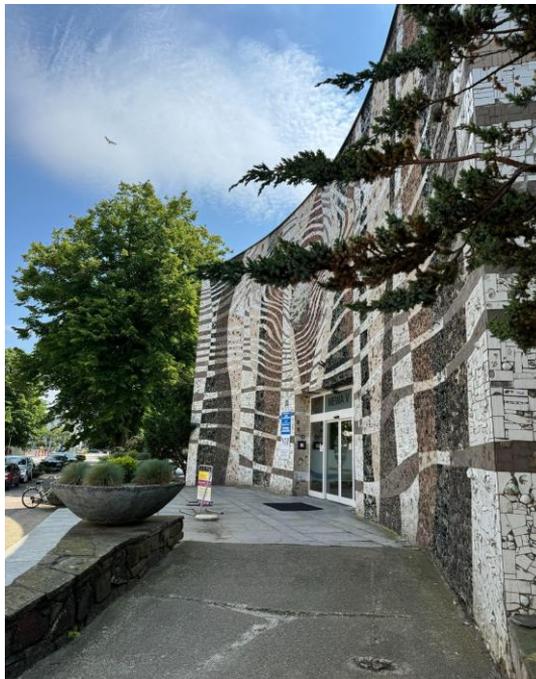
Fig. 7. Resort in Kołobrzeg – current condition

The architecture of the resort in Kołobrzeg is based on modernist principles – the building consists of two rectangular volumes stacked on each other: a longer one along the east-west axis and a shorter, lower one along the north-south axis. This layout allowed efficient use of the plot and the creation of two internal courtyards integrating space around the medical functions. The volumes vary in height and include, among others, a ground floor, a high ground floor, and an upper floor. The building's façades are adorned with horizontal bands of windows, providing good interior lighting and visual connection with the surroundings. Despite the lack of balconies, large glazed surfaces establish a relationship between the interior and the external landscape (Fig. 7).

The structure of the building is based largely on a reinforced concrete framework, which was typical for recreational architecture of that period. The façades are kept in a minimalist style, dominated by concrete, glass, and steel, with decoration limited to a single but highly striking accent: a monumental ceramic mosaic by Irena Zahorska and Olgierd Szerłağ. Located at the

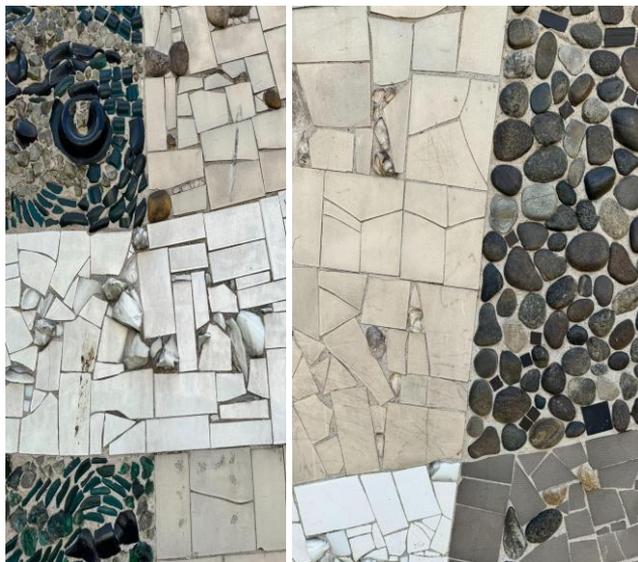
Fig. 8. Resort in Kołobrzeg—detail of the mosaic façade

main entrance from Rafińskiego Street, the mosaic forms an arch spanning two stories, serving as an excellent example of the use of art in modernist public spaces and emphasizing the unique character of the building.
