## ASSESSMENT OF URBAN-ARCHITECTURAL COHERENCE IN HISTORIC URBAN FABRIC: A CASE STUDY OF ALEJA NAJSWIETSZEJ MARYI PANNY IN CZESTOCHOWA

This paper attempts to assess the urban and architectural coherence of the historical development of Aleja N.M.P in the context of the changes made in the period from the end of World War II to the present.

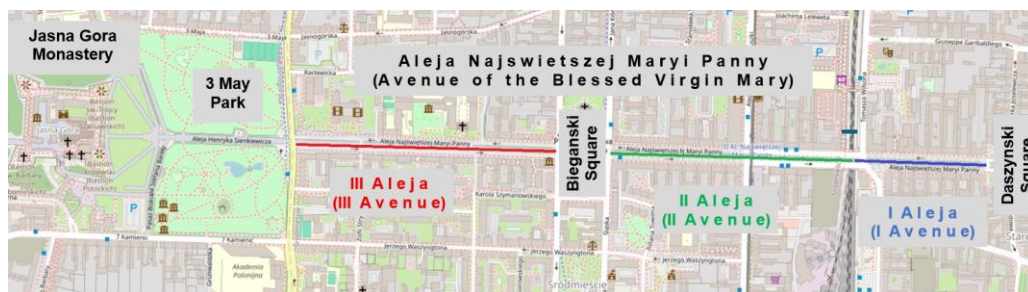
**Fig. 1.** Layout of Aleja Najświętszej Maryi Panny divided into I, II, and III Aleja.  
Source: Author's own elaboration based on © OpenStreetMap contributors [5]

Both cities developed in parallel until the beginning of the 19<sup>th</sup> century, when work began on connecting them. Today's Aleja Najświętszej Maryi Panny (Aleja N.M.P.) was marked out, connecting both urban organisms. On August 9, 1826, the merger of both cities into one common center was officially approved, which from then on was called Czeszochowa, with an estimated population of about 5,000 people [4]. The designated avenue was divided by three squares: Nowy Rynek (now Daszyński Square), Rynek Jakuba (now Bieganski Square), and Rynek Jasna Góra (now the area in front of the Jasna Góra Monastery). Based on these squares, an informal division of Aleja Najświętszej Maryi Panny (Avenue of the Blessed Virgin Mary) was adopted into I Aleja (I Avenue) from Daszyński Square to the viaduct over the railway tracks, II Aleja (II Avenue) from the viaduct to Bieganski Square, and III Aleja (III Avenue) from Bieganski Square to the parks near Jasna Góra—3 May Park (Fig. 1).

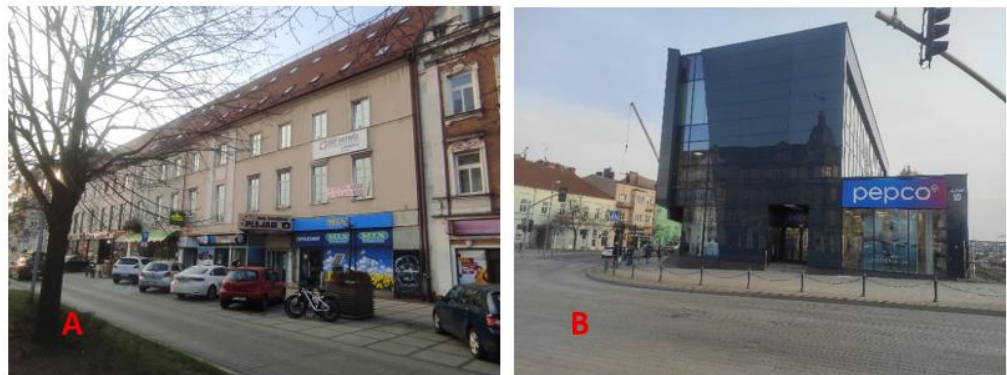
The average total score for the analyzed buildings on I Aleja was 3.35 points, which indicates a very moderate cohesion of the studied group with the rest of the development. This rating is lowered by the second analyzed building – no. 15. This is primarily due to the failure to preserve the historic architectural style (modern architectural form), materials used (glass and metal), function, and a completely different façade layout (a uniform, smooth plane of glass divided by vertical and horizontal metal elements) (Fig. 2B). The second building refers stylistically to the existing development, and its cohesion is much higher (Fig. 2A).

**Fig. 2.** Analyzed buildings: A – Aleja N.M.P. No. 12, B – Aleja N.M.P. No. 15.

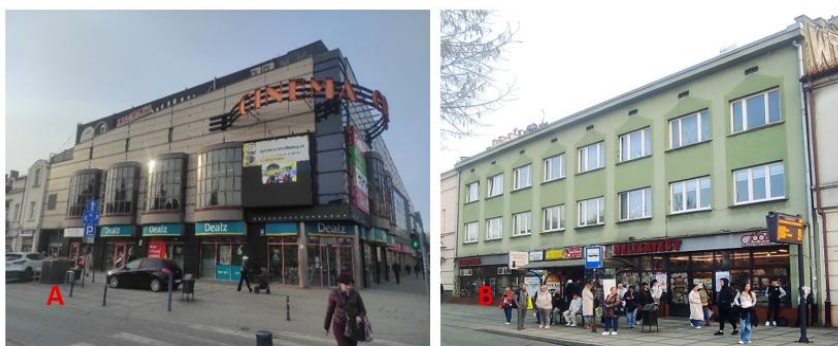
The obtained results allow us to conclude that the urban and architectural coherence for the studied group is moderate, except for building no. 26, whose assessment differs significantly from the others due to its diametrically different architectural style, materials used, and function (Fig. 3A). Buildings 21, 39/41, and 40/42 received higher scores, although they clearly stand out against the background of the historical buildings of II Aleja (Fig. 3B).

**Fig. 3.** Analyzed buildings: A – Aleja N.M.P. No. 26, B – Aleja N.M.P. No. 21.

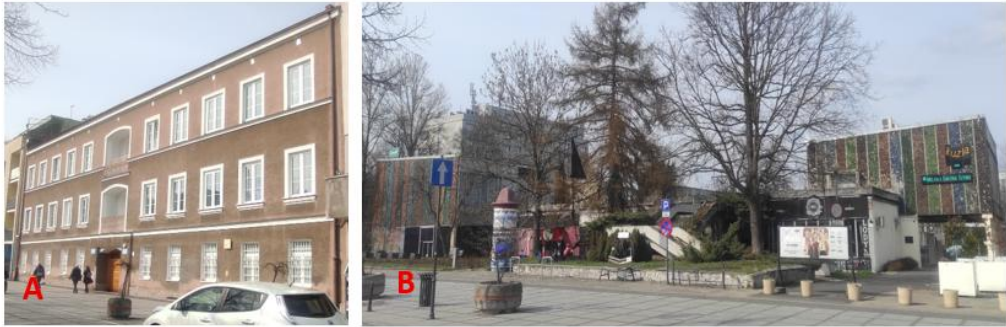
In the case of III Aleja, the number of buildings constructed after World War II and those that have undergone significant modernization is 63% of the total. This confirms the visual impression that this section of Aleja N.M.P. has undergone the most significant transformations in the last eighty years. The average rating for the analyzed group of buildings is 4.00, which allows us to conclude that the urban and architectural coherence of the studied group is good. The building that received the highest rating (no. 58/60) is the former Maliszewska tenement house – a historic building in which, as a result of subsequent renovations, certain architectural details have been simplified, but its historic character has been preserved (Fig. 4A). The building with the lowest rating is a structure built in the second half of the 20<sup>th</sup> century, which currently houses

the Municipal Art Gallery and conducts commercial and catering activities. It differs from the rest of the development in terms of architecture, function, and location (Fig. 4B).

**Fig. 4.** Analyzed buildings: A – Aleja N.M.P. No. 58/60, B – Aleja N.M.P. No. 64.

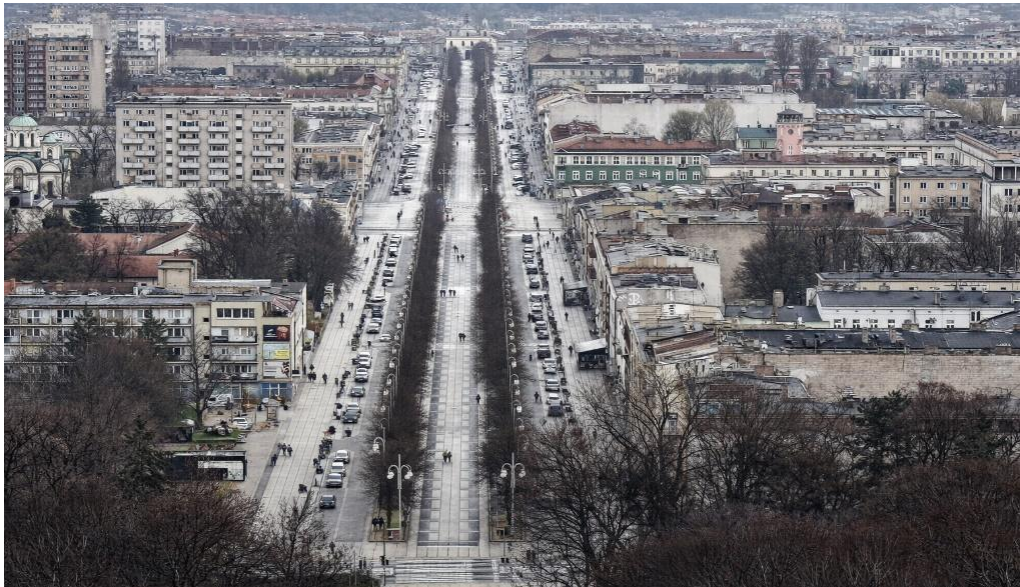
Assessing the urban and architectural coherence of the entire Aleja N.M.P., it can be concluded that the changing development has not disturbed its compositional axis. The visual axis between Jasna Góra Monastery and St. Sigismund's Church has been preserved, and almost all buildings on both sides of the avenue maintain the building line (Fig. 5).

**Fig. 5.** Panorama of Aleja Najświętszej Maryi Panny in Częstochowa
